**THIRD FIVE-YEAR REVIEW REPORT FOR
BOUNTIFUL/WOODS CROSS 5TH S. PCE PLUME SUPERFUND SITE
DAVIS COUNTY, UTAH**

Prepared by

Division of Environmental Response and Remediation

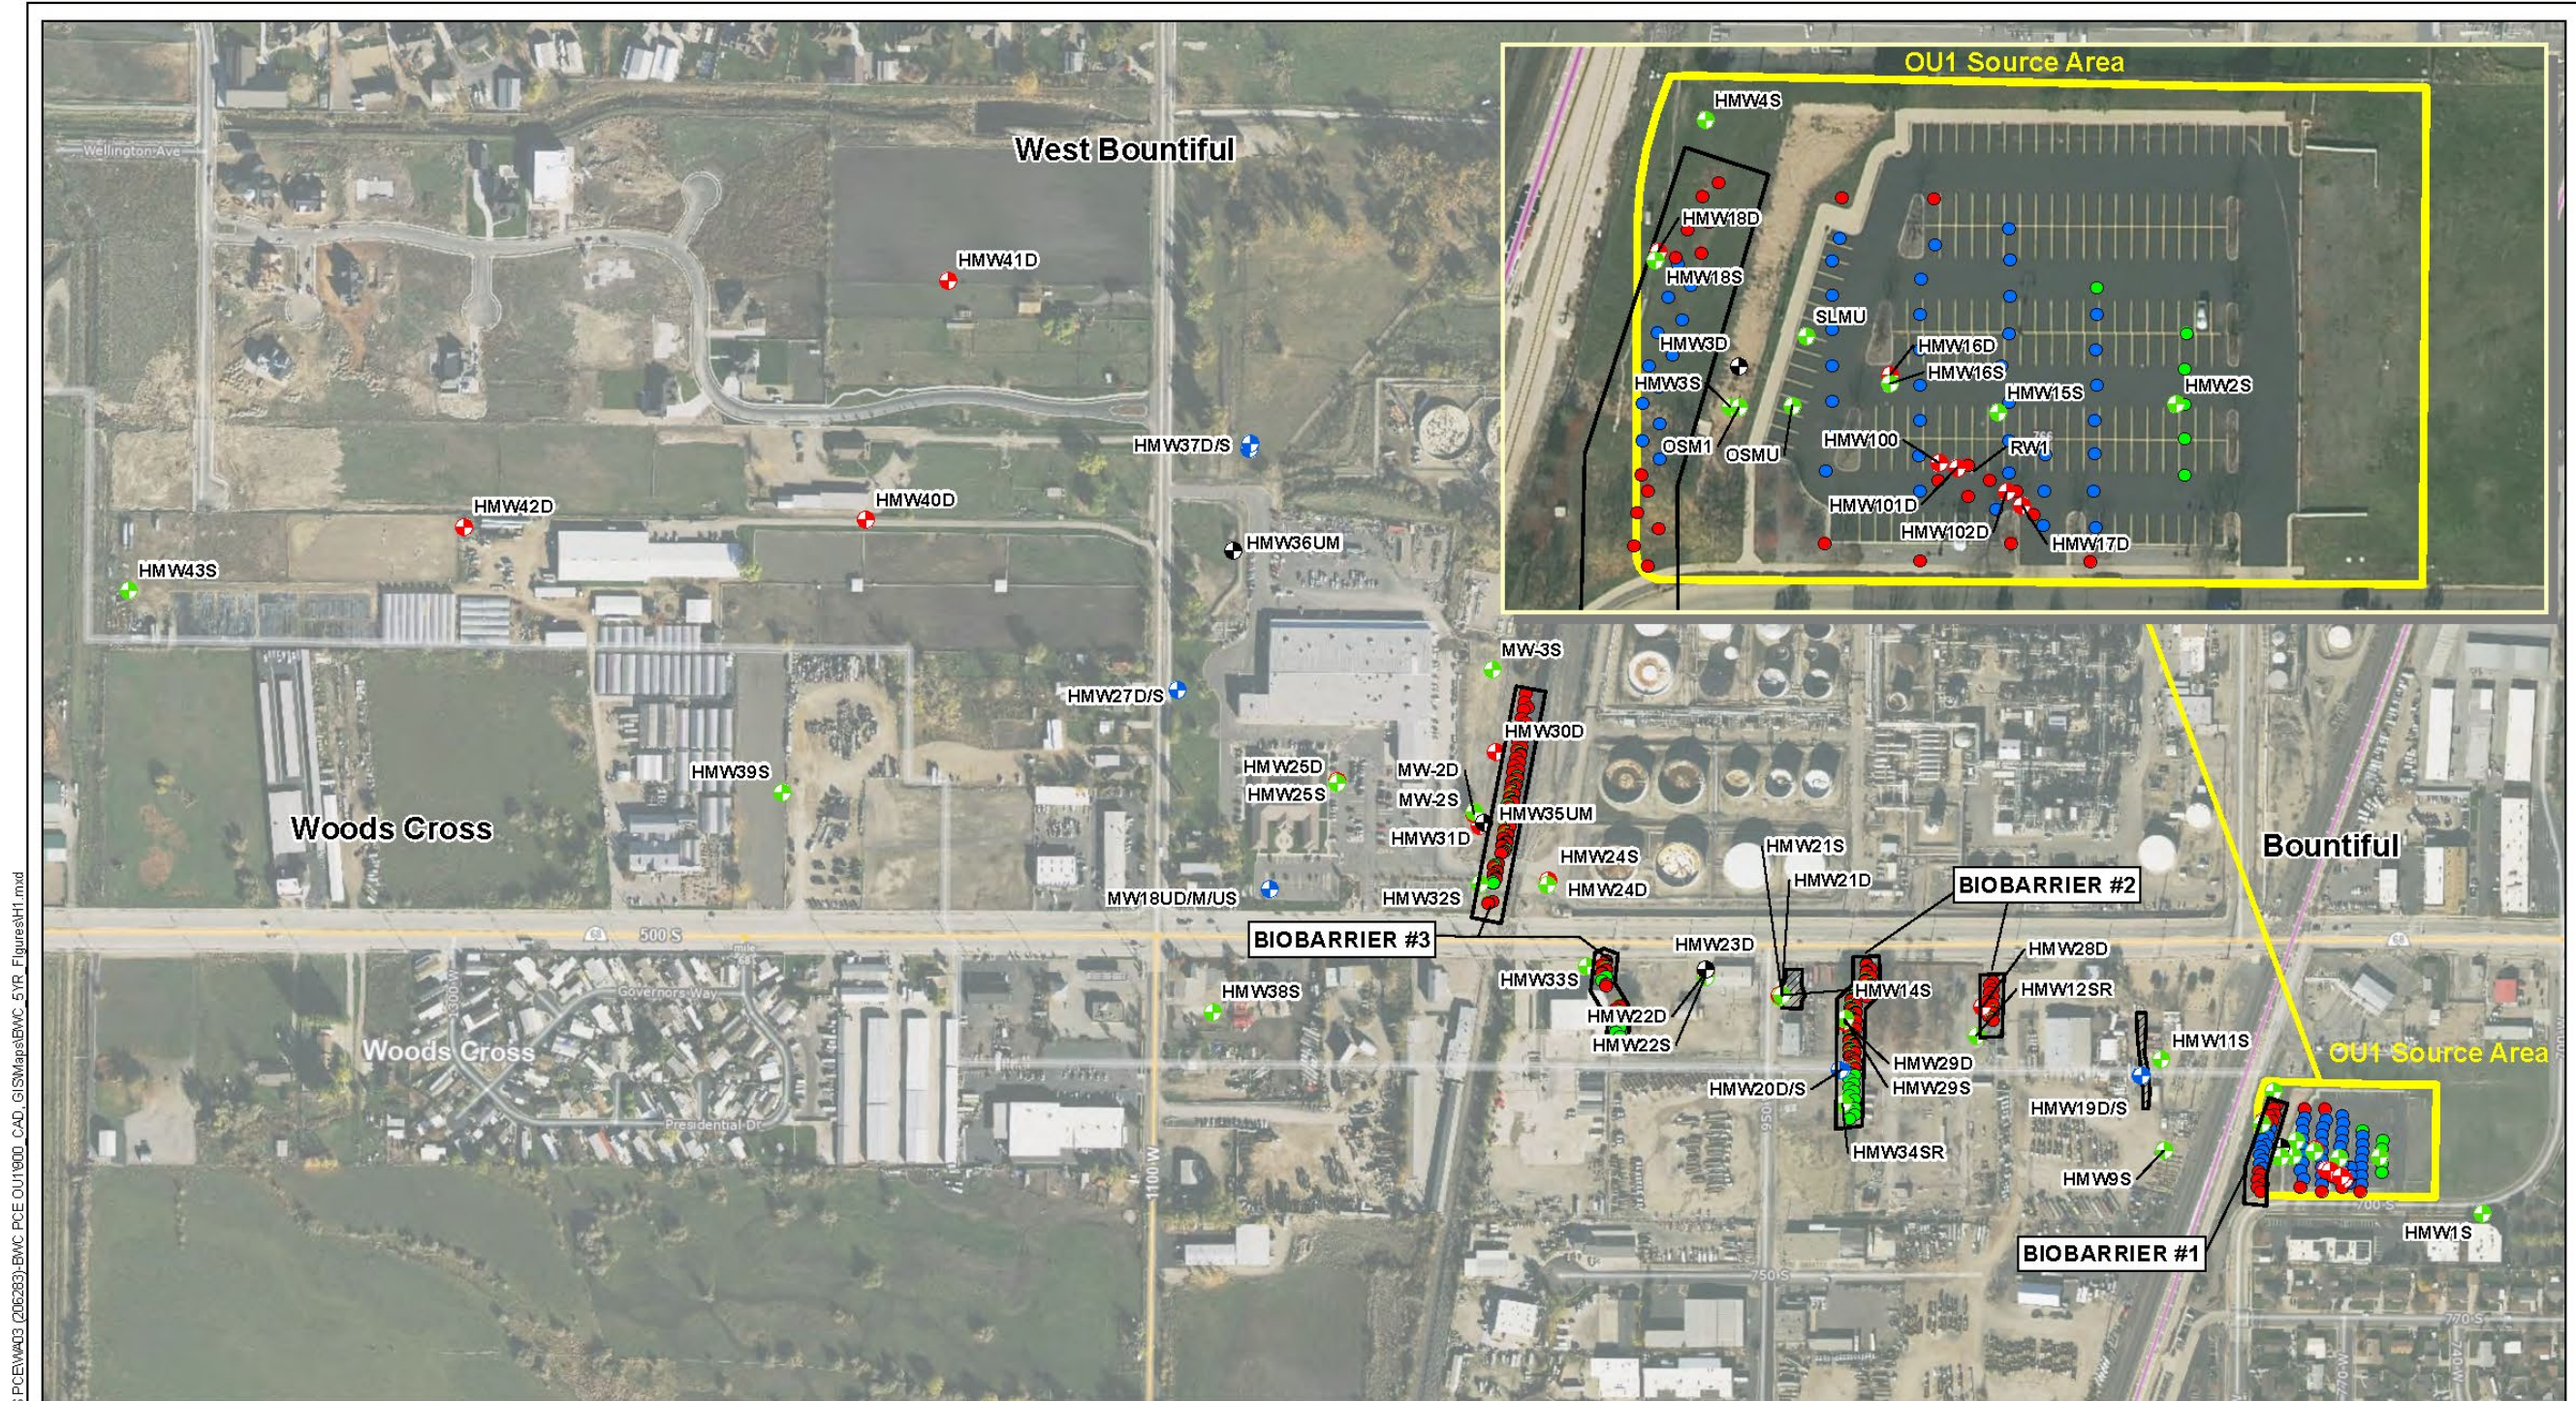
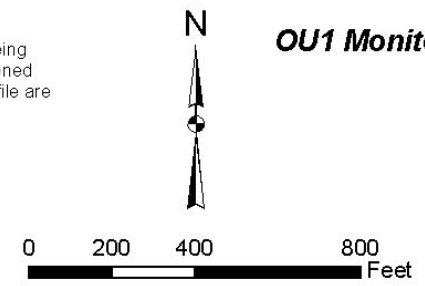
Figure H-1:
OU1 Monitoring Well and Biobarrier Locations
 Bountiful/Woods Cross
 5th South PCE Plume
 Operable Unit 1
 2021 (13th) Annual Monitoring Report

The EPA completed the OU1 remedial design between December 2006 and September 2007. During the remedial design, the EPA observed groundwater contamination at a depth of 70 to 80 feet in the shallow aquifer, which is deeper than the 50-foot depth identified during the RI. Thus, injection wells were installed – shallow wells, paired wells at shallow and deep intervals, and deep wells to address subsurface soil and groundwater contamination. The EPA began on-site remedial action in September 2008, and the baseline sampling took place between October and November 2008. From December 2008 to February 2009, the EPA installed the source area and biobarrier #1 injection wells and injected slow-release electron donor solution (emulsified oil) and distributed bacteria capable of reductive dechlorination, followed by additional electron donor injections in 2010 (source area and biobarrier #1) and 2012 (biobarrier #1 only). In addition, periodic lactate injections have been completed in two localized areas of elevated contamination (hot spots) near monitoring wells HMW-17D and HMW-18D to promote more rapid degradation of contaminants. From July 2012 to November 2016, additional monitoring and injection wells were installed in the source area and biobarrier #1, followed by injections in these areas. In January 2017, the EPA completed targeted sodium lactate injections in the source area and hot spots. In July 2017, the EPA completed a more aggressive treatment approach of biorecirculation with permeability enhancement at the source area and within the hot spot located at well HMW-17D. UDEQ completed additional combined sodium lactate/emulsified oil injections in the source area in August 2020. Figure H-1 shows the locations of the OU1 wells and biobarriers.

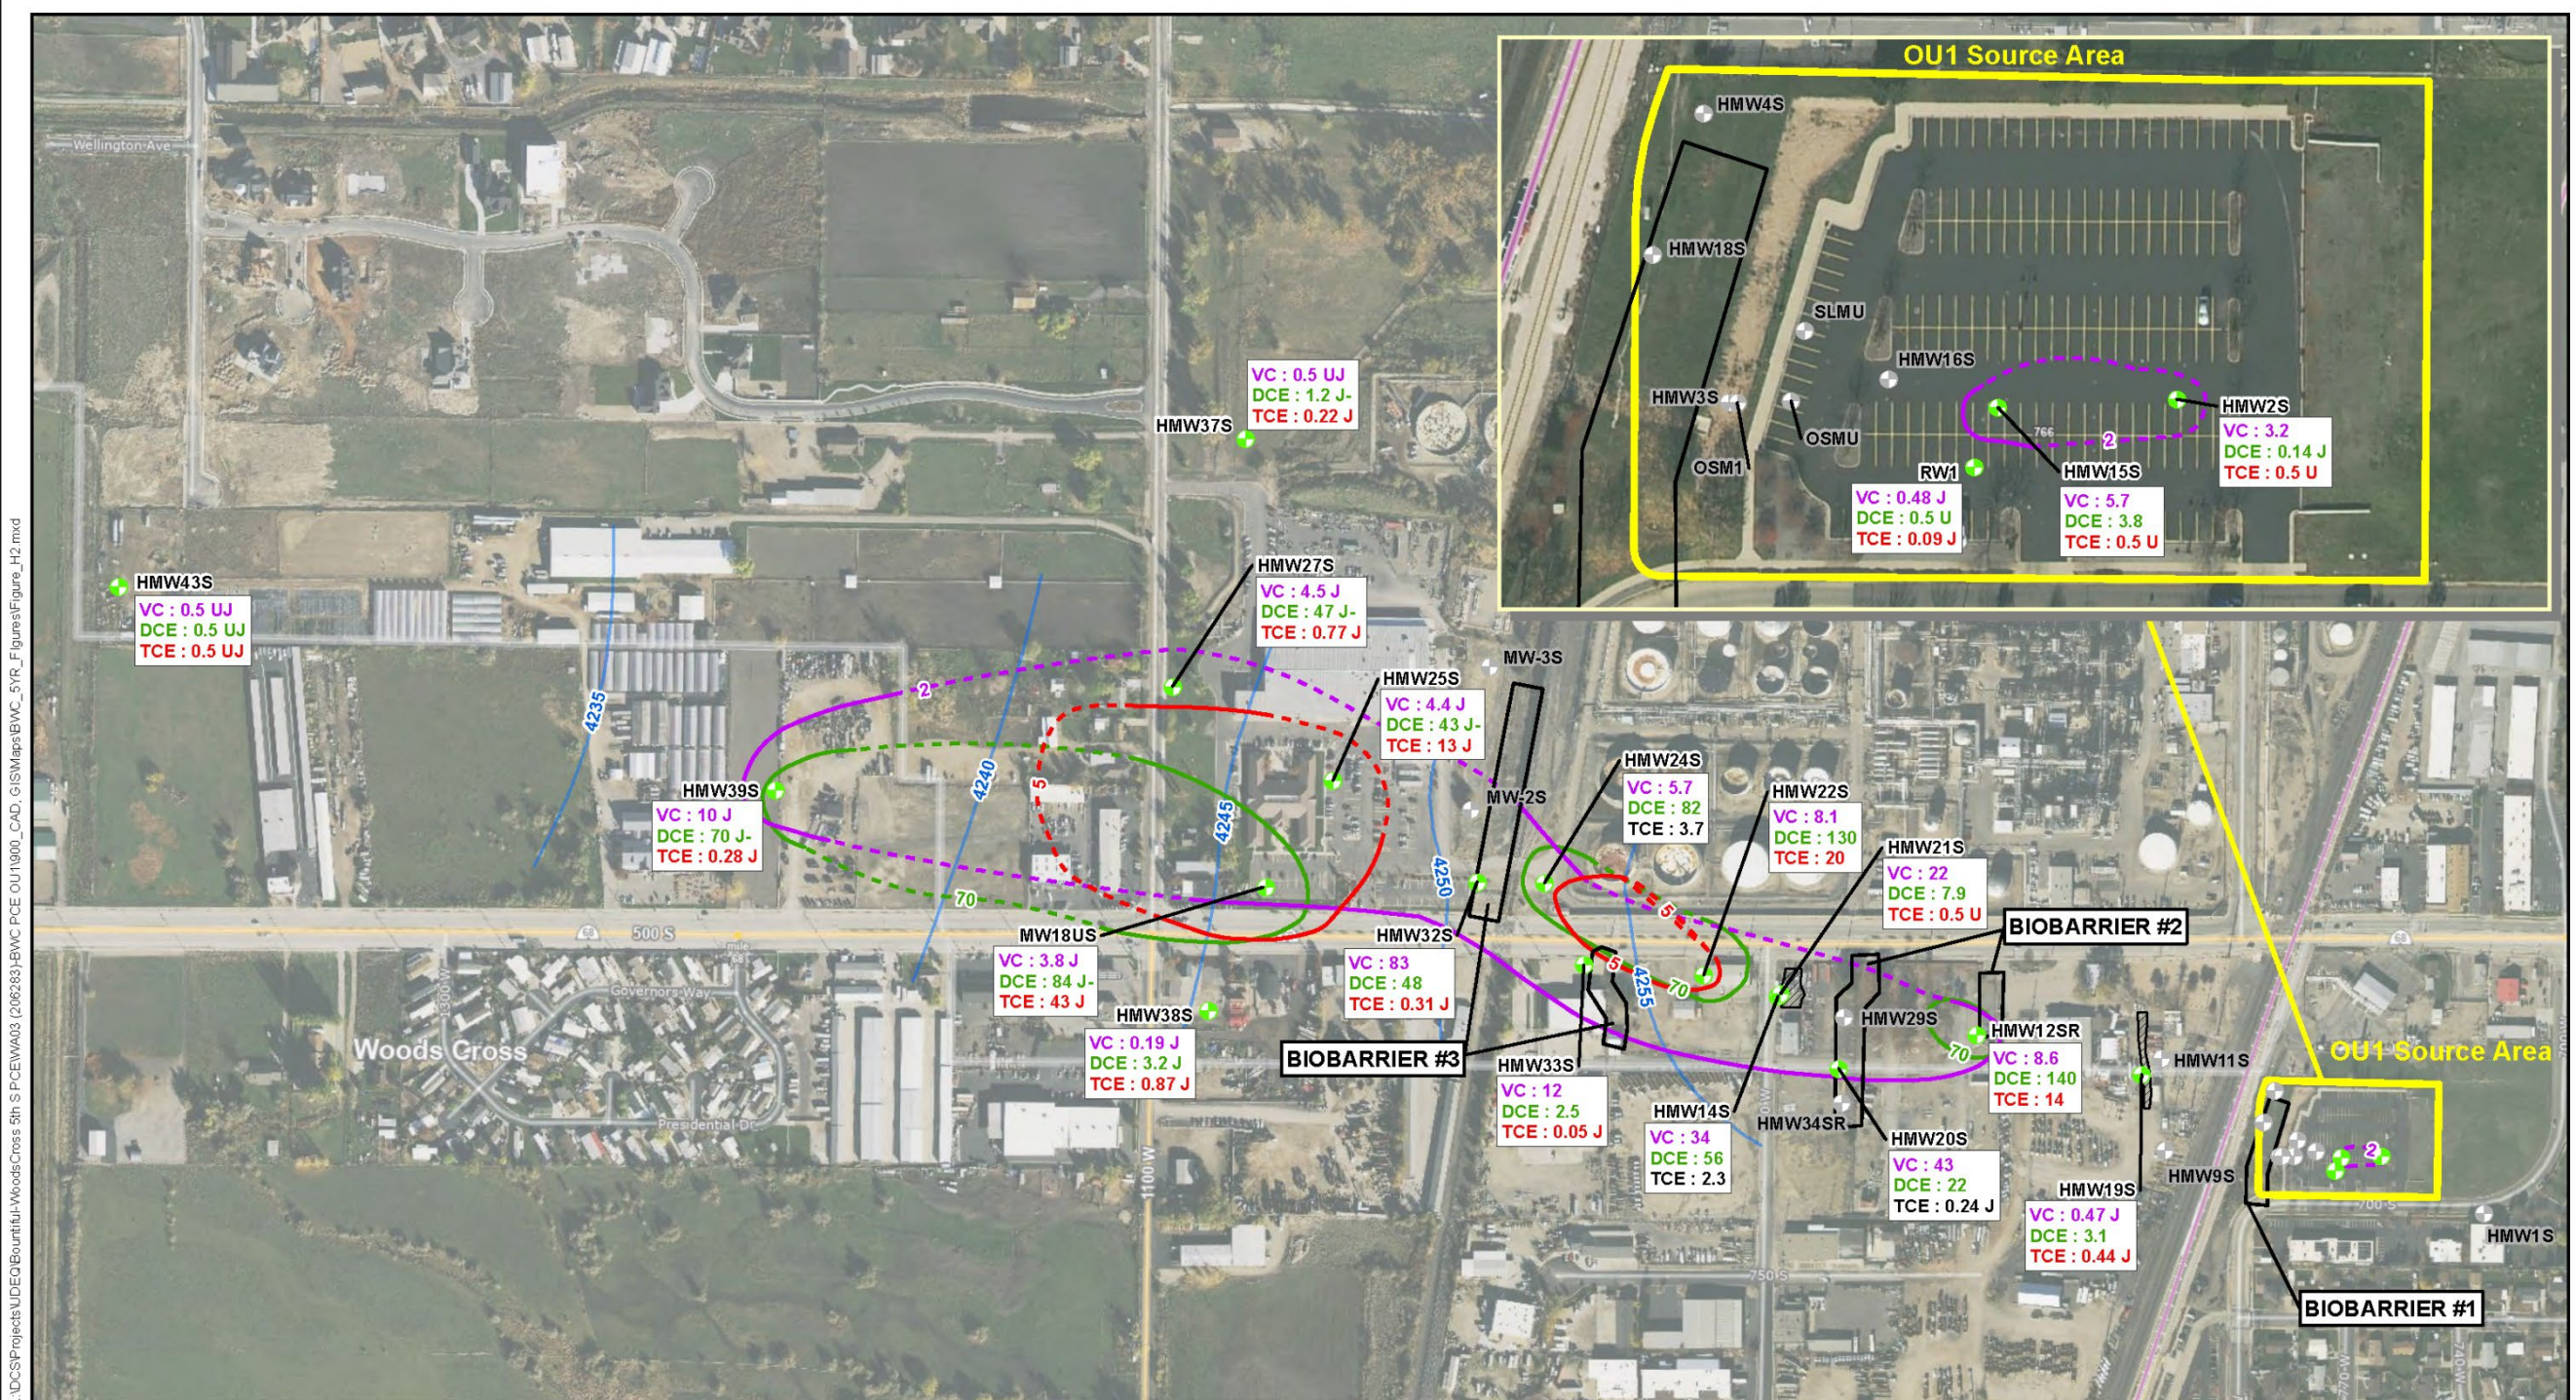
The highest concentrations of COCs detected between biobarriers #2 and #3 (Figure H-2) are TCE at 20 $\mu\text{g/L}$ detected in HMW-22S, cis-1,2-DCE at 140 $\mu\text{g/L}$ detected in HMW-12SR and vinyl chloride at 83 $\mu\text{g/L}$ detected in HMW-32S. TCE was detected at higher concentrations downgradient of biobarrier #3, with the maximum TCE concentration detected in HMW-18US (43 $\mu\text{g/L}$). TCE concentrations decline further west to below the cleanup goal. TCE degradation products cis-1,2-DCE and vinyl chloride follow a similar pattern, with concentrations at or above the MCL at HMW-39S, declining to below the cleanup goals further west at HMW-43S, demonstrating that MNA is reducing the concentrations over time and distance. As of November 2021, no shallow zone wells exhibit concentrations of total CAHs above 200 $\mu\text{g/L}$. It does not appear at this time that additional biobarrier amendment injections will be necessary.
