# Site Characterization Summary & Remediation Plan Milepost 174.5 Release Site

Chevron Pipe Line Company Salt Lake Pump Station Salt Lake City, Utah Bellaire, Texas

July 2010

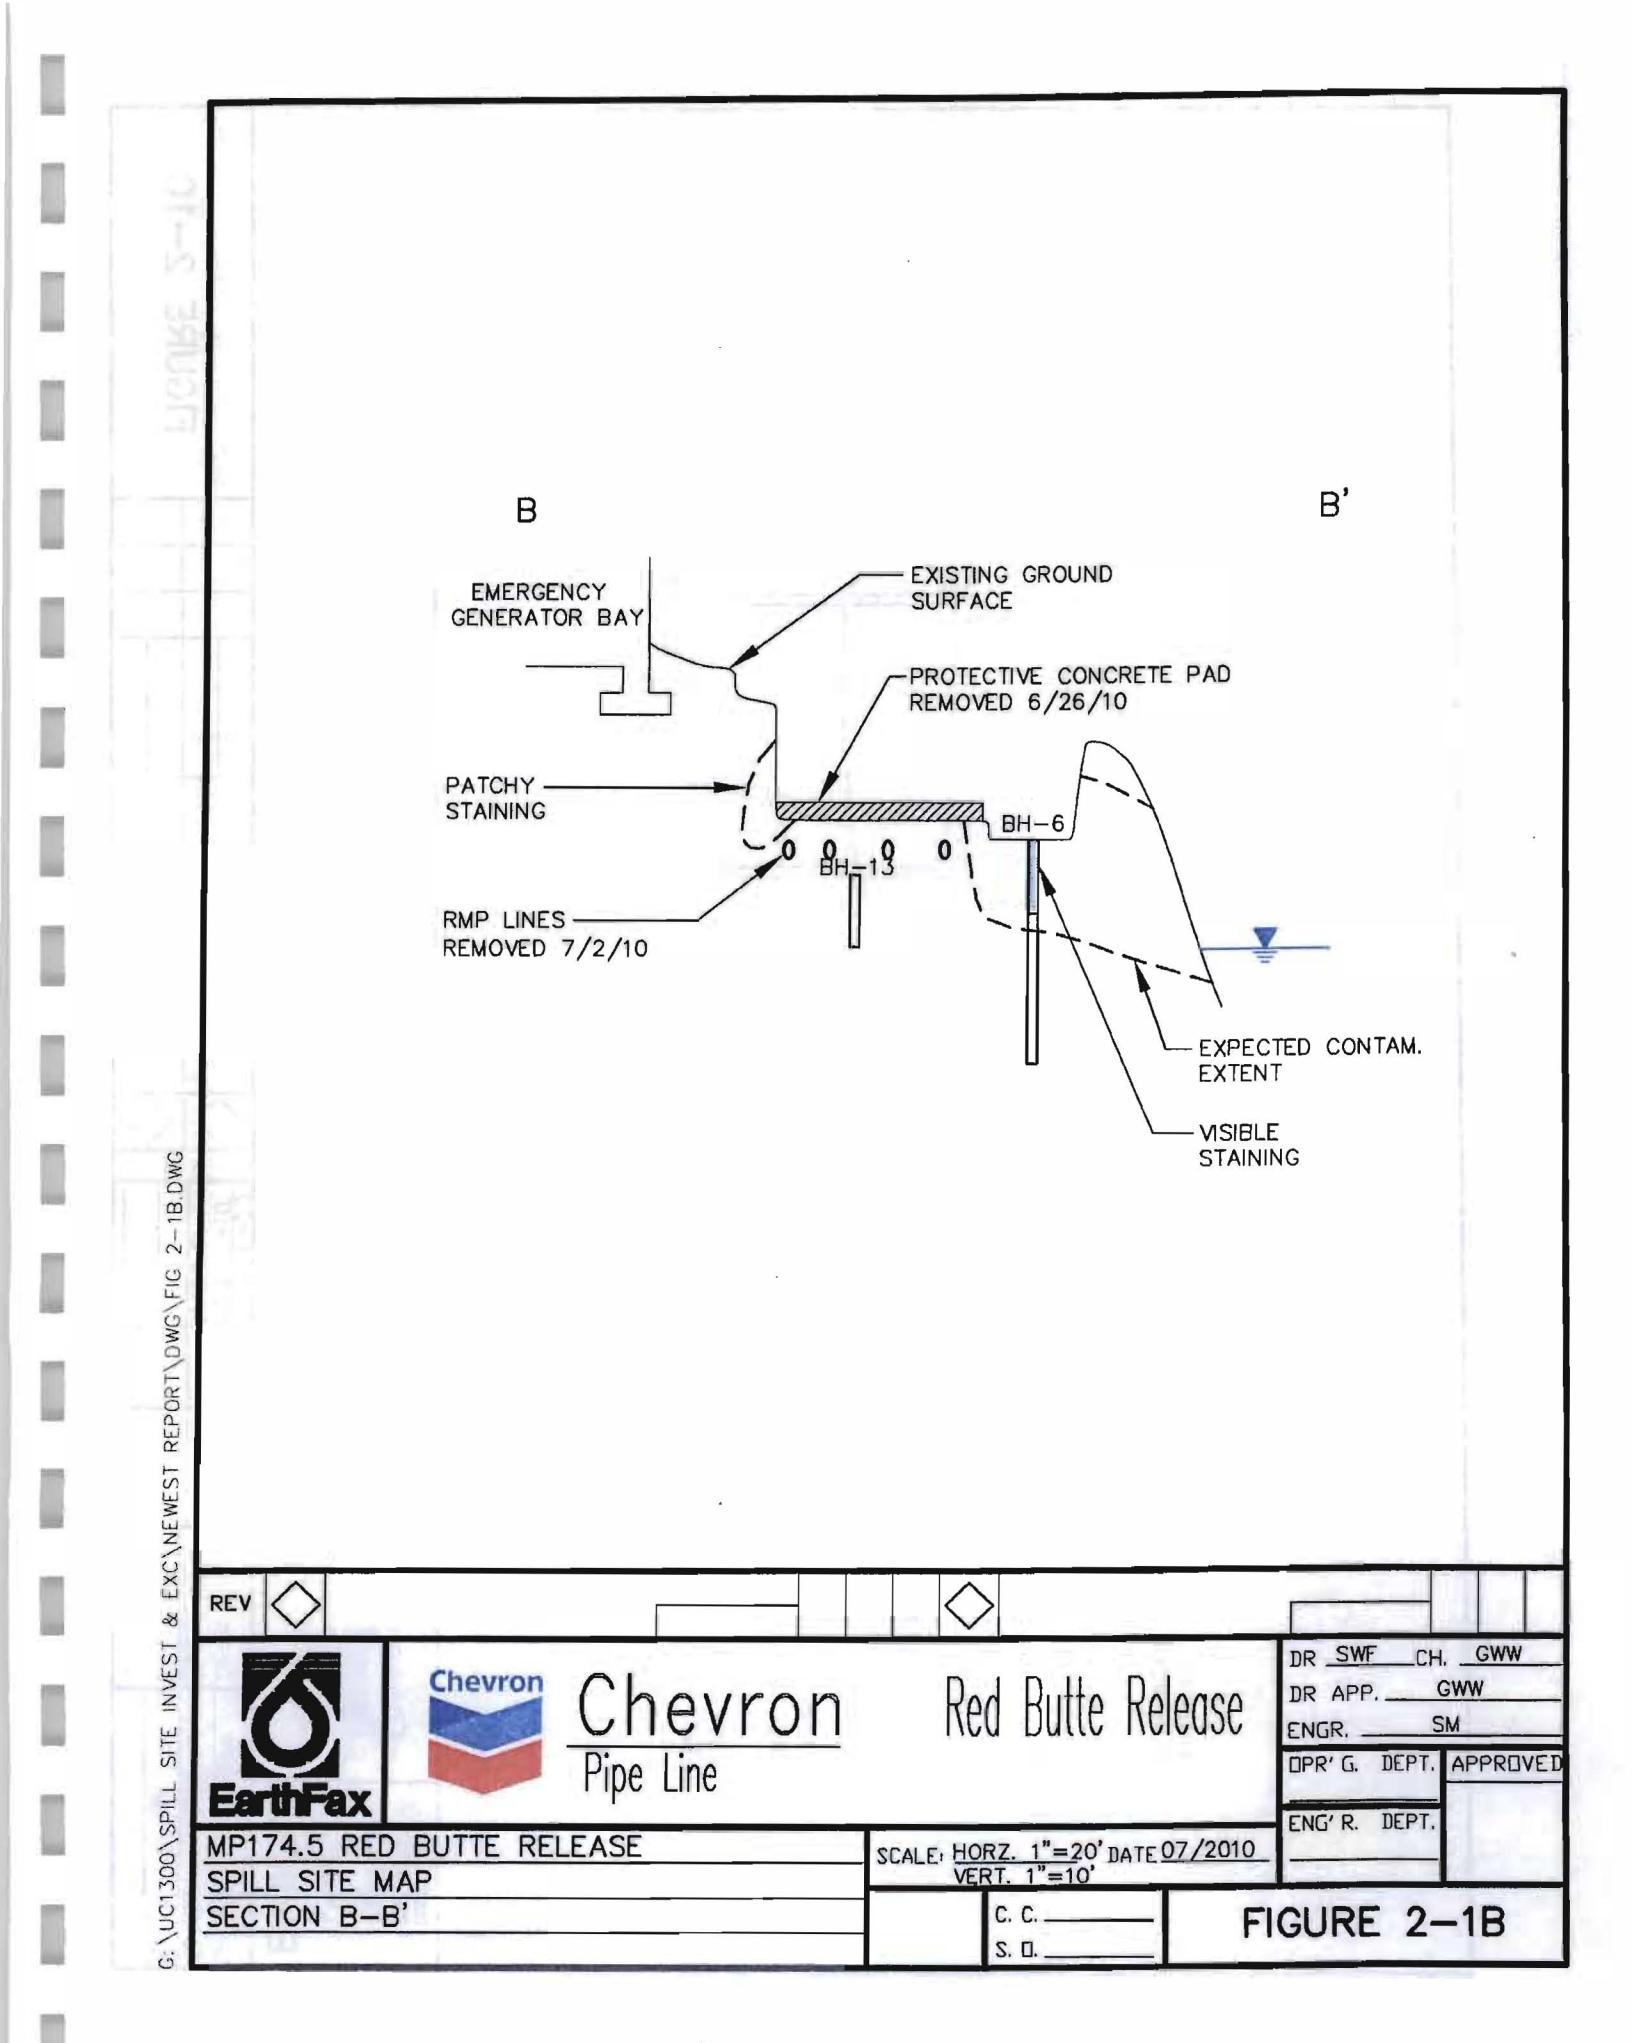
G: \UC1300\SPILL SITE INVEST & EXC\NEWEST REPORT\DWG\FIG 2-1A.DWG

Based on observations made during the drilling, it appears as if the crude oil is present in the soil roughly 12-14 feet below the ground surface (at the time of drilling) near the leak point at the electrical towers and 5-6 feet below the ground surface at the southern end of the pool location (see Figure 2-1). Three borings were installed uphill and south of the known contarninated area to assess whether the contamination had migrated off-site. Based on the observations made of these boreholes as well as observations made of the pipeline repair excavation, it appears as if the crude <u>did not</u> significantly migrate off site to the north, east, or south. However, based on soil staining and observations of excavations made at the level of the river, it is apparent that the crude oil migrated westerly through the soil down to Red Butte Creek.

Though a soil boring could not be safely drilled between the existing excavation at the crude pool location and the emergency generator bays, patchy crude staining was observed on the face of the excavation and is only expected to extend several feet toward the generator bays in the location shown on Figure 2-1.

- Excavation slopes will need to be benched/sloped at 1.5H:1V as required by OSHA for Type C soils in the northern (power terminal tower area) section where excavation depths are deeper and contamination is known to extend below the level of the river. The extent of the excavation at this slope can be seen on Figure 2-1 along with the extent of an access ramp excavated at 1.75H:1V. As seen on the figure, maintaining this slope will require exposing the Chevron crude pipelines in the area surrounding the excavation. Place supports under the pipe as directed by CPL to provide structural support for the pipelines as the excavation progresses.
