SITE MANAGEMENT PLAN

FORMER MILO'S CLEANERS

CANYON CENTER

SANDY, UTAH

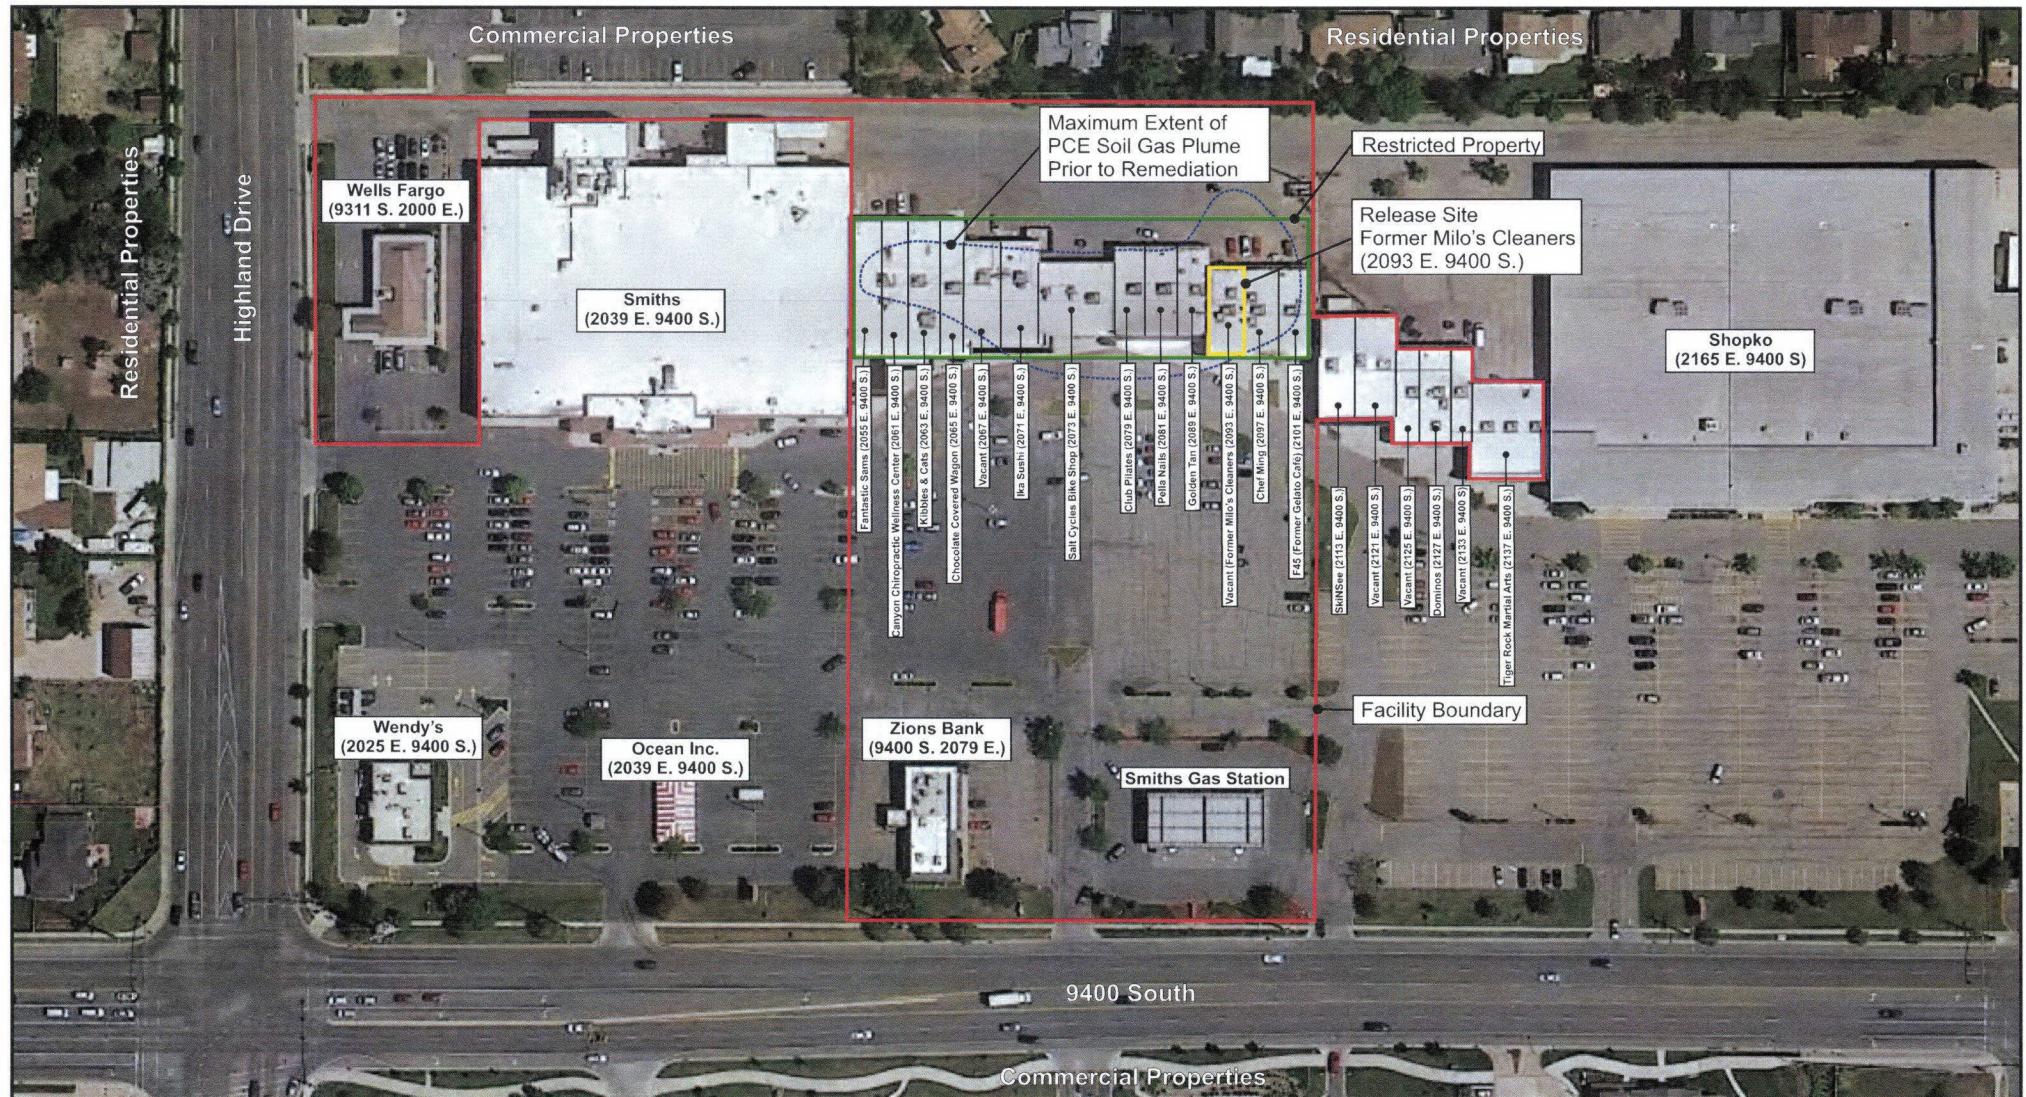
PROJECT NO.	DRAWING DATE	FIGURE
1771-005H	September 13, 2019	2

- Approximate release site boundary
- Approximate facility boundary
- Approximate restricted property boundary
- Approximate maximum extent of PCE soil gas plume prior to remediation
