UTAH ENVIRONMENTAL SERVICE CENTER
INCINERATION PLANT FOR INDUSTRIAL WASTES
BLDG. E-4 DECANT P&ID

CAD NO. I4137N
APTUS DWG NO. D-800-PI-408
REV. 8

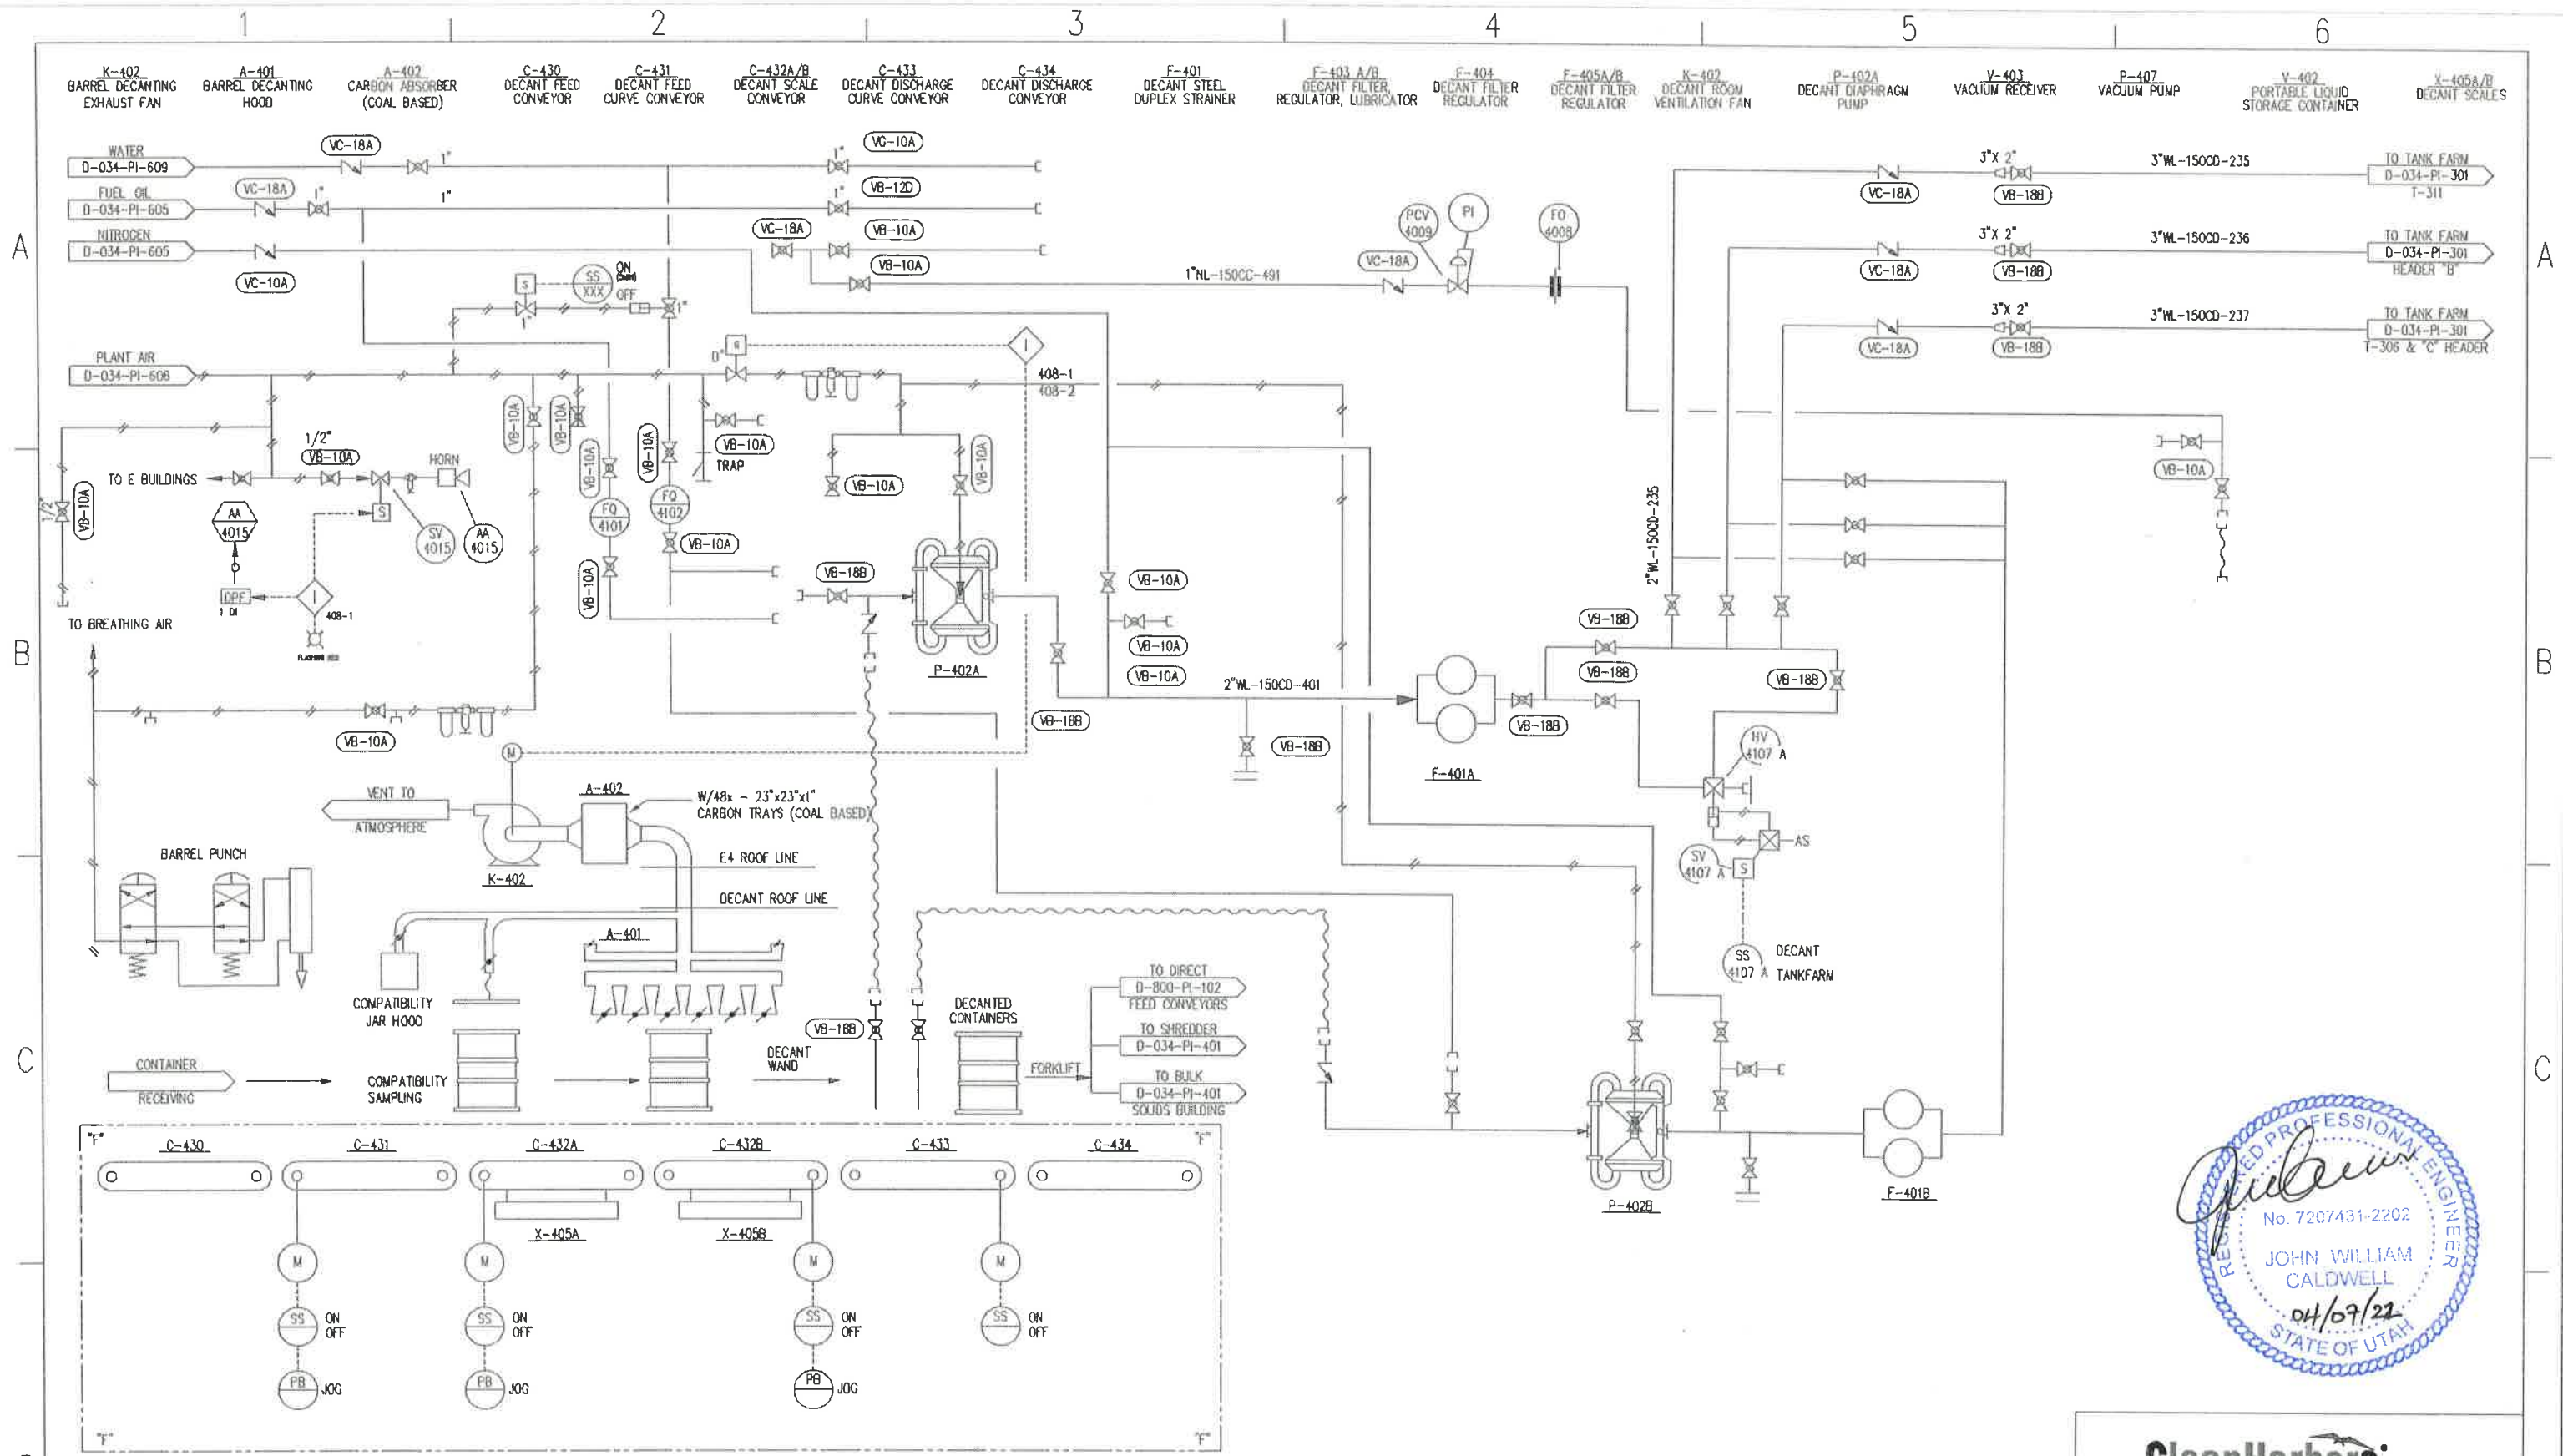
INTERLOCK DESCRIPTION

408-1 IF O2 NOT BETWEEN 19.5% AND 22% OR LEL ABOVE 20% HORN BLOWS FOR 30 SEC, RED LIGHT FLASHES, PUMP SOLENOID CLOSES.

408-2 IF FAN STOPPED PUMP SOLENOID CLOSES
