ATTACHMENT 3-5 DTTF FACILITY DESCRIPTION

1.0 INTRODUCTION

This attachment to the Dugway Resource Conservation and Recovery Act (RCRA) permit describes the Dugway Thermal Treatment Facility (DTTF) as required by 40 Code of Federal Regulations (CFR) §264.10; and the Utah Administrative Code (Utah Admin. Code) R315-264-10. This attachment is organized in the following sections:

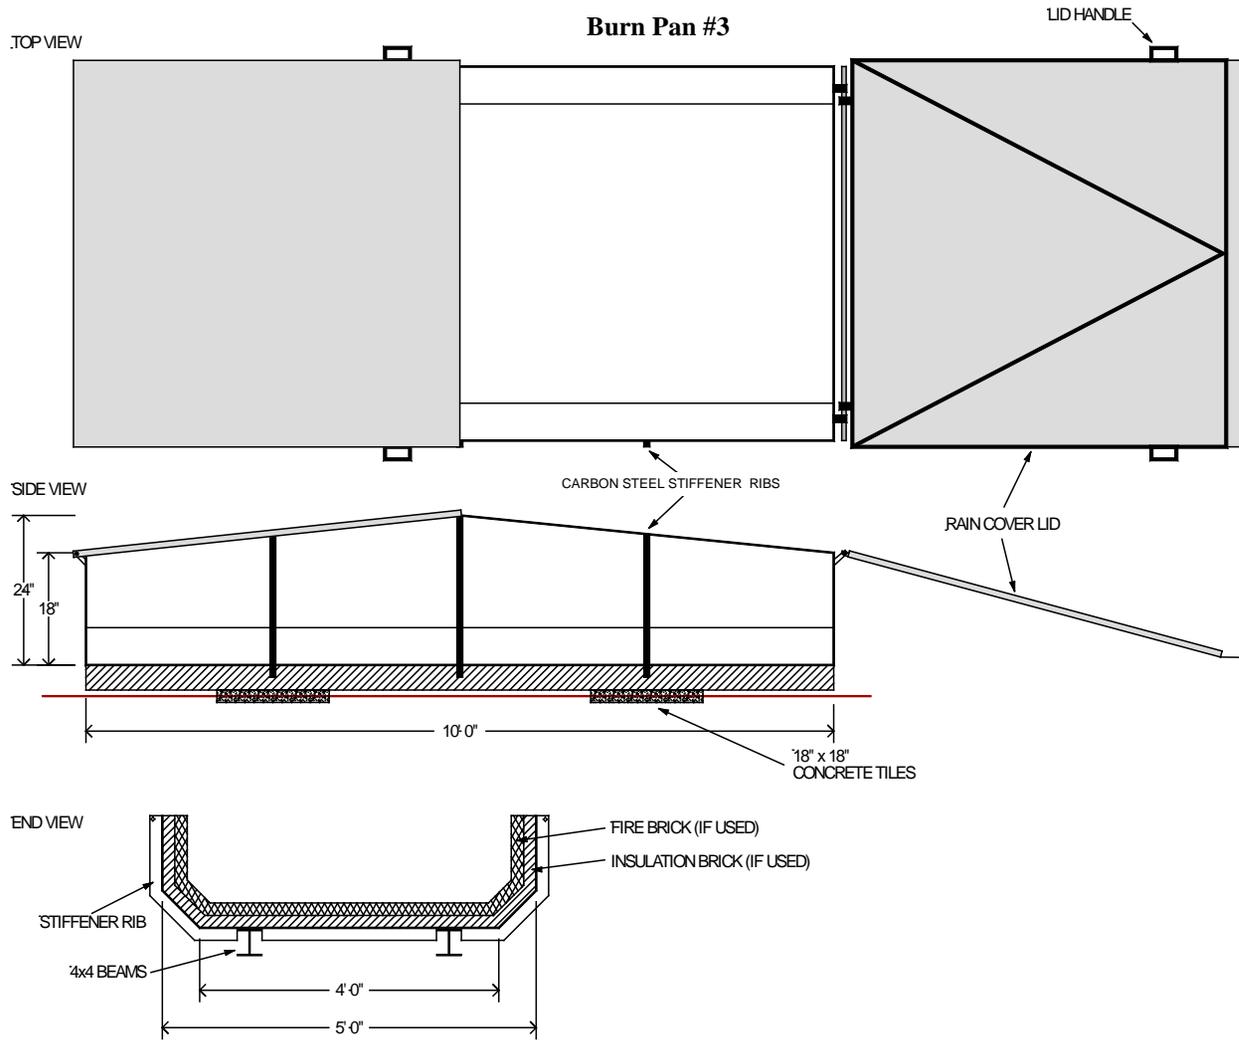
Figure 3. Burn Pan Drawings

Burn Pans #1 and #2 have been removed.

CARBON STEEL STIFFENER RIBS
 4"x4" CARBON STEEL I-BEAM
