# Site Management Plan

**Former Tesco-Williamsen Facility**

**1925 West Indiana Avenue**

June 17, 2015

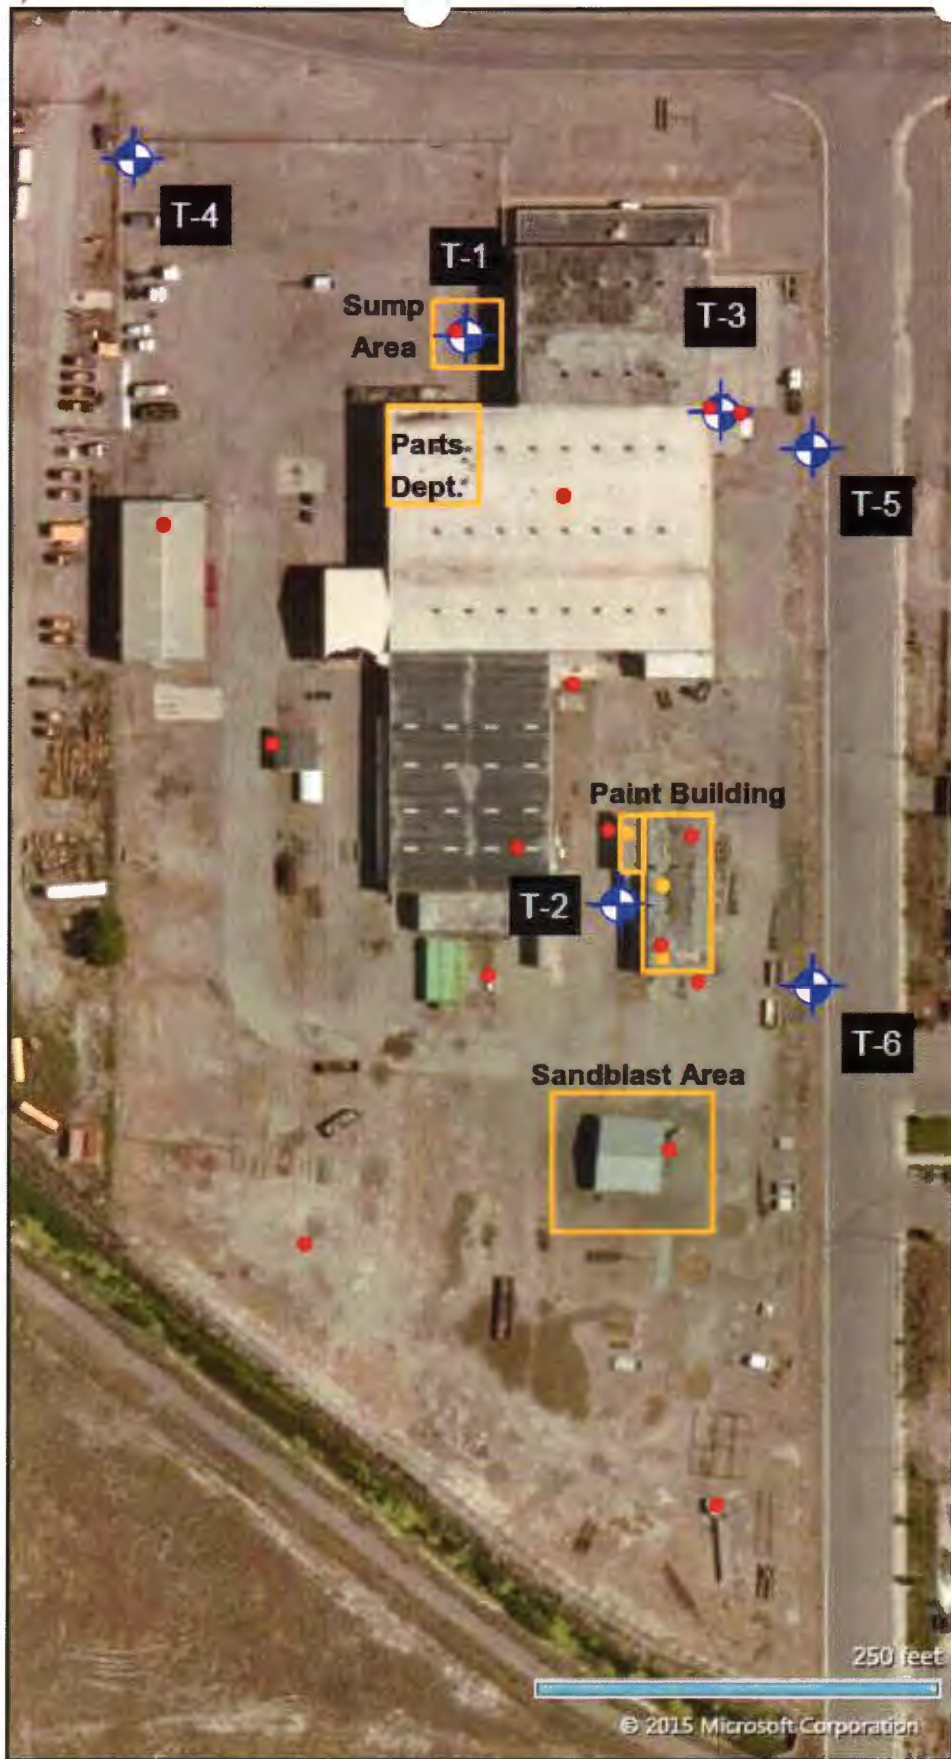
**Exhibit 1 - Site Diagram**

-   Monitoring Well Location
-

Based on the results of Terracon's LSIs and a review of the previous soil and groundwater data reported by EarthTouch in August 2013, the pattern of detected constituents and their relative concentrations suggests a past release of chlorinated solvents and petroleum products in the area of well T-1. The released constituents appear to have degraded over time, and as they have migrated down-gradient towards monitoring wells T-3 and T-5. There is no indication that released constituents have moved west towards monitoring well T-4 in the northwestern portion of the site.
