**SITE MANAGEMENT PLAN  
FORMER HENRIES DRY CLEANER  
COTTONWOOD SQUARE  
1781 EAST MURRAY-HOLLADAY ROAD  
MILLCREEK, UTAH**

**Project No. 2249-001D**

**SITE MANAGEMENT PLAN  
FORMER HENRIES DRY CLEANER  
COTTONWOOD SQUARE  
MILLCREEK, UTAH**

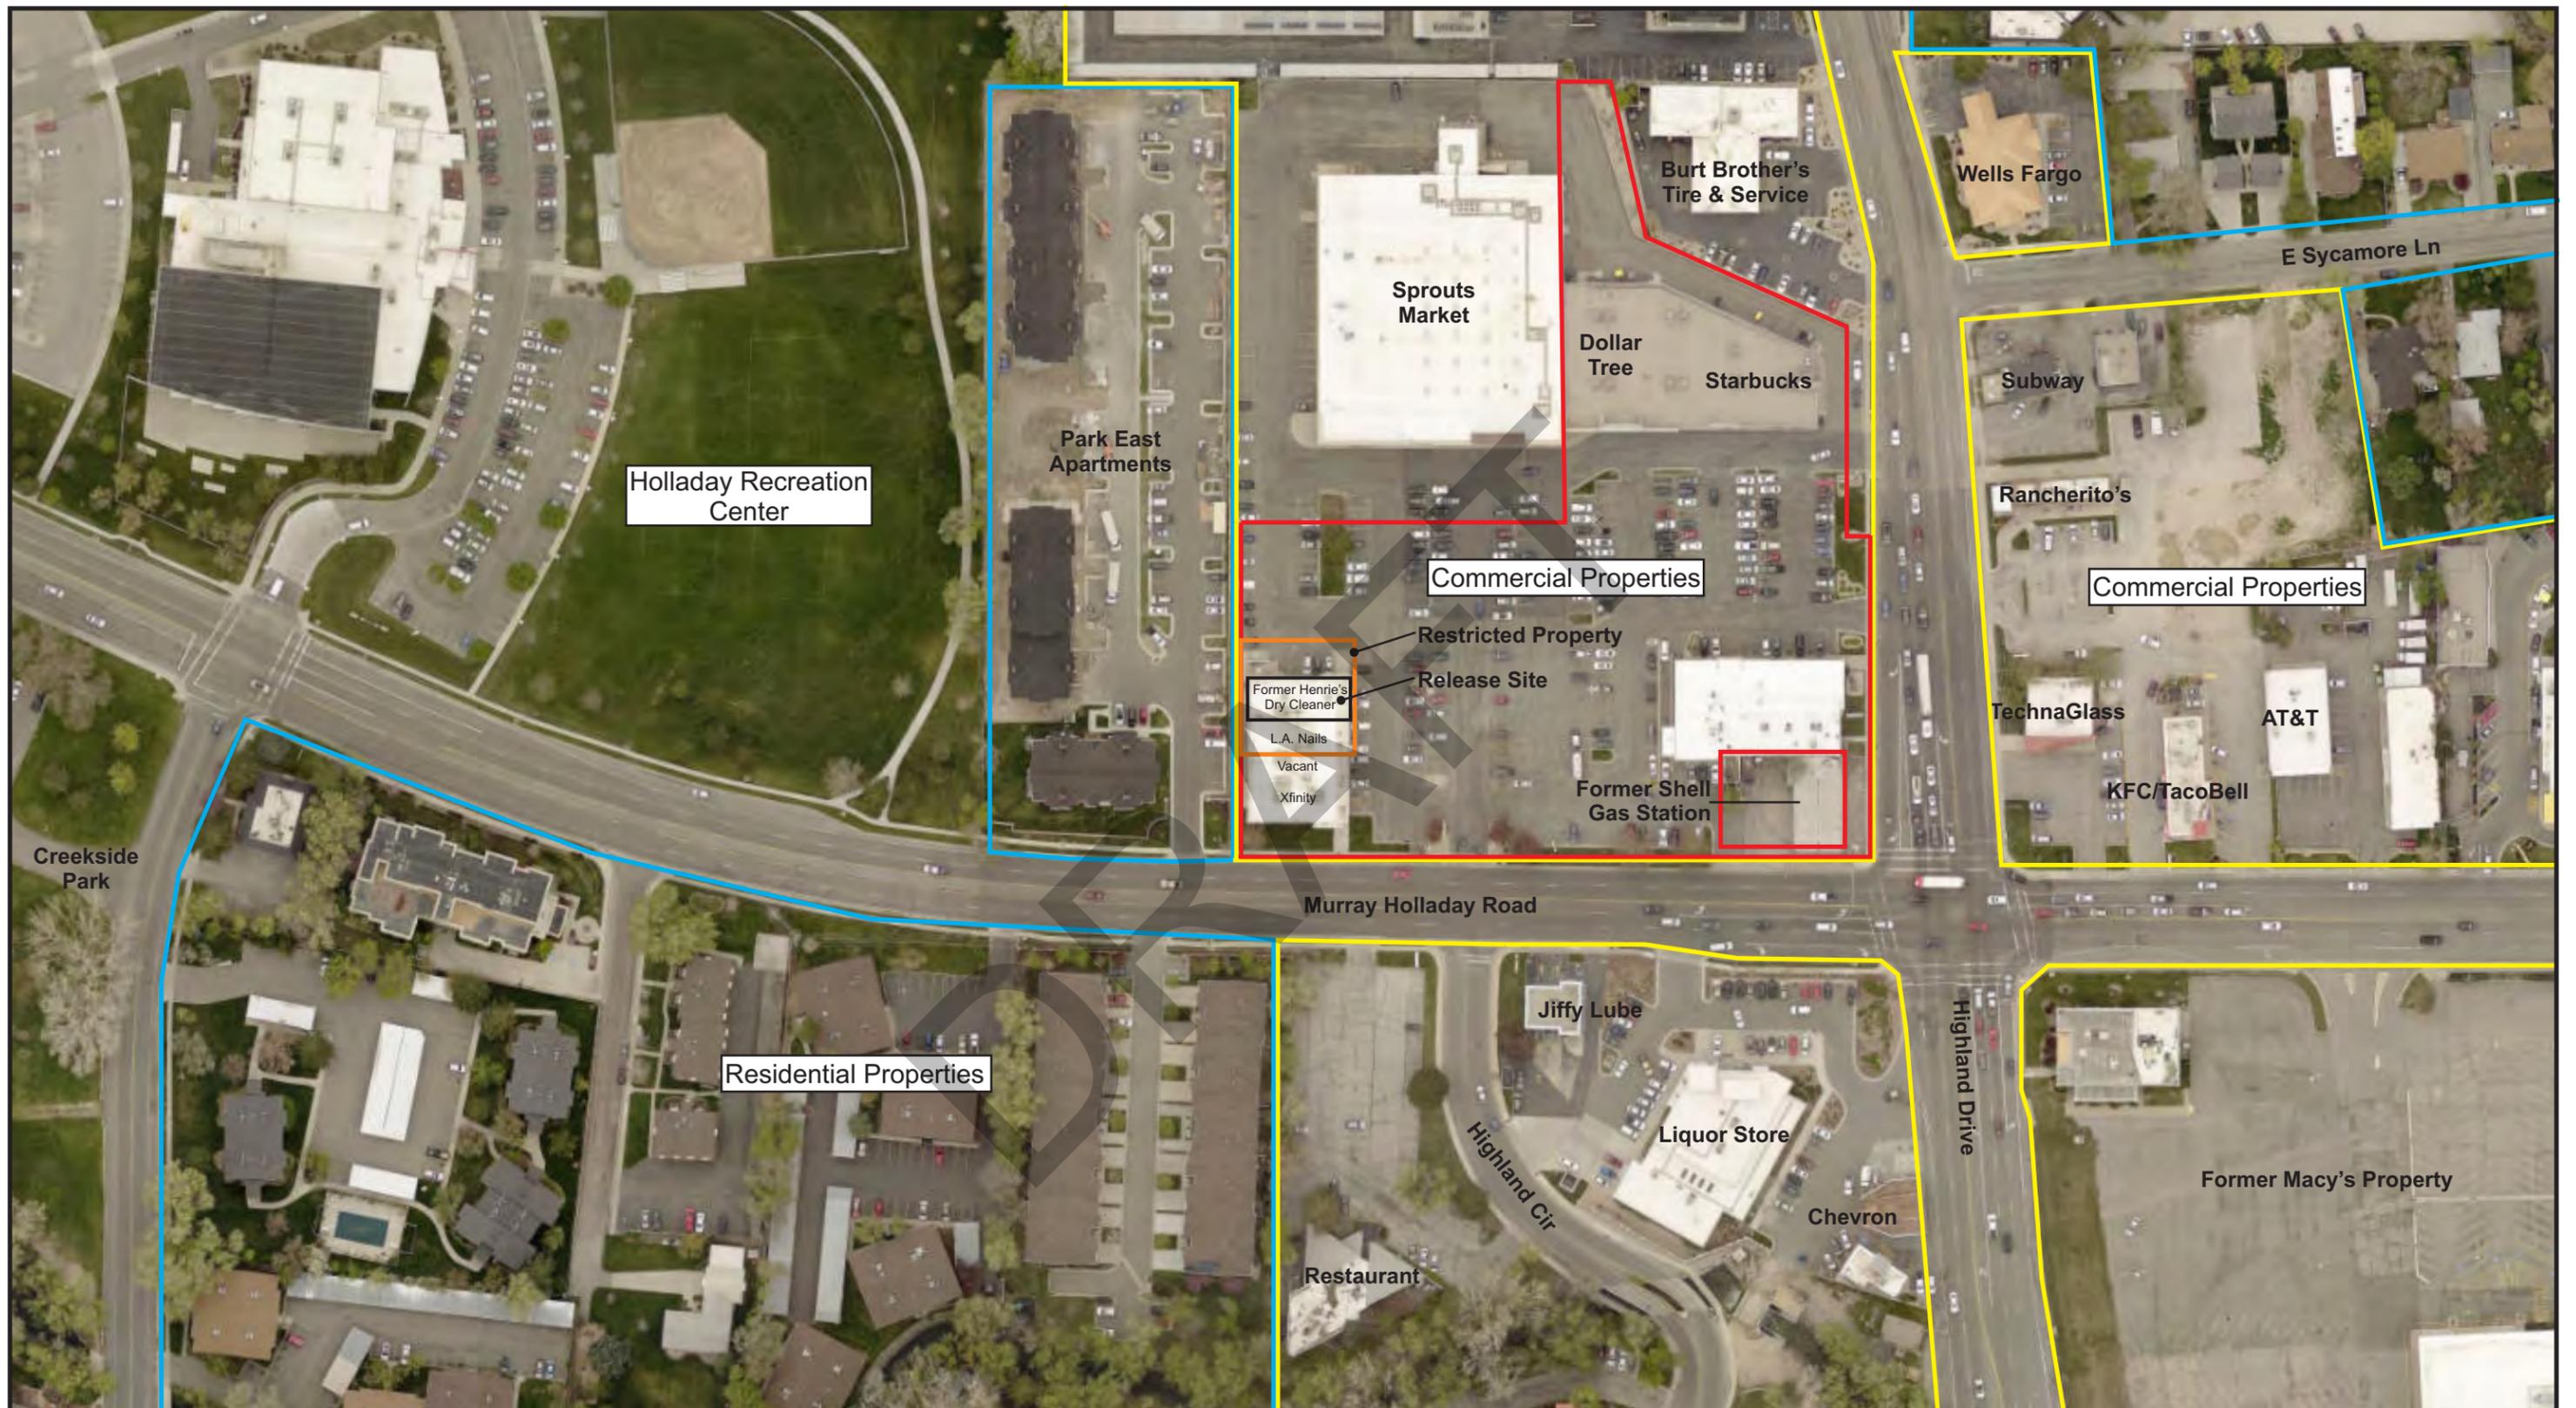
Scale: 1-inch equals approximately 125'

- Commercial Properties
- Residential Properties
- Release Site Boundary
- Cottonwood Square (Facility Boundary)

Exhibit A – Facility Location Map and Facility Feature Map
