## SITE MANAGEMENT PLAN

Sandy Village  
(formerly Sandy Mall)  
*One Hour Quality Cleaners Site*  
9467 South 700 East  
Sandy, Utah

Project No.: 203706007

May 9, 2019

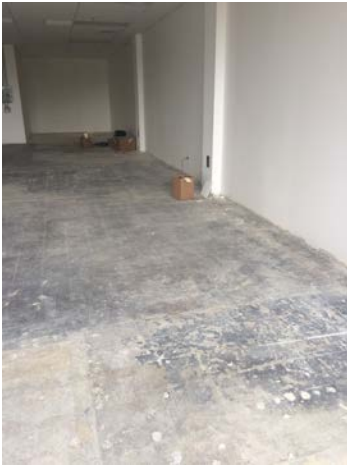
View toward East inside Property from front/west, entrance door...Boiler Room in rear/back of photograph.

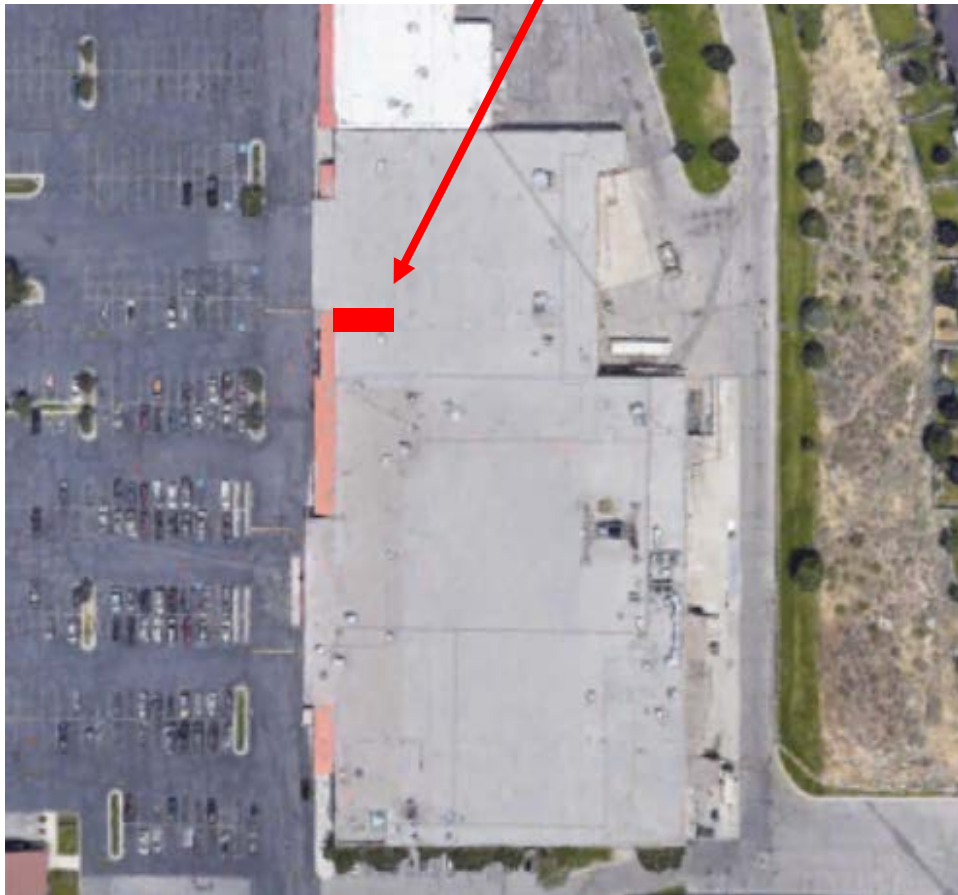
**PROPERTY, Aerial**  
FORMER 1-Hr. QUALITY CLEANERS  
SANDY MALL  
9467 S 700 E  
SANDY, UTAH
