RE: 1st QT 2011 Report - Coal Hollow Mine
Project ID: N14047-0002

Summary of PM₁₀ Data

Collected at Coal Hollow Mine, Utah

During the First Quarter, 2011

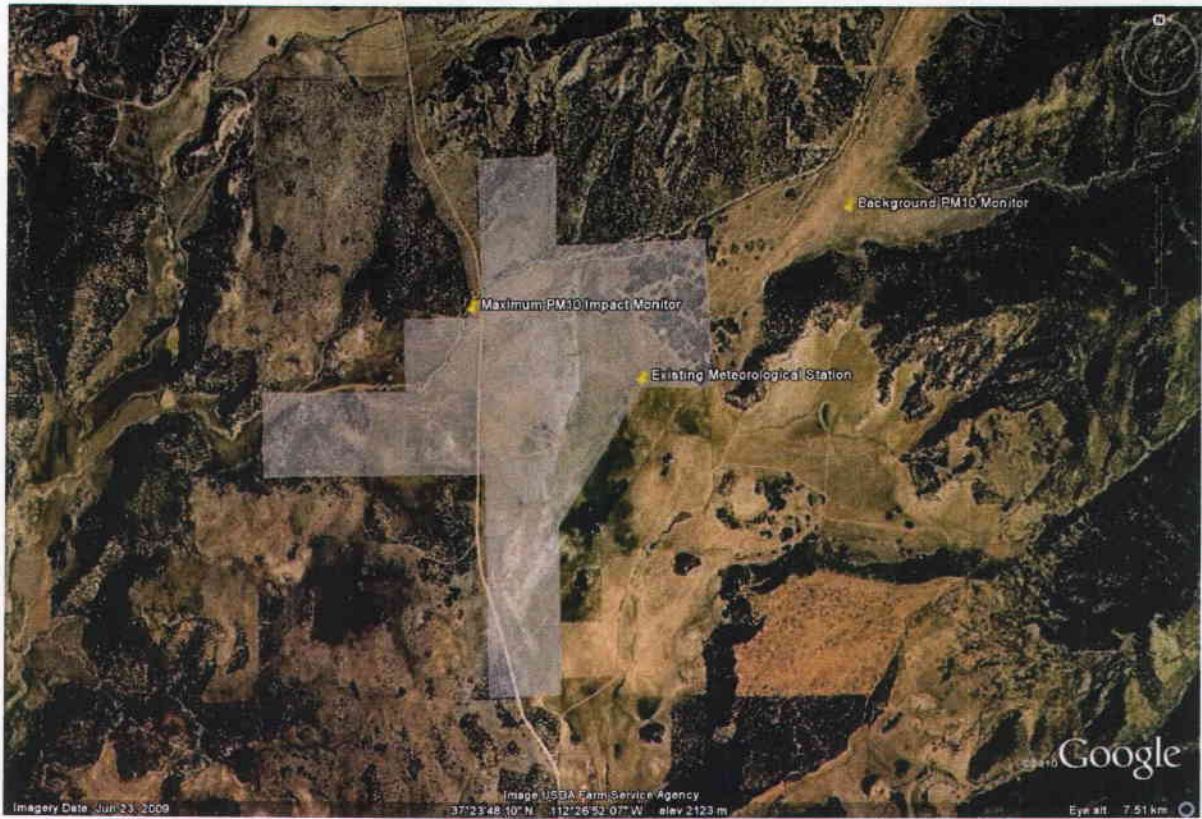
Figure 2 - Satellite View of Monitoring Locations

The two monitoring locations as depicted in Figure 2, are located in positions to collect both background and maximum PM₁₀ concentrations. The background monitor has a manufactures serial #962, therefore this monitor will be referred as monitor 962A. The compliance monitor has a manufactures serial #963, therefore this monitor will be referred as monitor 963B. The co-located monitor has a manufactures serial #964, therefore this monitor will be referred as monitor 964C. The compliance monitor and the co-located monitor coordinates are 37° 24' 5.04" North Latitude, 112° 27' 20.91" West Longitude, WGS84 Datum. The background monitor coordinates are 37° 24' 21.96" North Latitude, 112° 25' 59.97" West Longitude, WGS84 Datum.

PM₁₀ monitoring at the site consists of three BGI PQ200 PM₁₀ monitors run by solar power. Figure 2 of this report shows the approximate locations of the monitoring locations. The BGI PQ200 monitors are EPA Reference Method monitors and are operated on the National Particulate 1-in-6 Monitoring Schedule.
