SUBJECT: Corrective Action Alternatives Evaluation/Summary Letter
Bloomington Market
141 W. Bingham Road
St. George, Utah
Facility ID 6000342
UST Release Site MSM
WA MSM-13

FIGURE 1 - SITE MAP

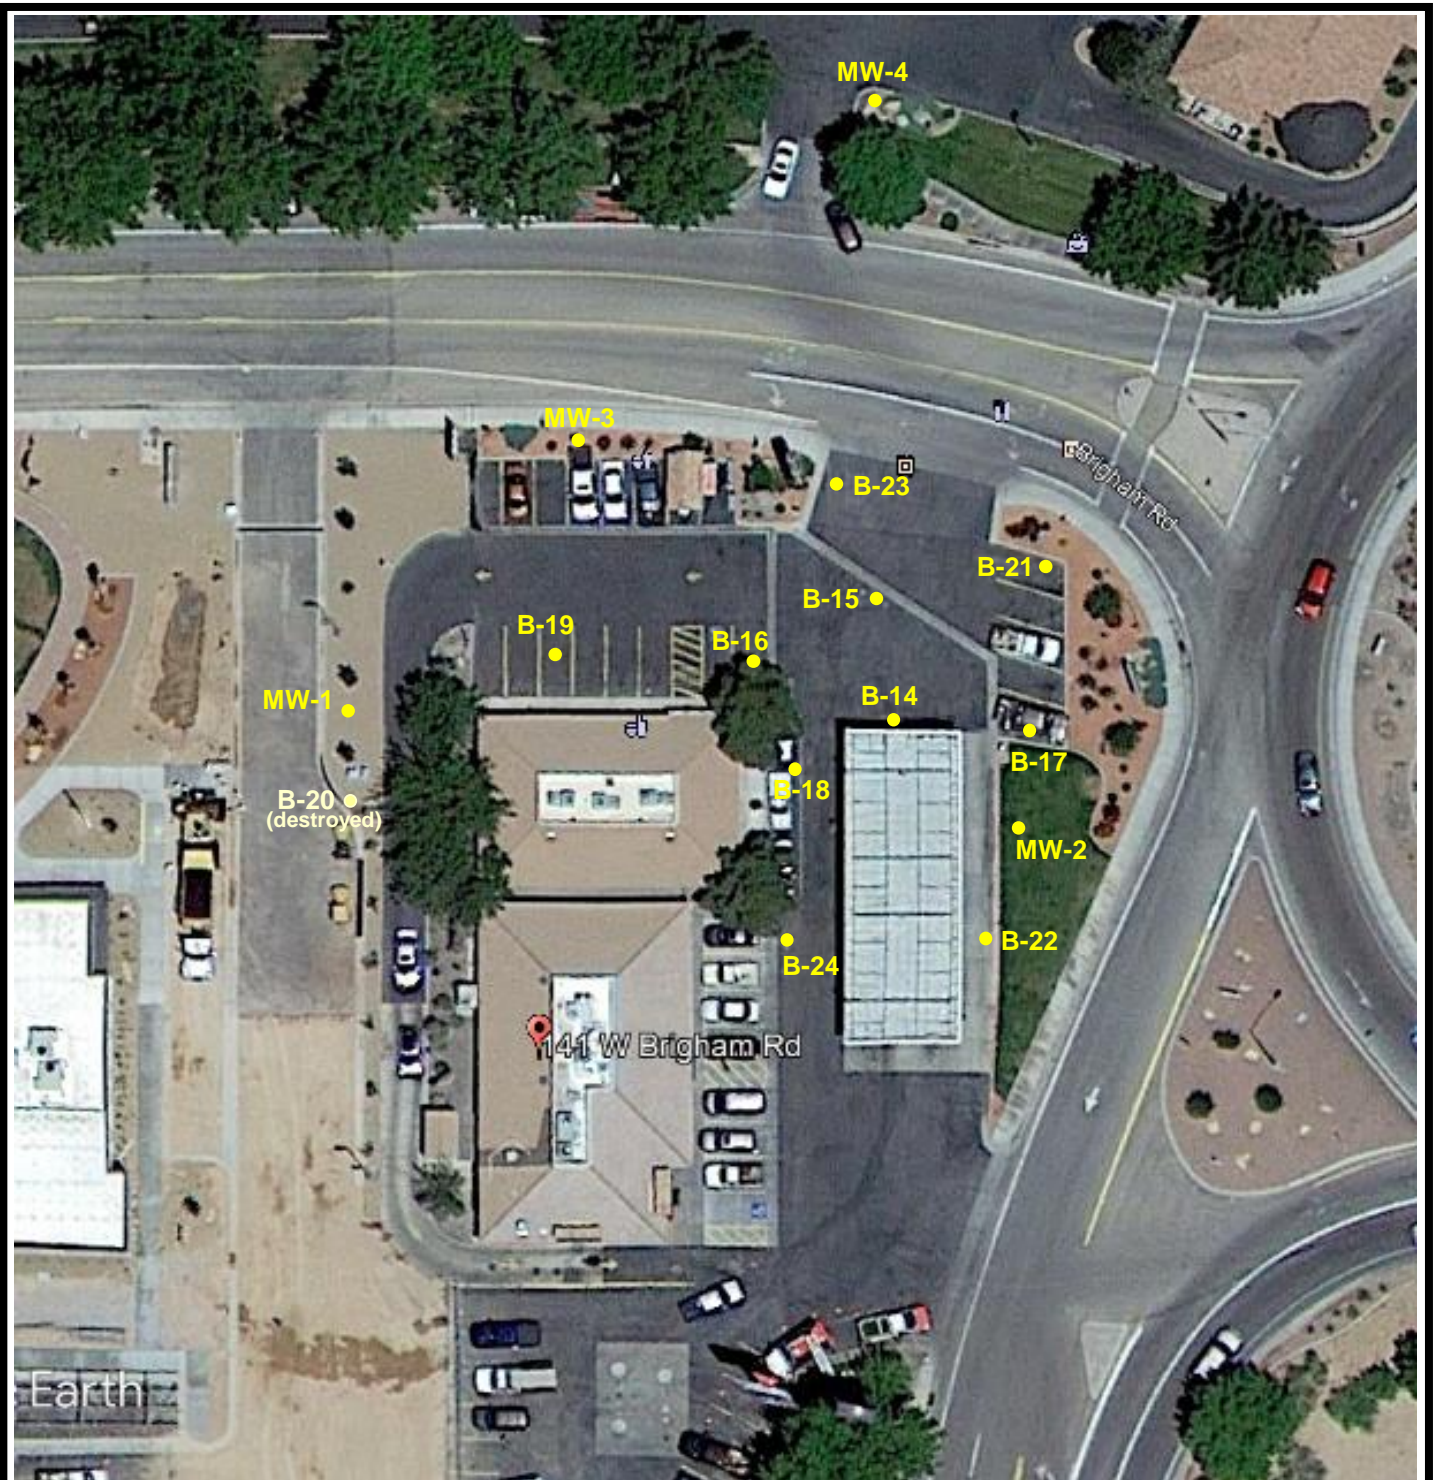
The Bloomington Market site is an operating convenience store, gas station, and business complex. Two buildings occupy the site, the southern building houses the convenience store, and the northern building houses offices and commercial operations. Gasoline dispensers are located under a canopy in the eastern portion of the site. Three underground storage tanks (USTs) were located beneath the northeast portion of the canopy, these tanks were closed in place in 2012. New USTs are located south of the store building. A site map showing the locations of the site features is presented as Figure 1.

Between 2010 and 2015, 13 borings (B-1 through B-13) and 11 monitoring wells (B-14 through B-24) were installed by Westech Environmental at the site. Please refer to Figure 1 for the well locations. Soil types encountered were primarily silts and fine sand to approximately 36 feet. Sandy gravel was encountered at approximately 36 feet and extended to approximately 45 feet. Shale bedrock was encountered below the gravel and extended to the depths explored.

On April 14 & 15, 2020, ATC Group Services (ATC) installed four additional monitoring wells (MW-1 through MW-4). Please refer to Figure 1 for the well locations. The monitoring wells were installed to better define the extent of groundwater impacts and to replace B-20.

● = Monitoring Well

This correspondence presents the results of a corrective action alternatives review for the Bloomington Market site located at 141 W. Bingham Road, St. George, Utah (Figure 1). The work was performed on behalf of the Utah Department Environmental Quality, Division of Environmental Response and Remediation (DERR) under Work Assignment MSM-13.
