UTAH TANK NEWS

Summer
2019

Using Environmental Covenants to Assist in Closing LUST Sites with Residual Free Product

What's Wrong with this Picture?

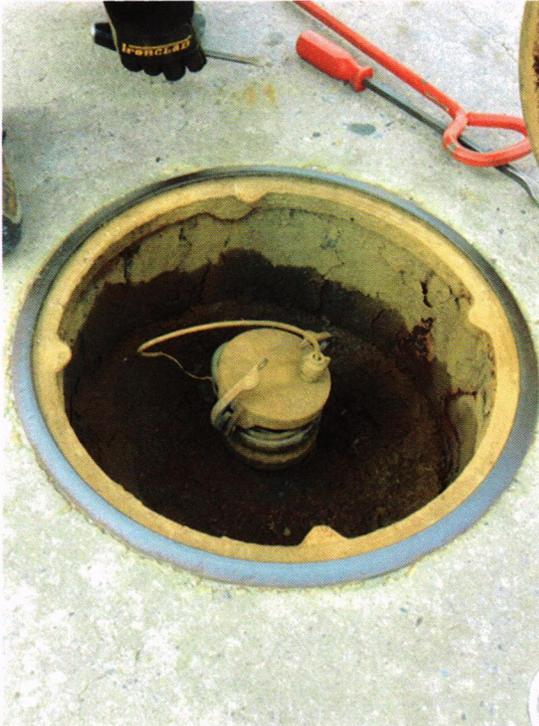
Do you have a properly fitted seal or cap on your vapor recovery port?

We often see poorly fitted or broken caps that can cause a release of fuel.

In this photo, a broken cap has allowed vapor and or fuel to come out of the vapor recovery port.

Please ensure that all caps or seals are properly fitted and that broken caps or seals are replaced with new ones.
