# **UTAH TANK NEWS**

# January 2018

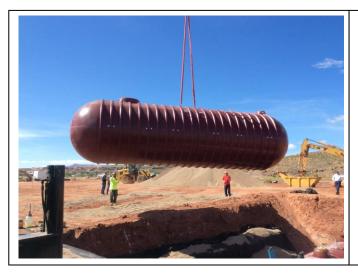
~ continued on page 2

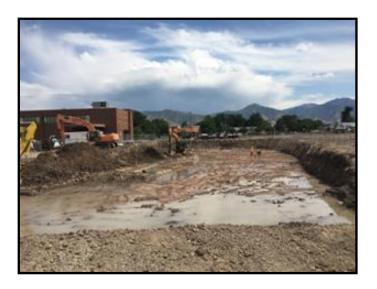
Petroleum contaminated soil and groundwater was discovered during the initial site assessment activities for this property in July 2015. Historic records indicate a former service station with underground storage tanks was the source of the contamination and a Leaking Underground Storage Tank (LUST) release was opened.

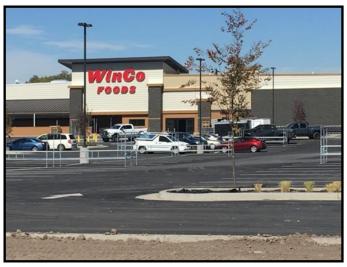
Since the tanks were reportedly removed in 1974 and the responsible party was long gone, South Salt Lake City as the property owner, submitted a Corrective Action Plan (CAP) to clean up the site.
