UTAH TANK NEWS

Summer 2012

SUCCESSSES – Bullfrog Marina

Nicely Done by Bruce Hagans

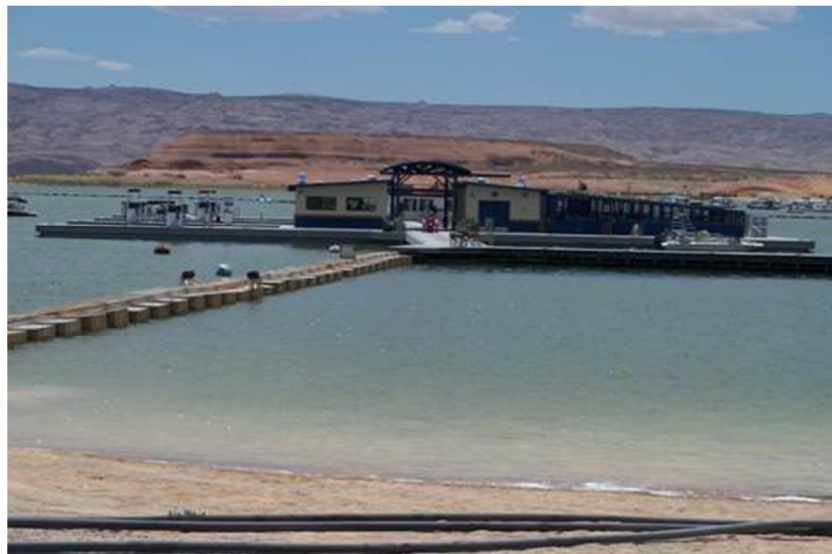
If you have a chance to visit beautiful Lake Powell via Bullfrog Marina take a close look at all the engineering that has gone into their fuel facility. Their USTs and ¾ of a mile of underground piping have been replaced by 3 double-walled ASTs located on a floating tertiary containment structure. All piping and tanks are double-walled; leak detection consists of sump monitoring (for dispensers) and interstitial monitoring for tanks and piping. Overfill protection is by way of Overfill Protection Device (OPD), Veeder Root high level alarm plus an electric solenoid valve which closes if the overfill alarm sounds. All piping is accessible from the topsides of the dock through FRP fibergrate panels covering the chases.

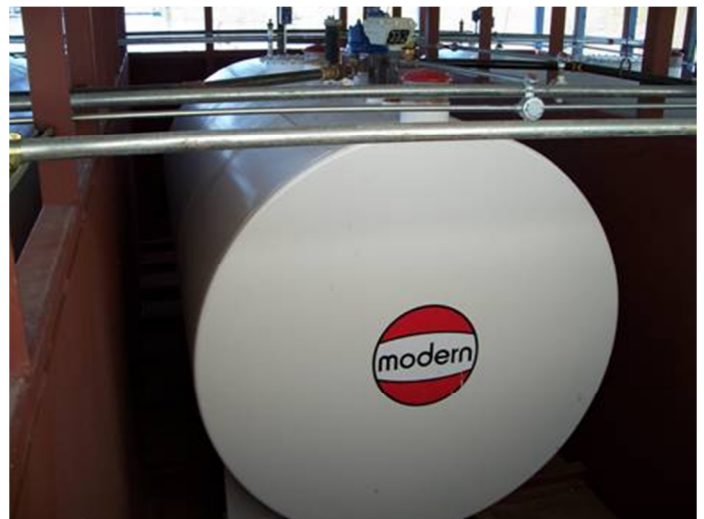
This small diesel tank sits between the 2 larger gasoline tanks. Each tank has its own independent enclosure within the floating tertiary containment structure. The ASTs are filled from a shore-side tanker through a loading manifold on the beach which is equipped with spill containment and double-walled piping to the ASTs.
