# **ATTACHMENT 1**

# FACILITY DESCRIPTION AND LOCATION

### FACILITY DESCRIPTION AND LOCATION

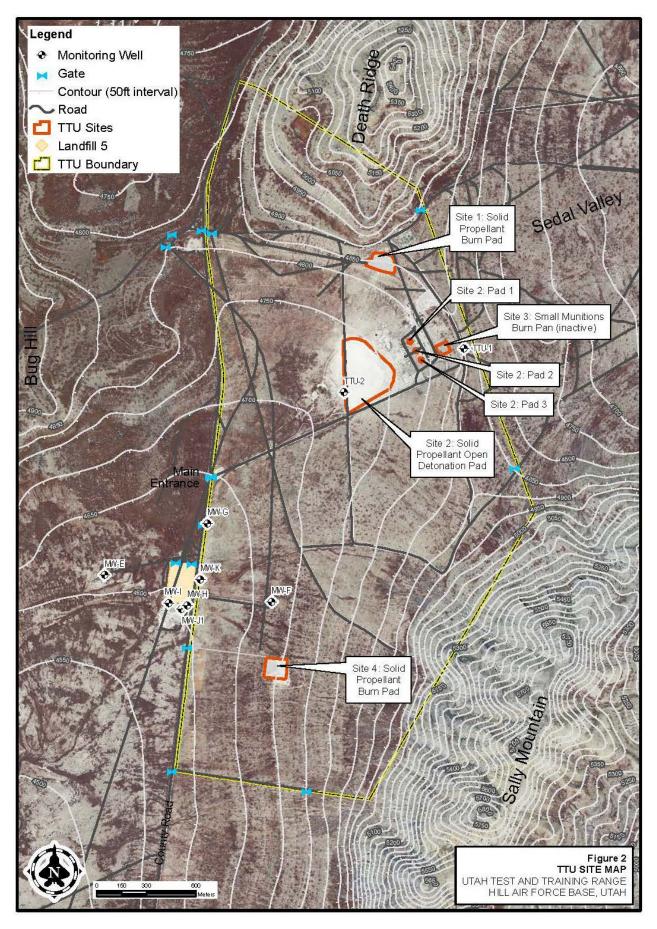
The TTU occupies a 2-square mile area in a gently southwestward-sloping valley. The TTU topography and geology, its proximity to a Box Elder County Road, the types of operations conducted, and the quantities of munitions treated were all taken into consideration in determining the size and shape of the TTU. The TTU is outlined on the aerial photograph shown in Figure 2.

The burn pan is located approximately 150 ft southeast of the burn pit it replaced. Figure 2 details the location of these sites.

The layout of the four TTU treatment sites is illustrated in Figure 2. They include the rocket motor and bulk propellant OB pads (Sites 1 and 4), the OB/OD staging and treatment pads (Site 2), and the miscellaneous munitions OB pan (Site 3). Perimeter fences, cliffs, and/or other mountainous terrain restrict public access. The area is undeveloped with no supporting utilities. The only man-made features are the four OB/OD sites and associated roadways, fences, and fire breaks. Figure 3 presents a series of photographs of each site and the main TTU entrance gate.

The topography surrounding the TTU is shown in Figure 2. Other than the Great Salt Lake, there are no perennial streams or permanent surface water bodies in the vicinity of the TTU. Precipitation is usually short-lived and generates only small quantities of water in this arid environment, although brief, intense thunderstorms can occur. Larger storms cause local ponding in surface depressions, but the ponds normally last only a few days due to the consistently high evaporation rates.

north end of Sink Valley as a separate, independent groundwater basin called the North Valley Subdistrict. Additional hydrogeologic information is contained in a Closure/Post-Closure Plan from the installation of six Monitoring Wells at Landfill 5 (CH2M HILL 1988). The locations of these wells are presented in Figure 2.

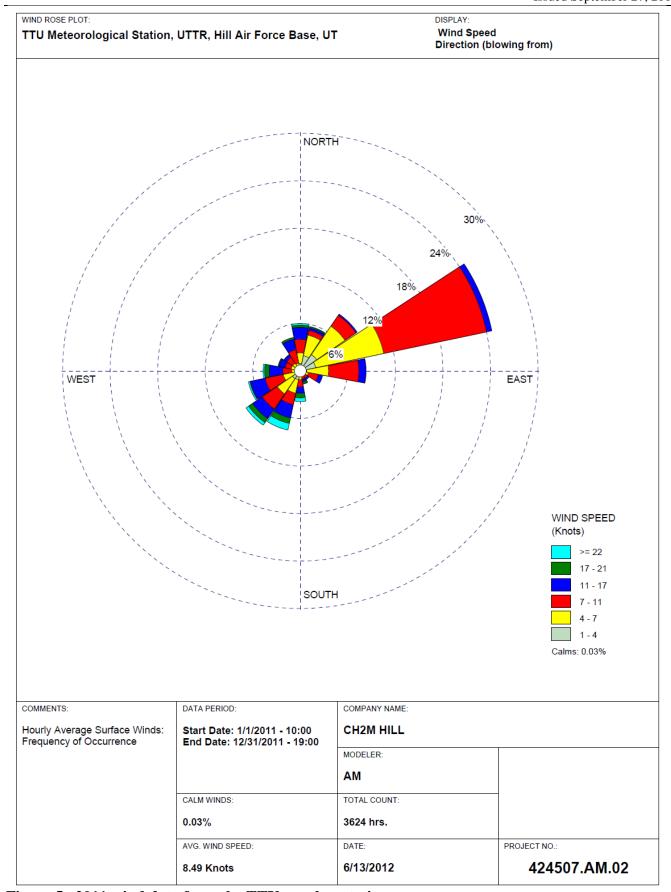
Figure 5. 2011 wind data from the TTU weather station.

Because of the surrounding topography, the wind at the TTU is tunneled through the gap in the ridge and varies consistently between either a northeasterly or southwesterly flow. This flow is largely a function of the Great Salt Lake where a lake effect easterly wind will often dominate the synoptic scale westerly wind. The 2011 average daily wind features are shown in Figure 5 in the form of a Wind Rose diagram.
