2.0 FACILITY DESCRIPTION

2.1.1 General Description of the Bacchus Facility

2.2 DESCRIPTION OF HWMUs

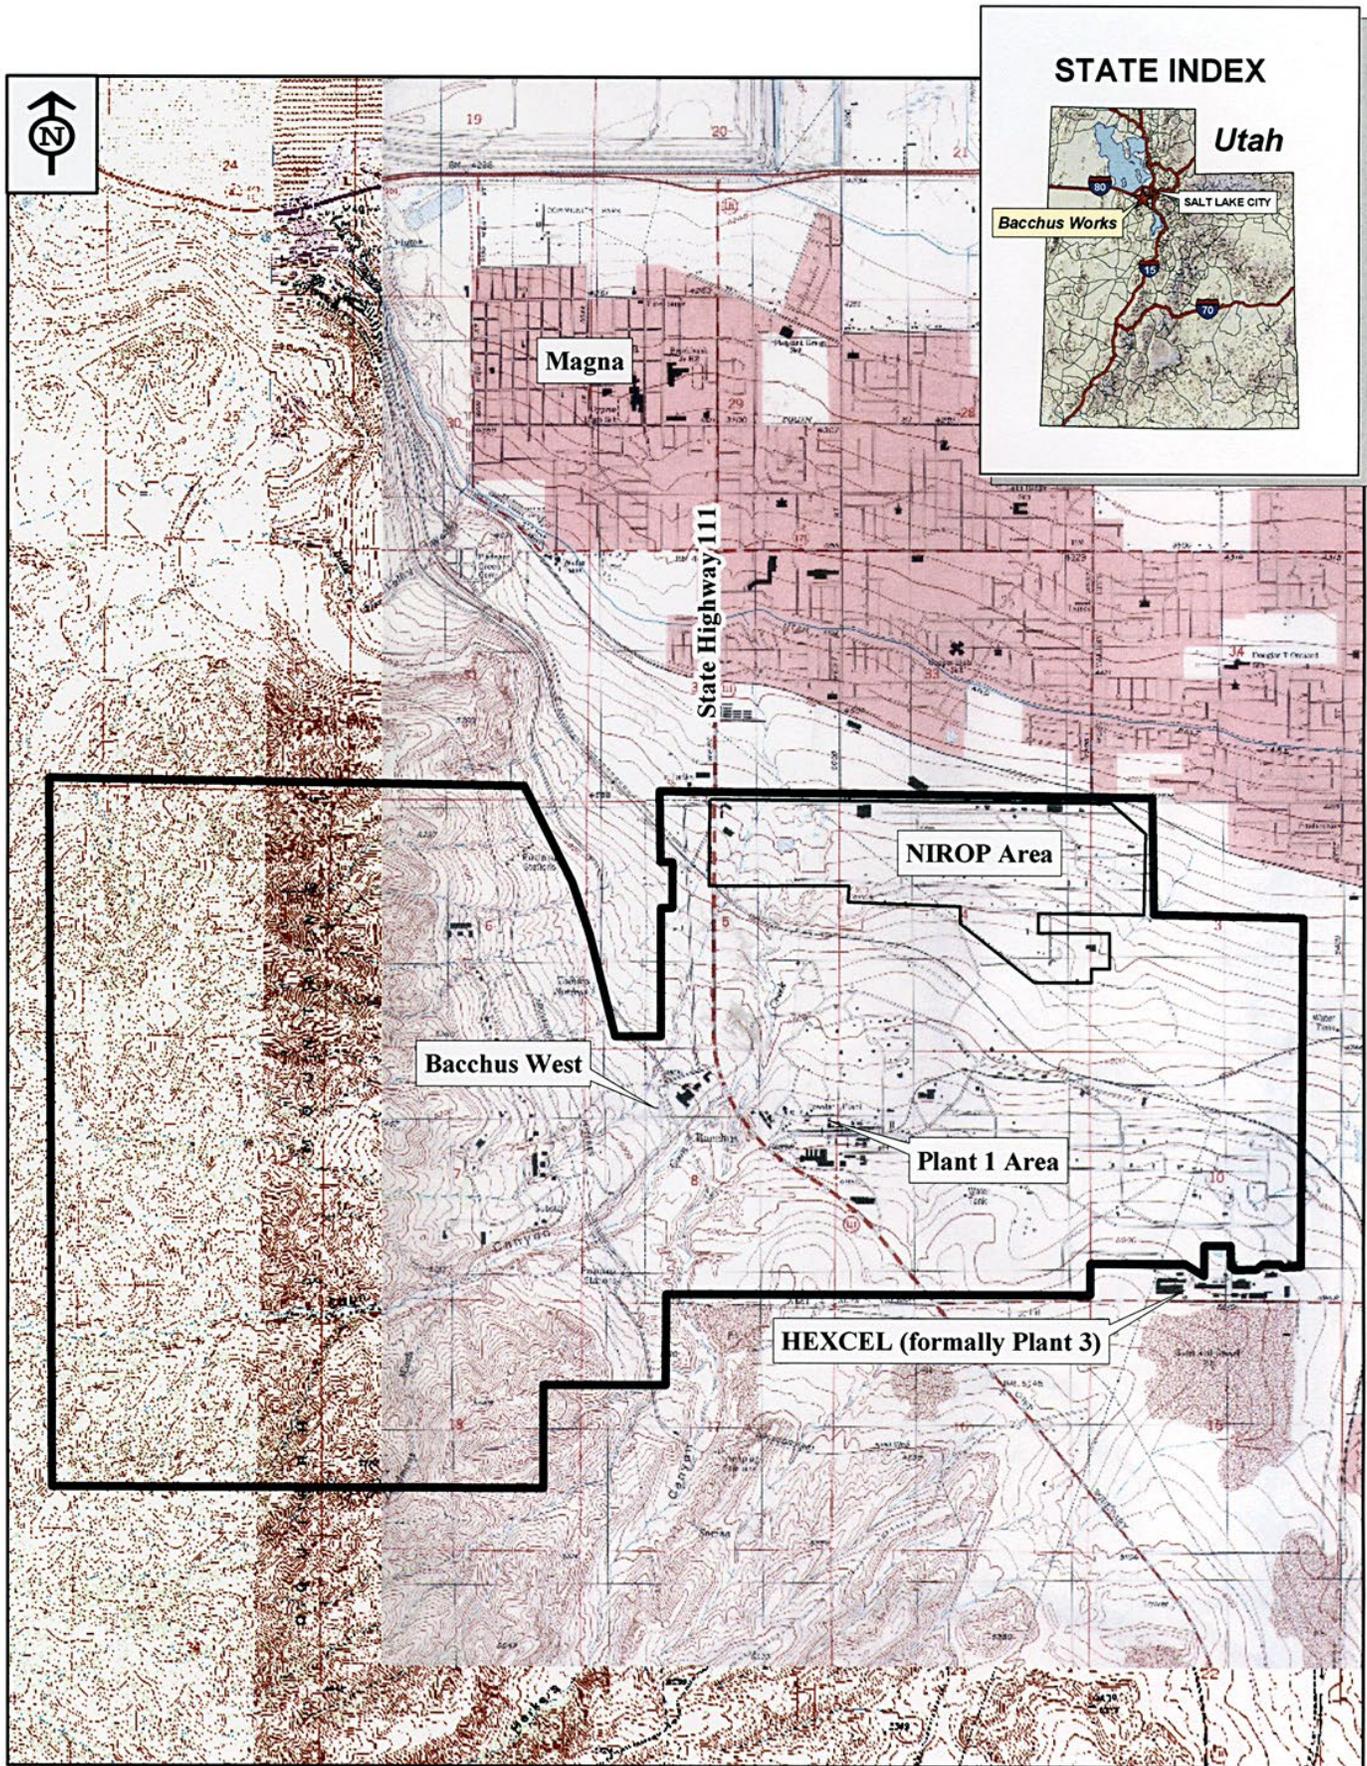
Figure 2-1.1a
ATK Launch Systems Inc. - Bacchus

Source base map: USGS 1:24,000 Quadrangles "Magna, UT", "Famsworth Peak, UT"

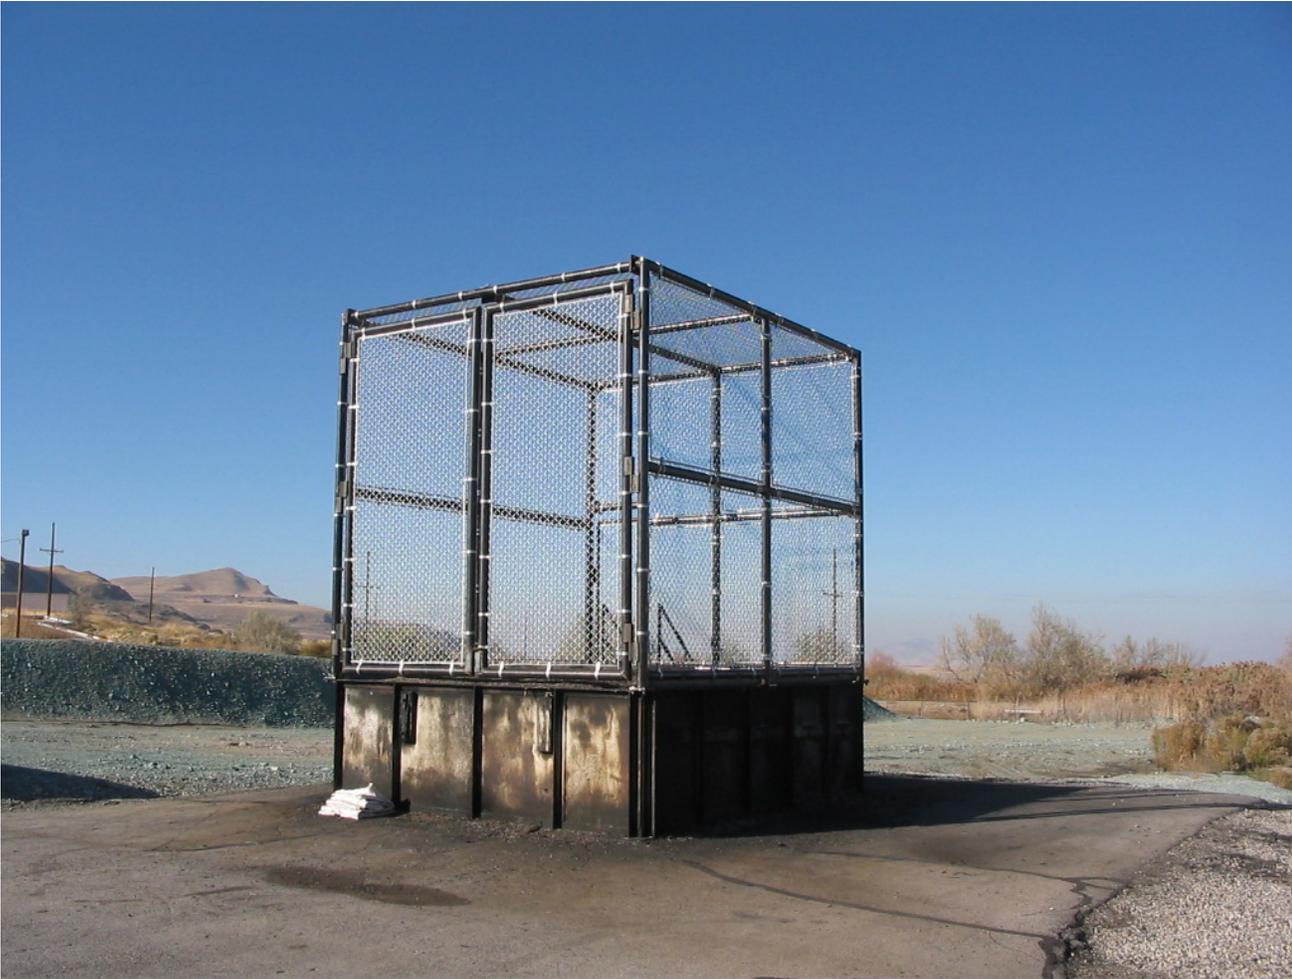
**Figure 2-2.8 Burn Cage 19
(Picture is looking North)**

In addition to the burn pans, the NIROP Burning Grounds has two burn cages (Cages 12 and 19) (Figure 2-2.8) that are used to treat wastes which are lightly contaminated with small amounts of explosives. Each cage dimensions are 12' high x 12' wide x 14' long. Three-inch diameter schedule 40 steel pipe is used as the support structure for the cages. The cages are covered with a metal fabric on the sides and top. Each cage has a large access door on the south side and a small access door on the north side. Cages 12 and 19 also have a leachate collection system similar to the system used on burn pans.

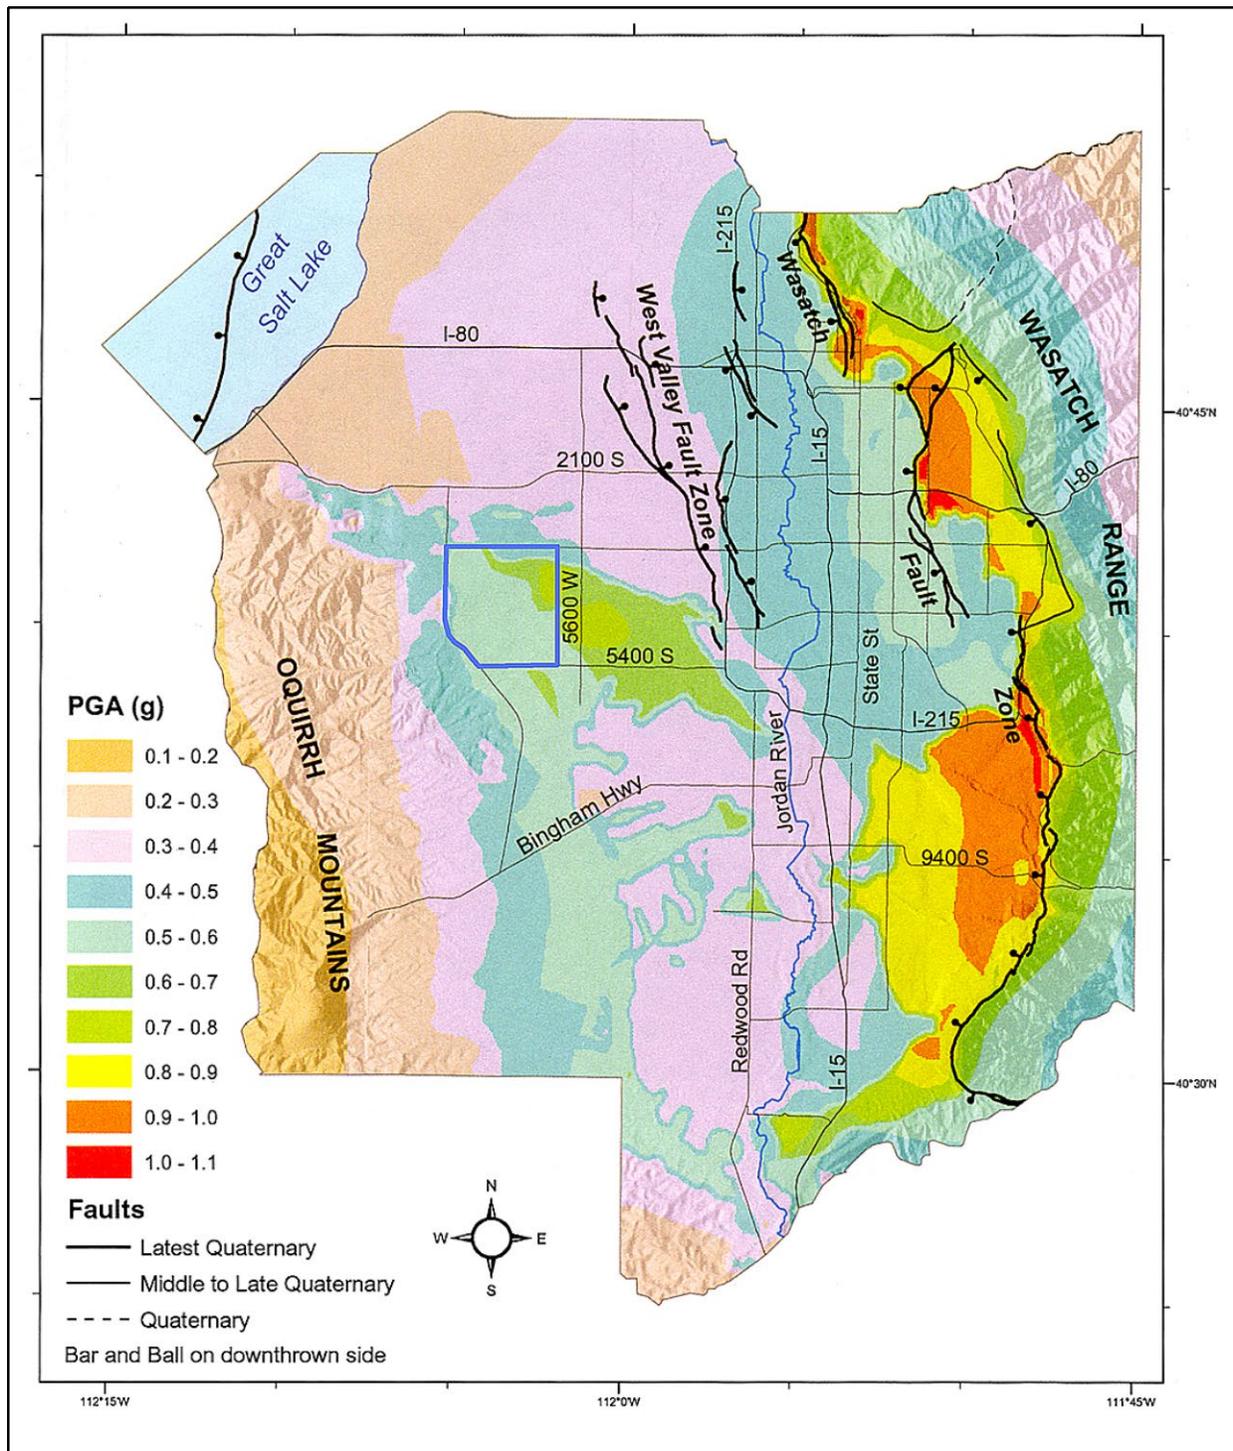
Figure 2-5.21
Salt Lake City Segment, Wasatch Fault M 7.0 Earthquake, Peak Horizontal Acceleration (g) at Ground Surface
UGS MP 02-5, 2002

The MP 02-5 report presents hazard maps that show the frequency-dependent amplification of unconsolidated sediments in the Salt Lake Valley. In summary, locations along the bench areas near the Wasatch Fault will exhibit the highest peak accelerations, while the central portion of the valley will show lower peak accelerations due to damping. The site is situated on, what is termed in the report as, lacustrine alluvial gravels (Figure 2-5.20). This material, along with a shallowing of the sediments near the Oquirrh Mountains would cause an increase in ground shaking. The study estimates the peak horizontal ground acceleration (PGA) in the site area to be between 0.5g

and 0.6g (Figure 2-5.21). This level of PGA is considered moderate to heavy, with slight damage to specially designed structures and considerable damage to ordinary buildings.
