ATTACHMENT 1

**FACILITY DESCRIPTION
AND LOCATION**

FACILITY DESCRIPTION AND LOCATION

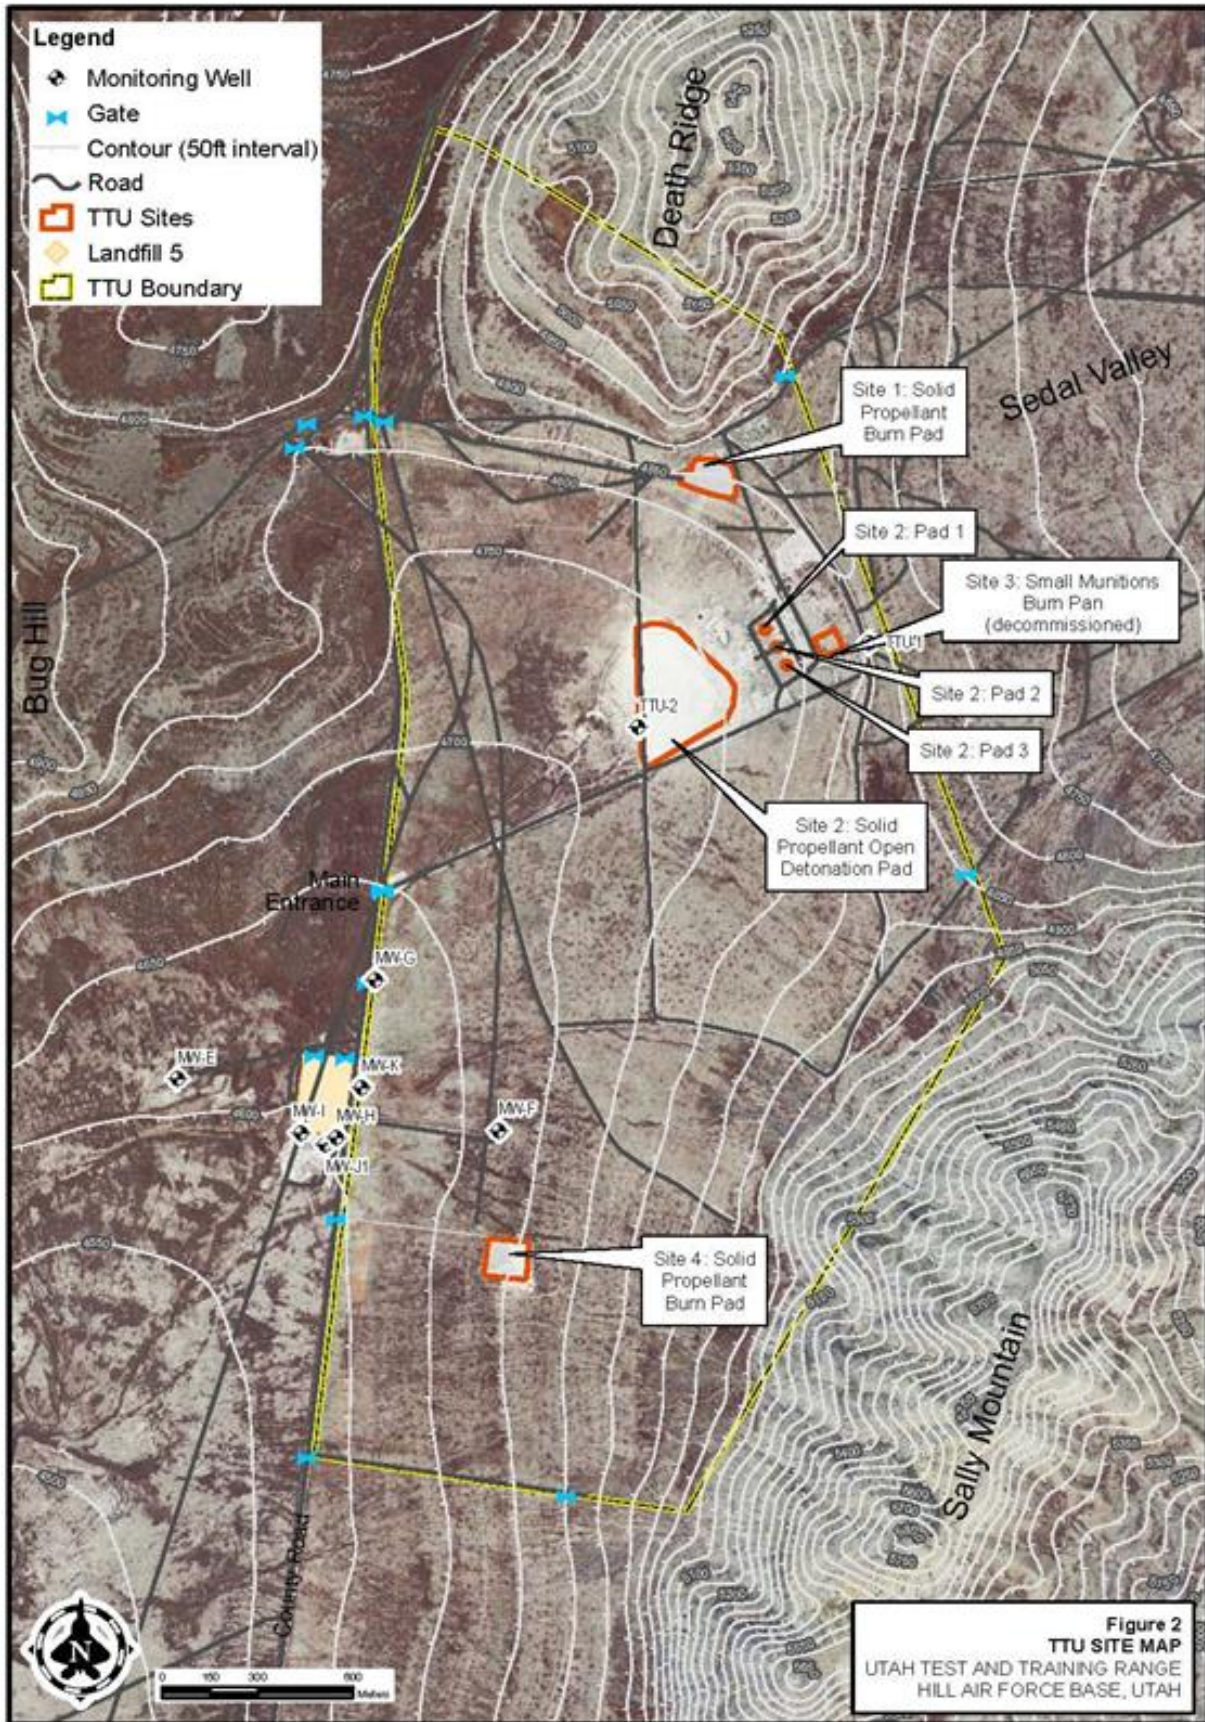
The TTU occupies a 2-square mile area in a gently southwestward-sloping valley. The TTU topography and geology, its proximity to Box Elder County Road 02230, the types of operations conducted, and the quantities of munitions treated were all taken into consideration in determining the size and shape of the TTU. The TTU is outlined on the aerial photograph shown in Figure 2.

The layout of the four TTU treatment sites is illustrated in Figure 2. They include the rocket motor and bulk propellant OB pads (Sites 1 and 4), the OB/OD staging and treatment pads (Site 2), and the miscellaneous munitions OB pan (Site 3). Perimeter fences, cliffs, and/or other mountainous terrain restrict public access. The area is undeveloped with no supporting utilities. The only man-made features are the four OB/OD sites and associated roadways, fences, and fire breaks. Figure 3 presents a series of photographs of each site and the main TTU entrance gate.

device (PAD) items, flares, and small arms ammunition were treated by OB. The burn pan was decommissioned and partially closed in 2018. Figure 2 details the location of these sites.

The topography surrounding the TTU is shown in Figure 2. Other than the Great Salt Lake, there are no perennial streams or permanent surface water bodies in the vicinity of the TTU. Precipitation is usually short-lived and generates only small quantities of water in this arid environment, although brief, intense thunderstorms can occur. Larger storms cause local ponding in surface depressions, but the ponds normally last only a few days due to the consistently high evaporation rates.

The regional groundwater conditions for the Sink Valley Hydrogeologic Basin are described in general terms in a hydrogeologic investigation by Price (1970). This investigation describes the north end of Sink Valley as a separate, independent groundwater basin called the North Valley Subdistrict. Additional hydrogeologic information is contained in a Closure/Post-Closure Plan from the installation of six Monitoring Wells at Landfill 5 (CH2M HILL 1988). The locations of these wells are presented in Figure 2.

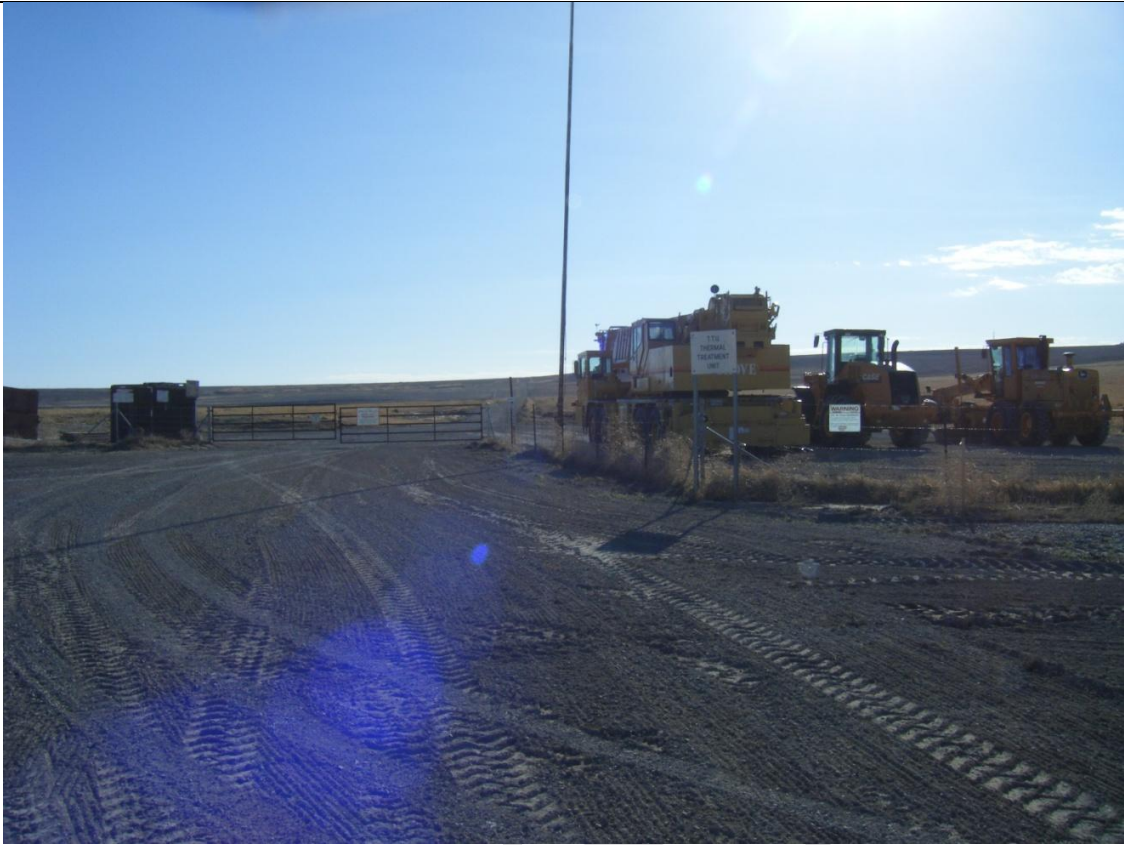
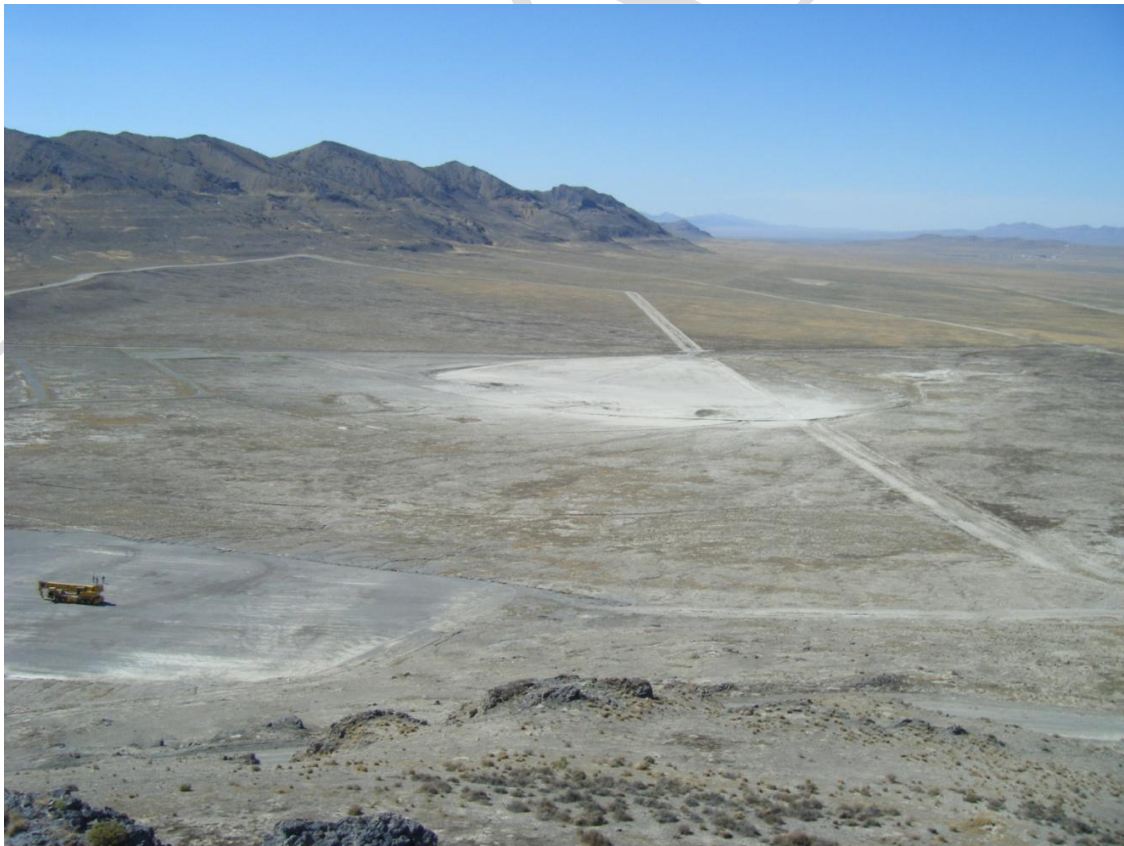
Figure 3. TTU Photos (Front gate and Sites 1 and 2)

Site 1, centered at 41° 08' 13.58" North latitude and 112° 53' 41.00" West longitude, was built in 1989 and is an OB pad used for thermal treatment of solid rocket propellants and whole rocket motors. OD does not take place at this location. The pad consists of a filled and raised area, with dimensions 300 ft north to south and 400 ft east to west. The surface of the OB pad consists of 8 to 12 in. of pit-run material, covered with 6 in. of 0.75 minus crushed gravel. Grounding rods are driven into the surface for each OB event as needed, isolating the propellant from electrostatic discharge (ESD).

All of the smaller pads consist of 8 to 12 in. of pit-run material, covered with 6 in. of 0.75 minus crushed gravel. Site 2 pads are used for staging OB/OD operations only, providing a stable surface for off-loading conventional high explosives and large missile sections. The surficial soils in the operational areas consist of fine sandy silt with some clay. Grounding rods are driven into the soil at the operational location for each OB event, as required. Craters created by OD operations are filled in by the Oasis Civil Engineers within two weeks of the event. Craters and grading actions significantly reduce the off-pad soil compaction, so the pads are used alternately, allowing natural settling processes to restore the site. This allows safe movement of the heavy transport vehicles from Site 2 pads to the adjacent areas. Pad 3 serves for OB treatment of rocket motors as well as the preferred pad for OD of items that fragment or require specific site preparation, such as the creation of berms.

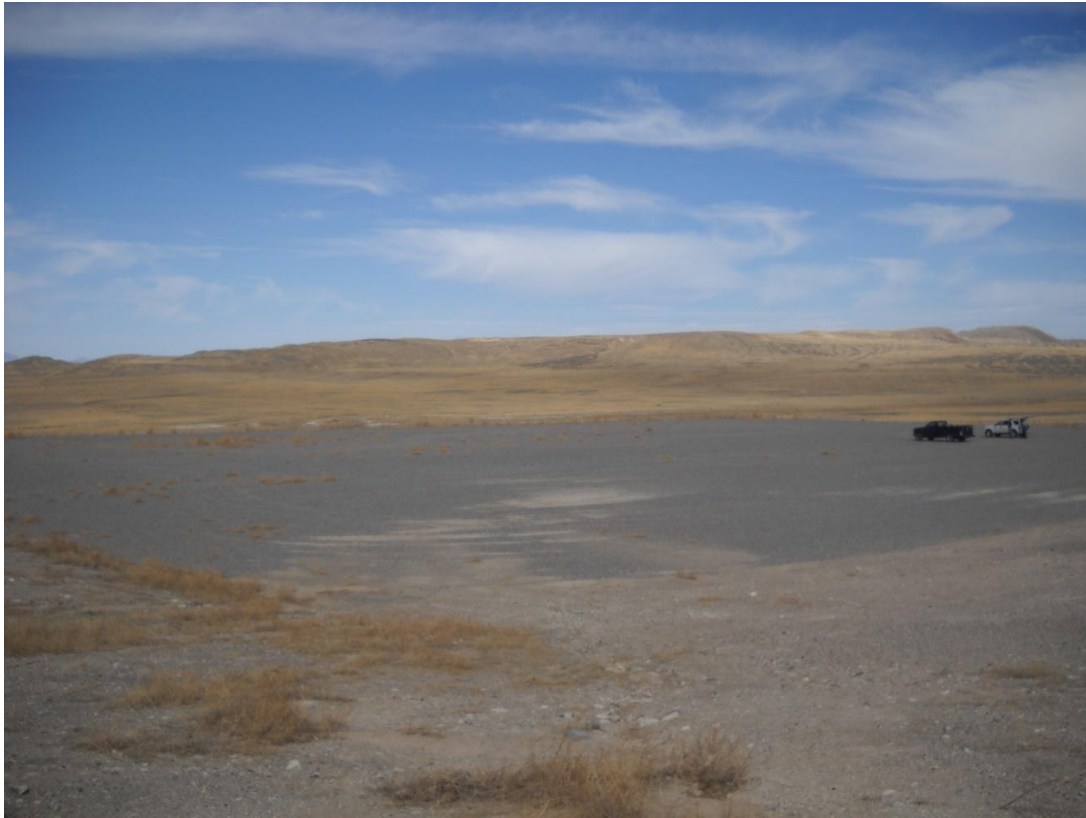
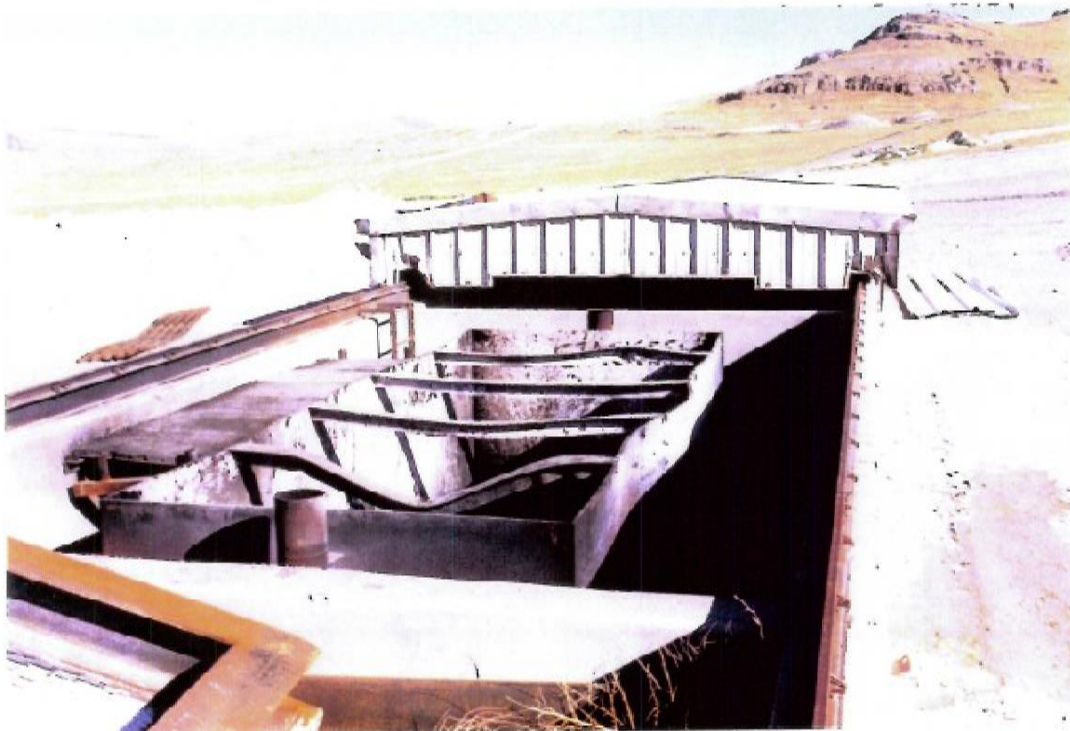
Figure 3 Continued. TTU Photos (Site 4 and former burn pan [Site 3])

Site 3 is the location of the former miscellaneous munitions burn pan that was decommissioned and partially closed in 2018. Information about the partial closure and historical use of the burn pan is found in Attachment 8, Appendix A.

Site 4, centered at 41°06'54" North latitude and 112°54'8" West longitude, was built in 2008 and is an OB pad used for thermal treatment of solid rocket propellants and whole rocket motors. OD does not take place at this location. The pad consists of a filled and raised area, with dimensions of 385 ft north to south and 325 ft east to west. The surface of the OB pad consists of 8 inches or more of pit-run material, covered with 6 in. of 0.75 minus crushed gravel. Grounding rods are driven into the surface for each OB event as needed, isolating the propellant from electrostatic discharge (ESD).

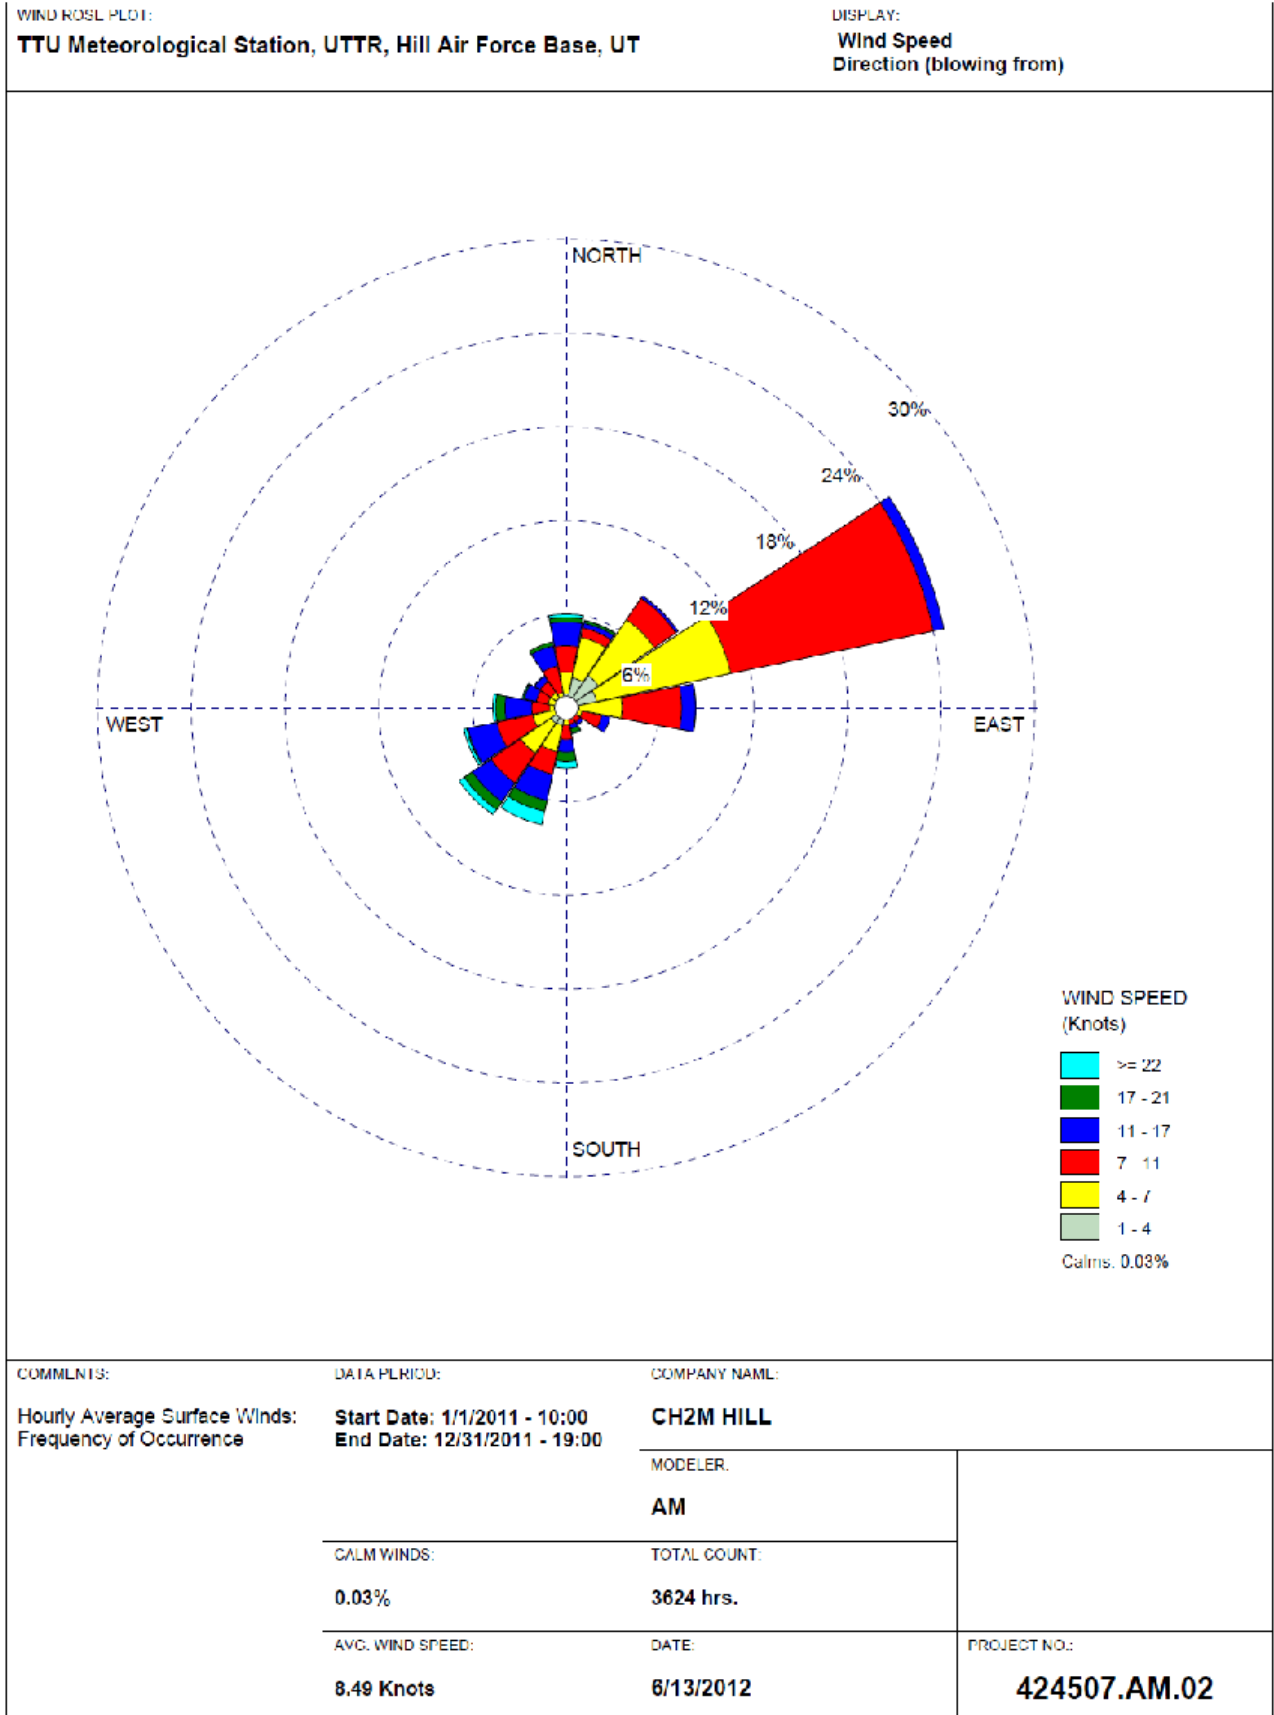
Because of the surrounding topography, the wind at the TTU is tunneled through the gap in the ridge and varies consistently between either a northeasterly or southwesterly flow. This flow is largely a function of the Great Salt Lake where a lake effect easterly wind will often dominate the synoptic scale westerly wind. The 2011 average daily wind features are shown in Figure 5 in the form of a Wind Rose diagram.

Figure 4. 2011 wind data from the TTU weather station.
