**CONSTRUCTION WASTE MANGEMENT**

**APPLICATION FOR PERMIT**

**TO OPERATE A**

**CLASS VI LANDFILL**

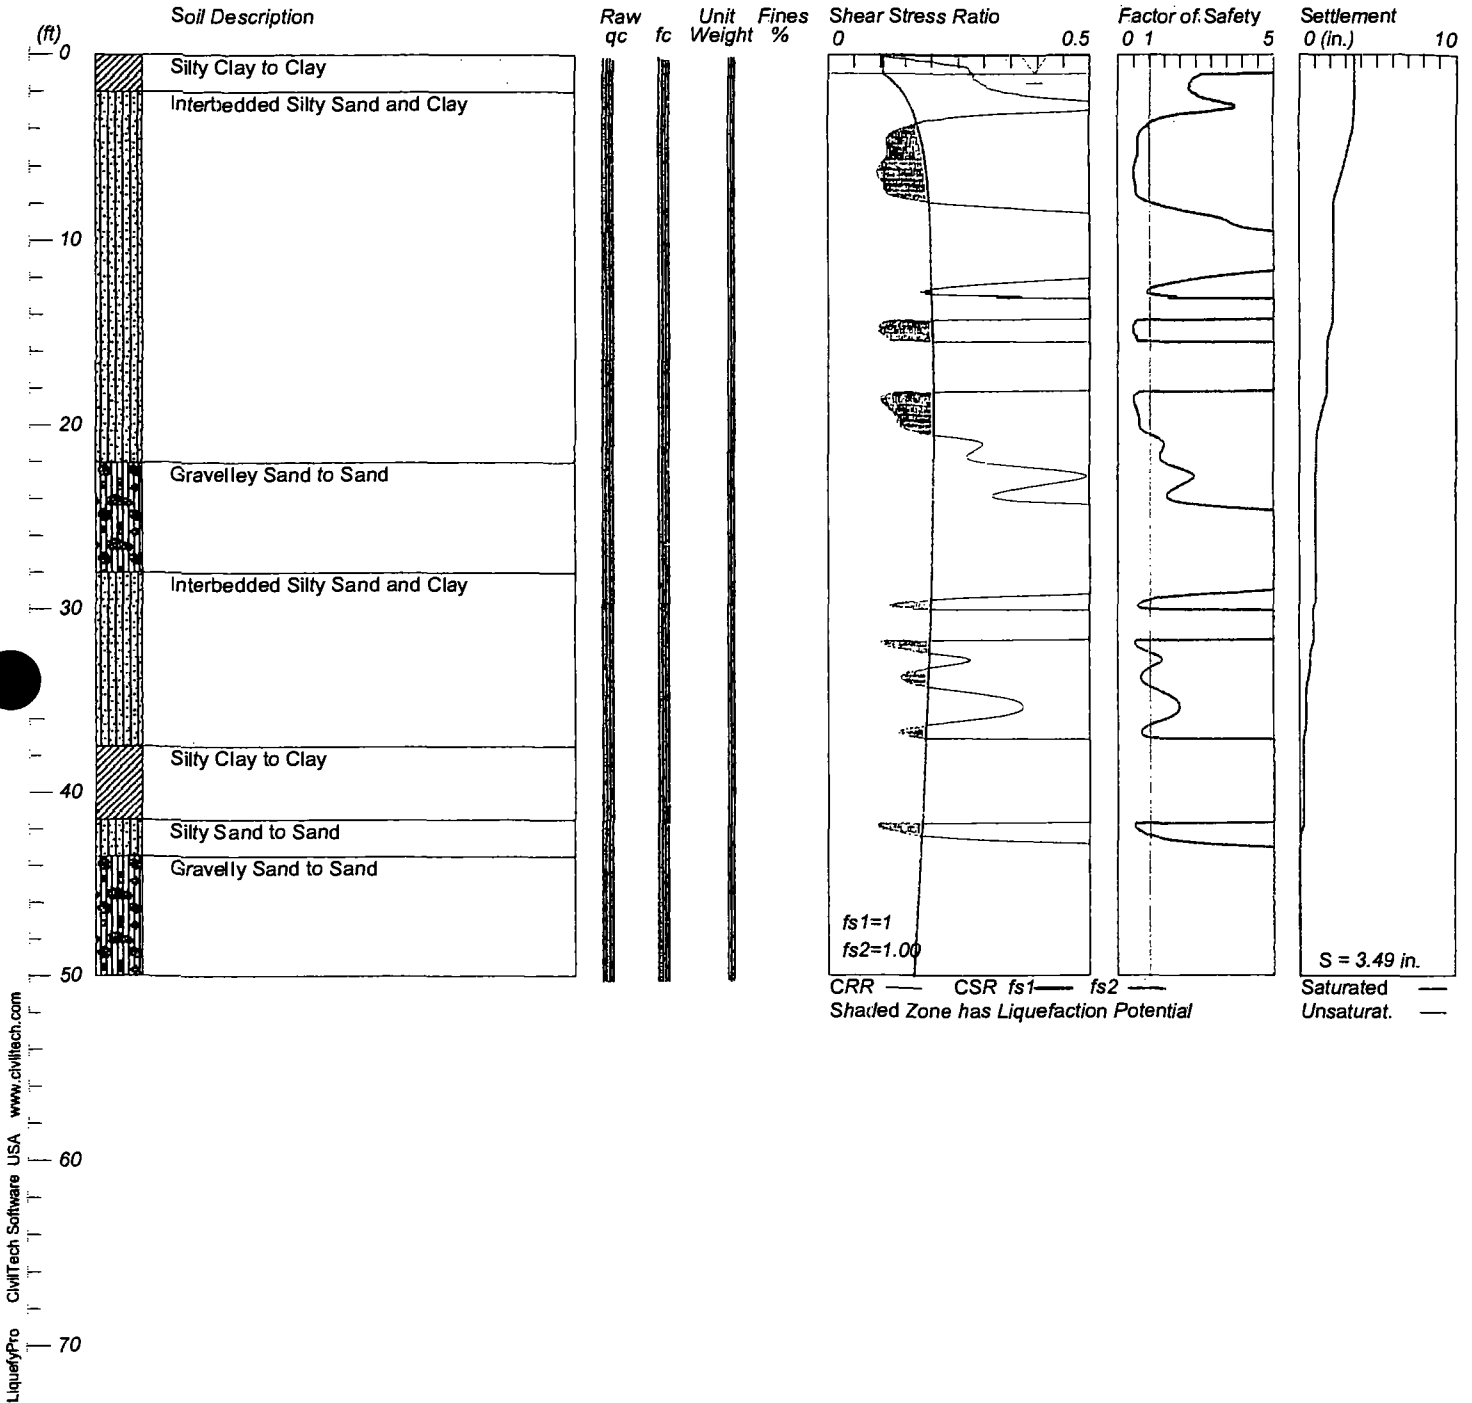
# LIQUEFACTION ANALYSIS

Magnitude=7.5  
Acceleration=0.16g

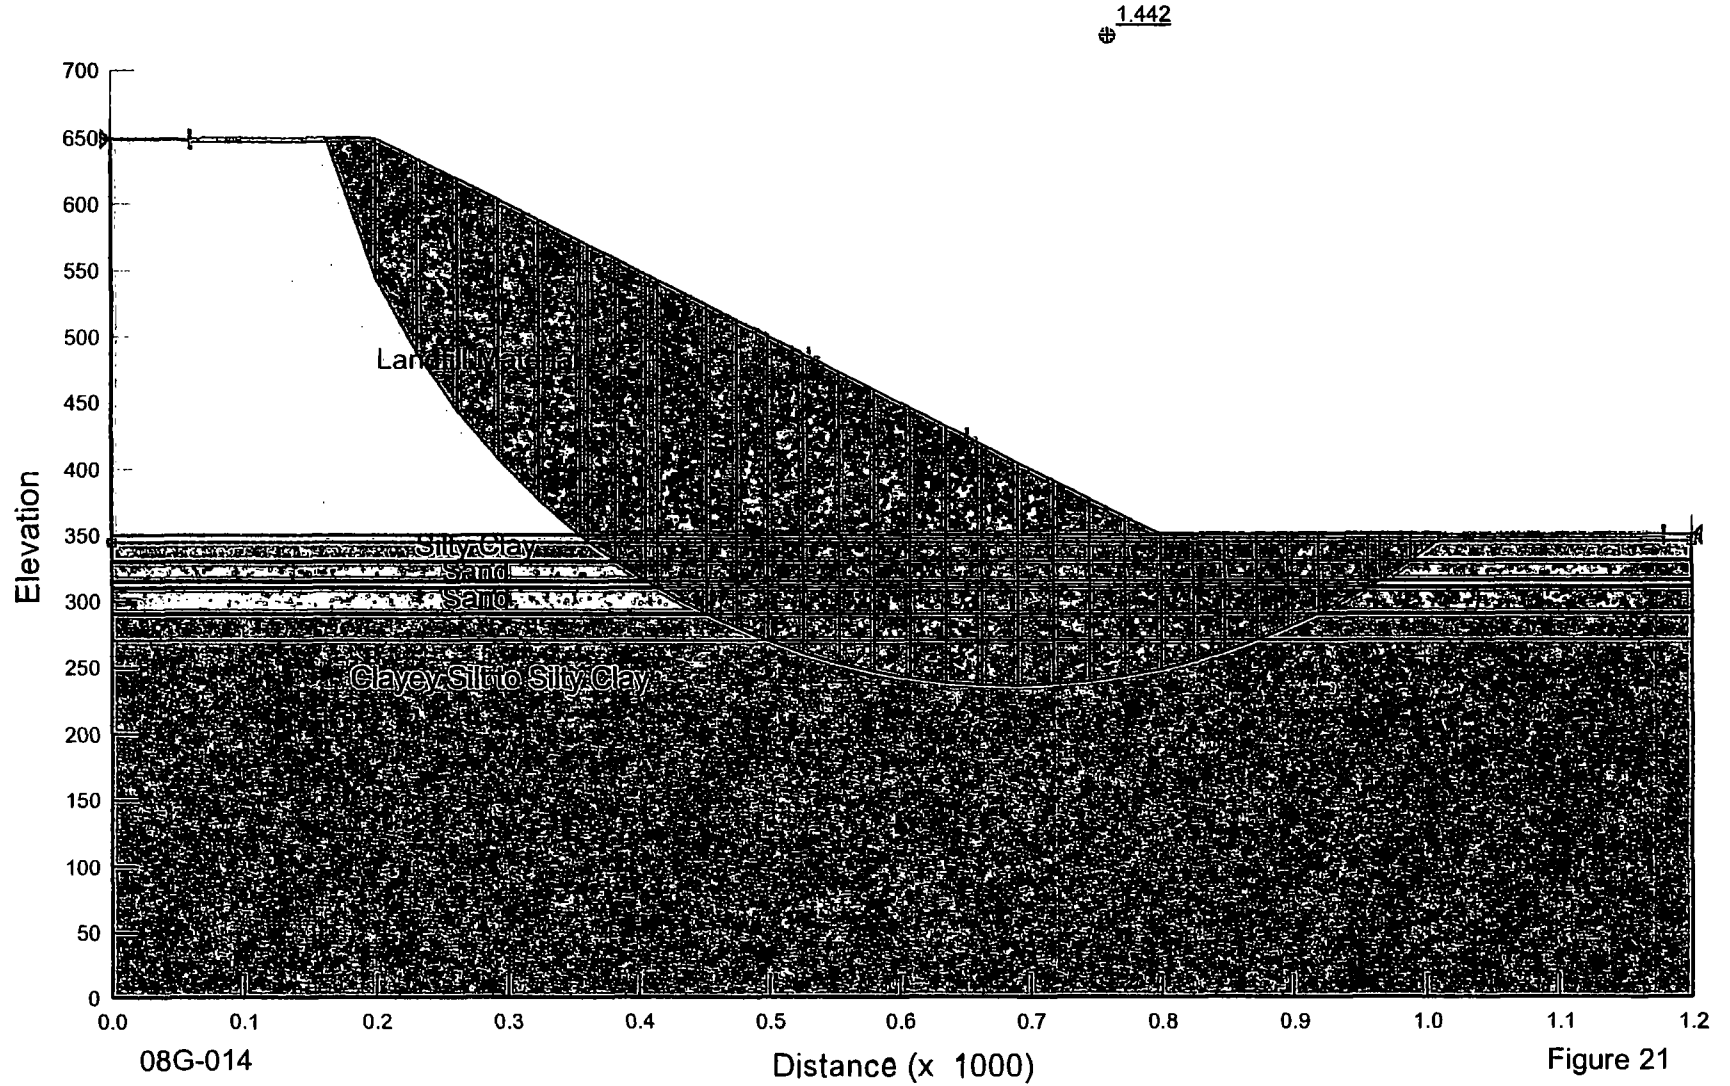
Central Valley Water Reclamation Facility  
Static Conditions

Name: landfill material Weight: 135 pcf Cohesion: 0 psf Phi: 38 °  
 Name: Silty Clay 1 Weight: 113 pcf Cohesion: 200 psf Phi: 26 °  
 Name: Sand Weight: 120 pcf Cohesion: 0 psf Phi: 32 °  
 Name: Clayey Silt Weight: 114 pcf Cohesion: 200 psf Phi: 24 °

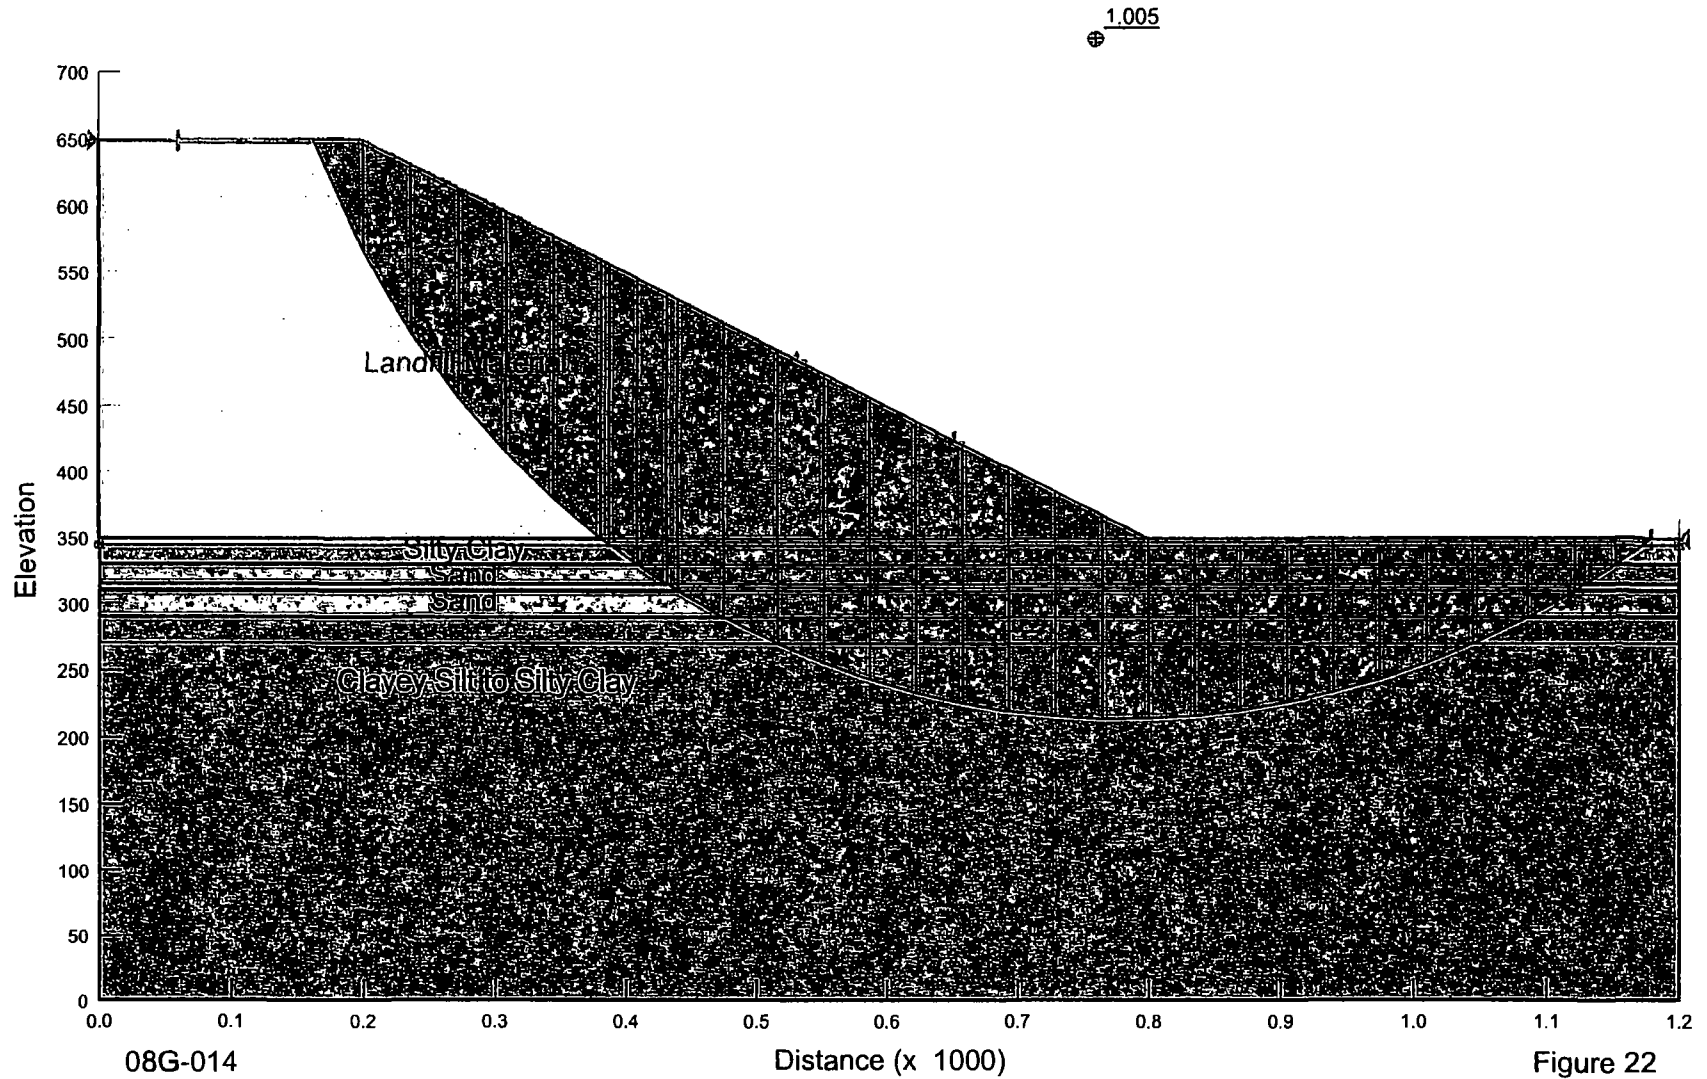
**Central Valley Landfill Facility**  
 Psuedo-static Conditions  
 P.G.A. = 0.15g

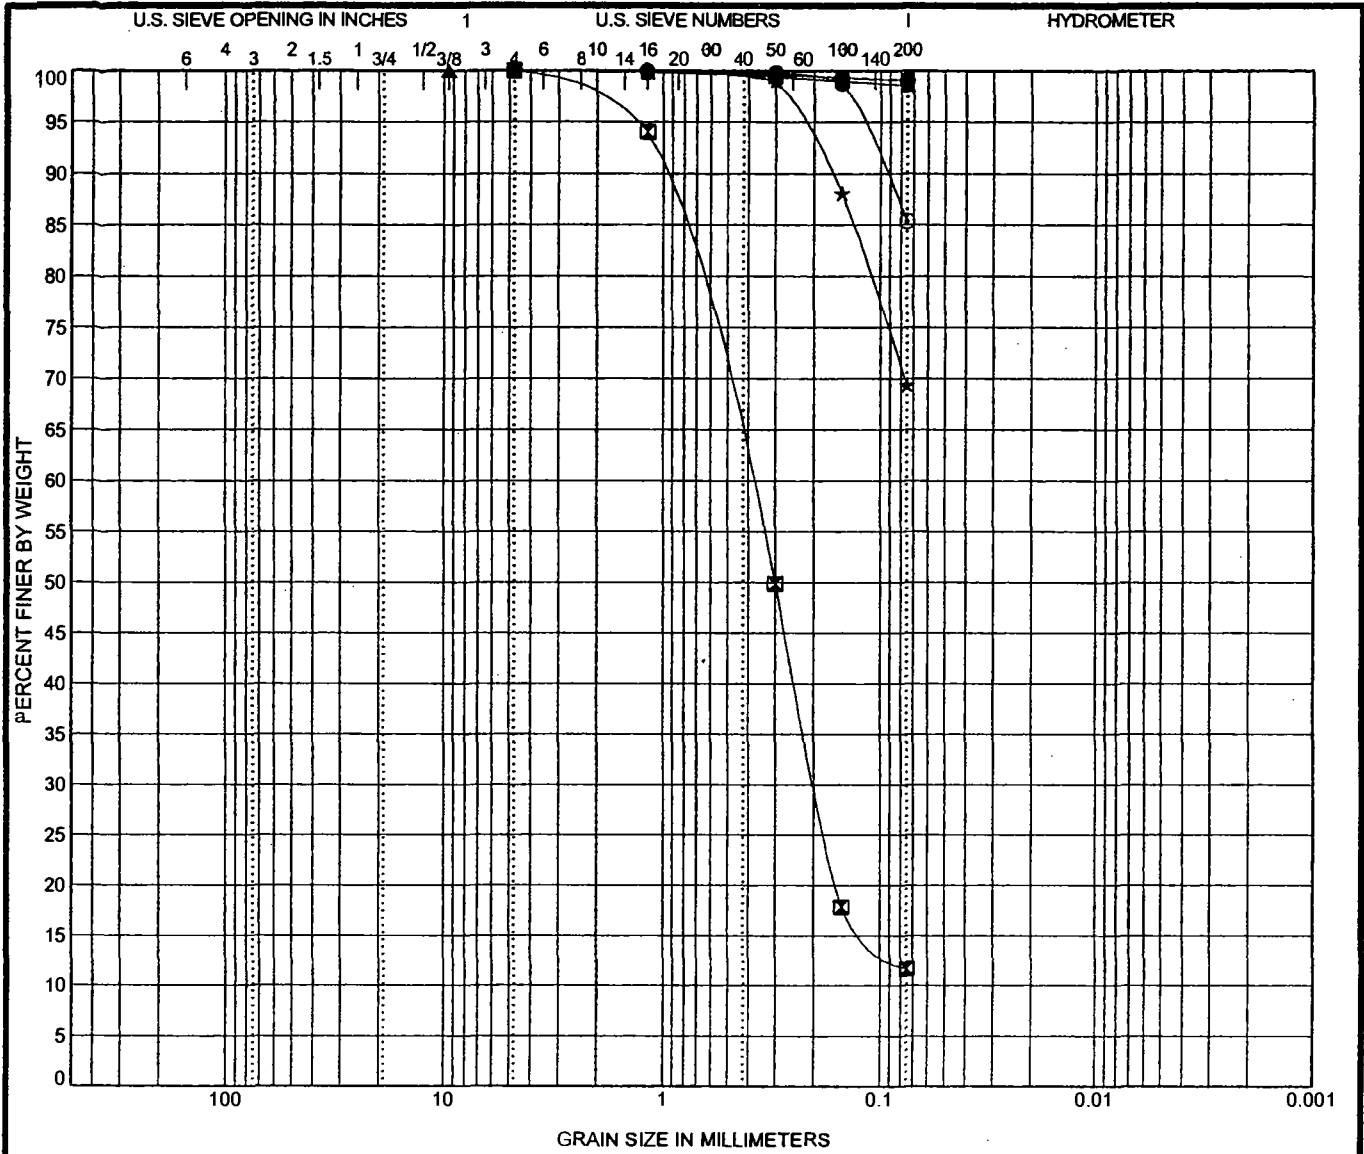
Specimen Identification	Classification	LL	PL	PI	Cc	Cu
● B-1 11.0	LEAN CLAY (CL)	48	24	24		
☒ B-1 27.0	WELL-GRADED SAND with SILT (SW-SM)	NP	NP	NP	1.5	6.6
▲ B-2 3.0	LEAN CLAY (CL)	44	21	23		
★ B-2 17.0	SANDY SILT (ML)	NP	NP	NP		
◎ B-3 7.0	LEAN CLAY (CL)	31	20	11

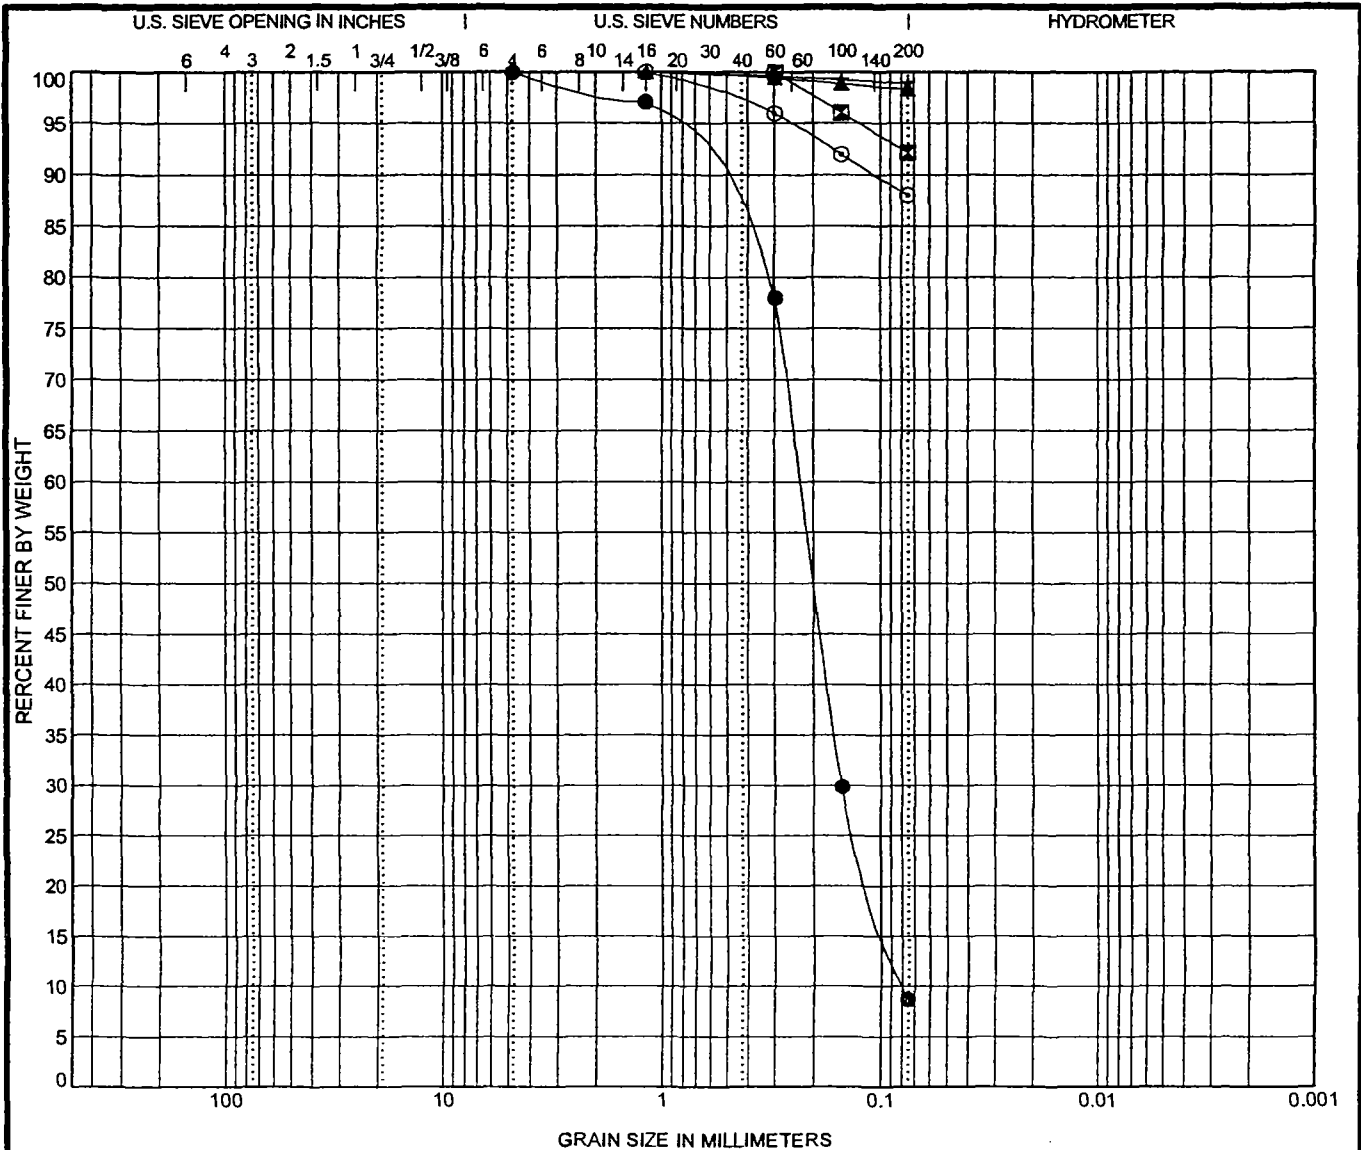
Specimen Identification	Classification	LL	PL	PI	Cc	Cu
● B-3 19.0	POORLY GRADED SAND with SILT(SP-SM)	NP	NP	NP	1.2	3.0
☒ B-4 7.0	LEAN CLAY(CL)	31	16	15		
▲ B-4 15.0	FAT CLAY(CH)	50	19	31		
★ B-5 3.0	LEAN CLAY(CL)	43	21	22		
⊙ B-5 11.0	SILT(ML)	NP	NP	NP

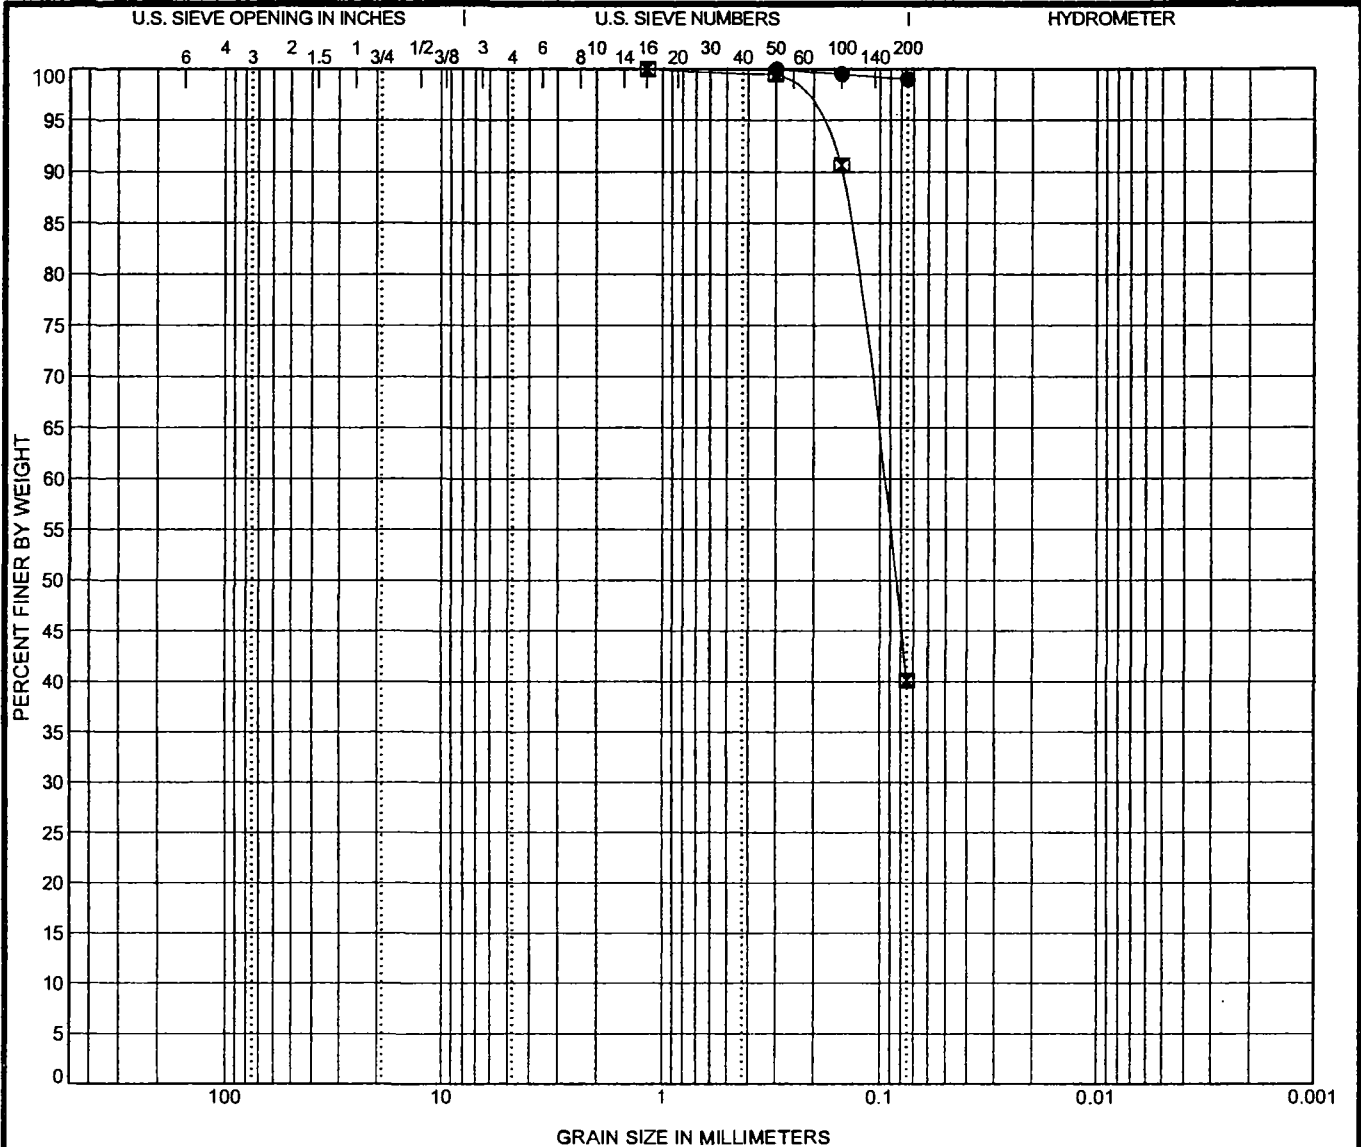
Specimen Identification		Classification	LL	PL	PI	Cc	Cu
●	B-6 5.0	FAT CLAY(CH)	50	21	29		
☒	B-6 11.0	SILTY SAND(SM)	NP	NP	NP

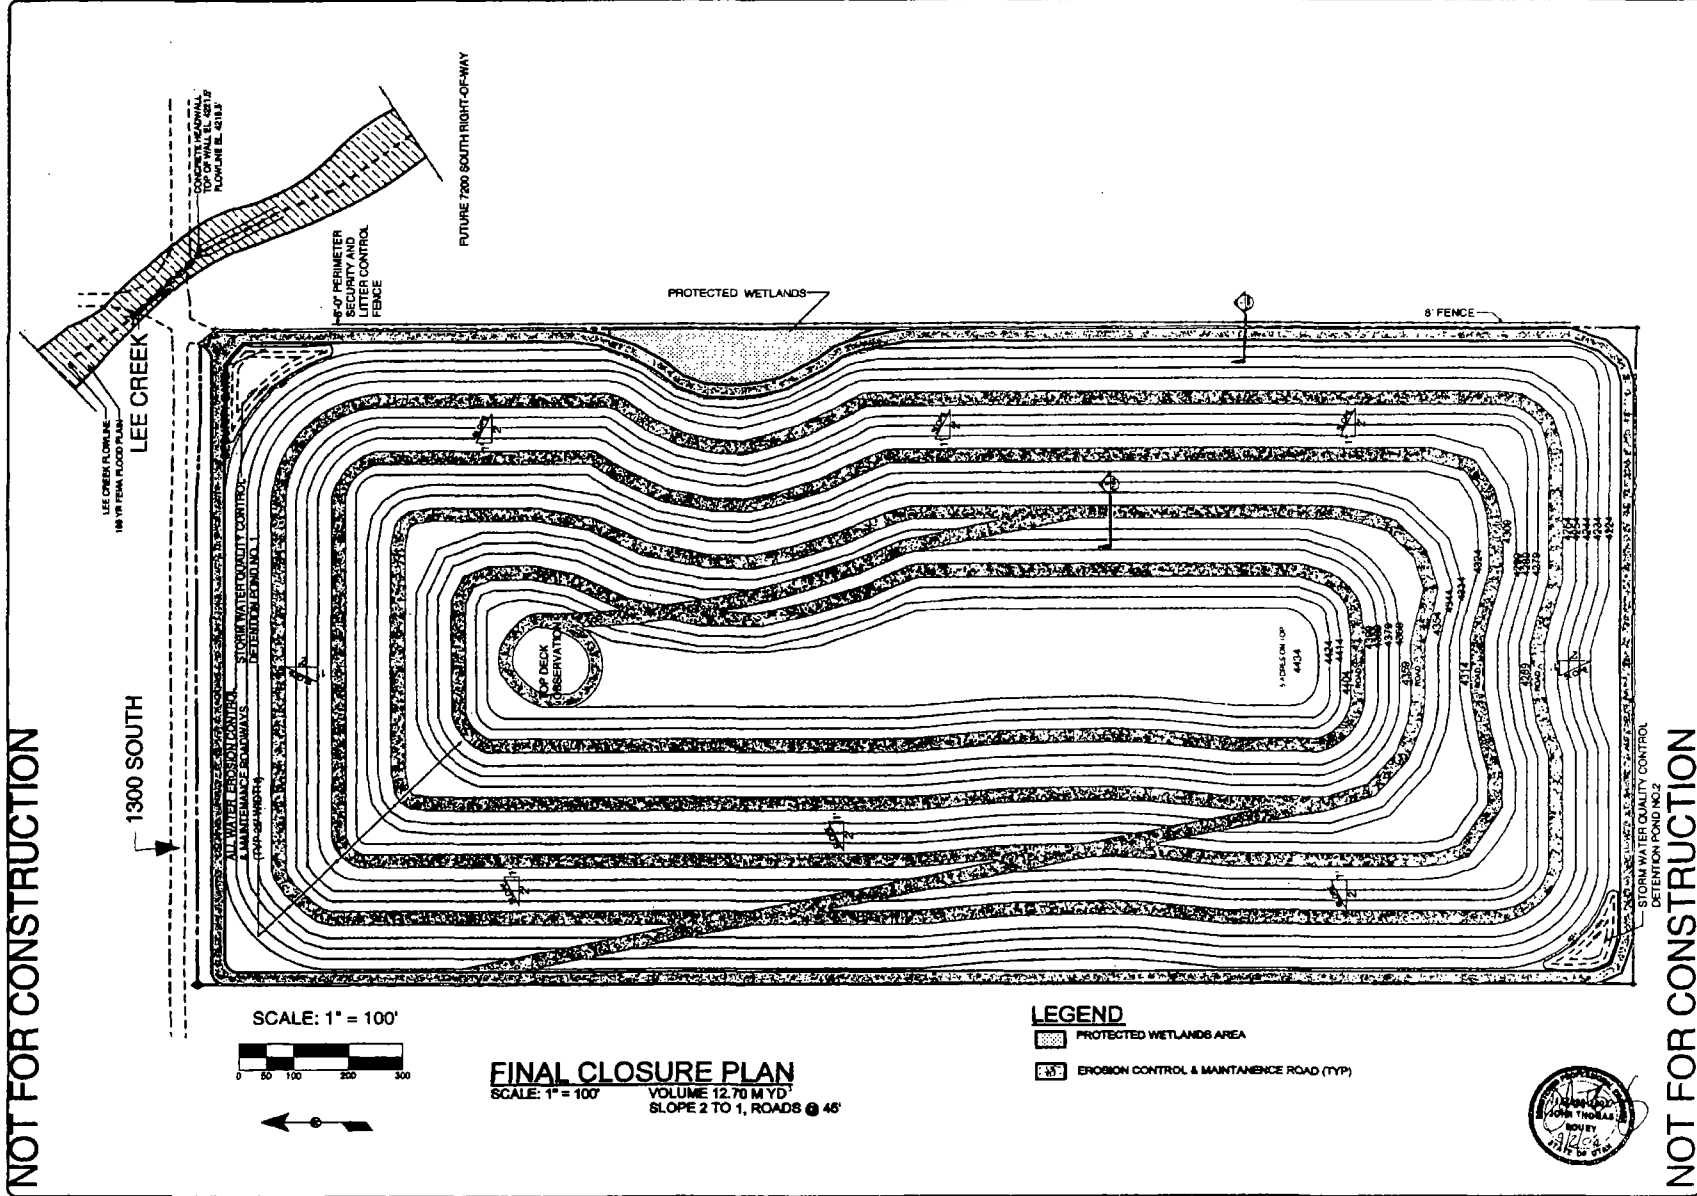
**FINAL CLOSURE PLAN**  
 SCALE: 1" = 100'  
 VOLUME 12.70 M YD'  
 SLOPE 2 TO 1, ROADS @ 45'

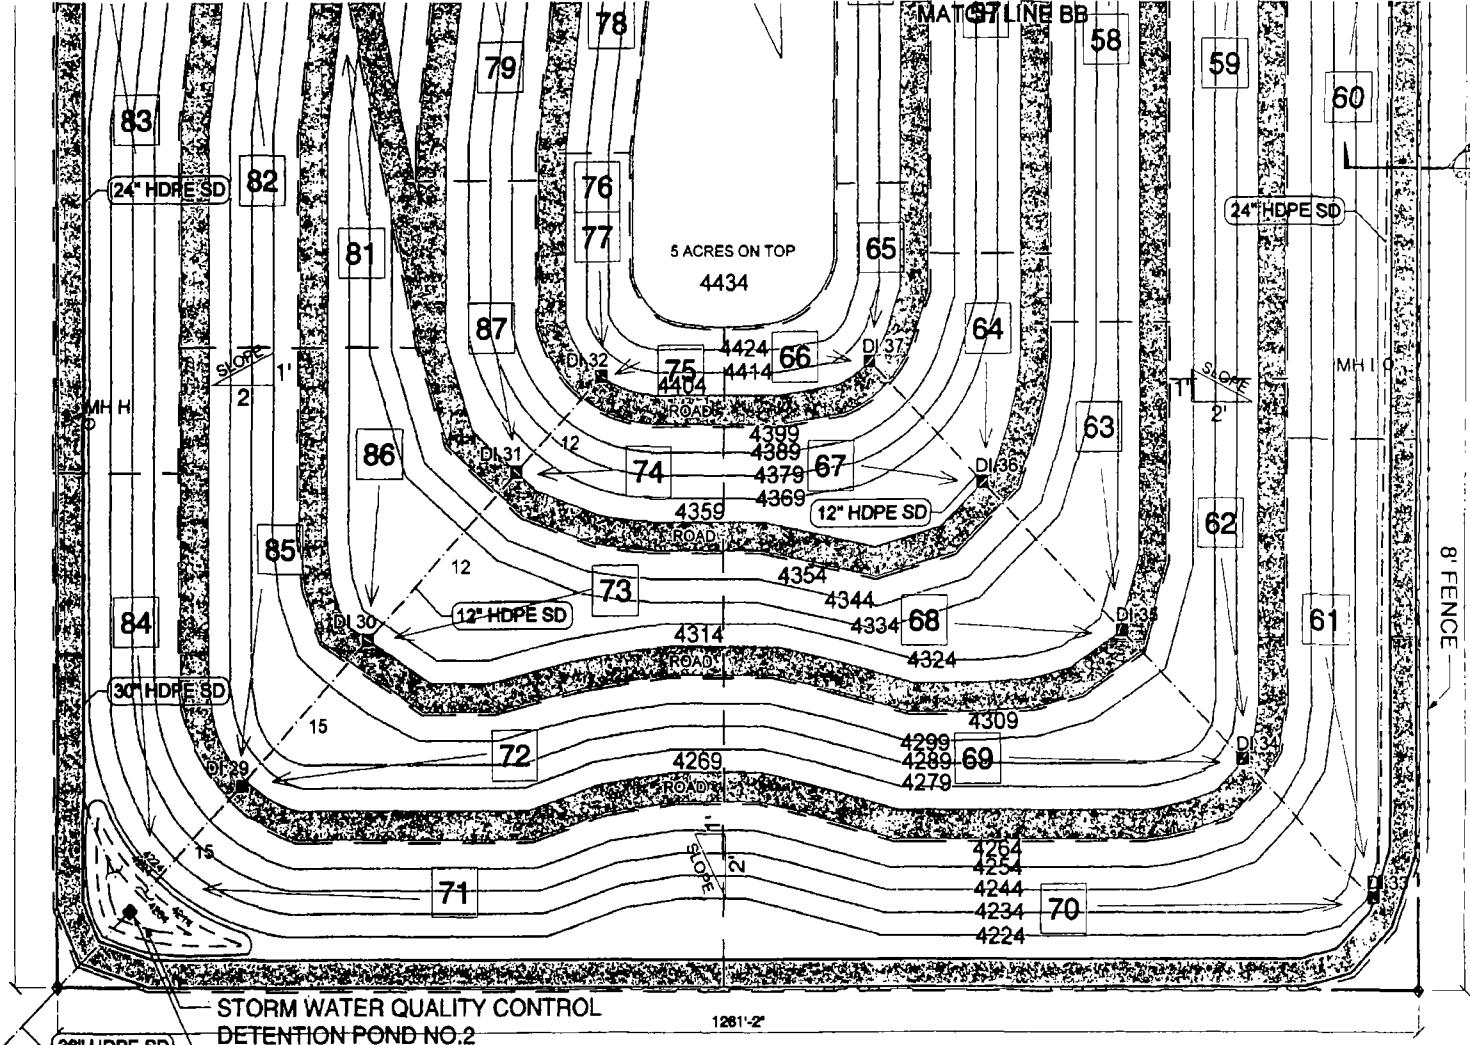
**DRAINAGE PARTIAL PLAN  
 SOUTH @ CLOSURE**

STORM WATER QUALITY CONTROL  
 DETENTION POND NO.2  
 OVERFLOW STRUCTURE  
 36" HDPE SD  
 OUTFALL TO  
 KERSEY CREEK
