**NPSWSSD CONSTRUCTION AND DEMOLITION (C&D)
2020 LANDFILL REPERMIT
APPLICATION**

November 6, 2020

IGES, INC.

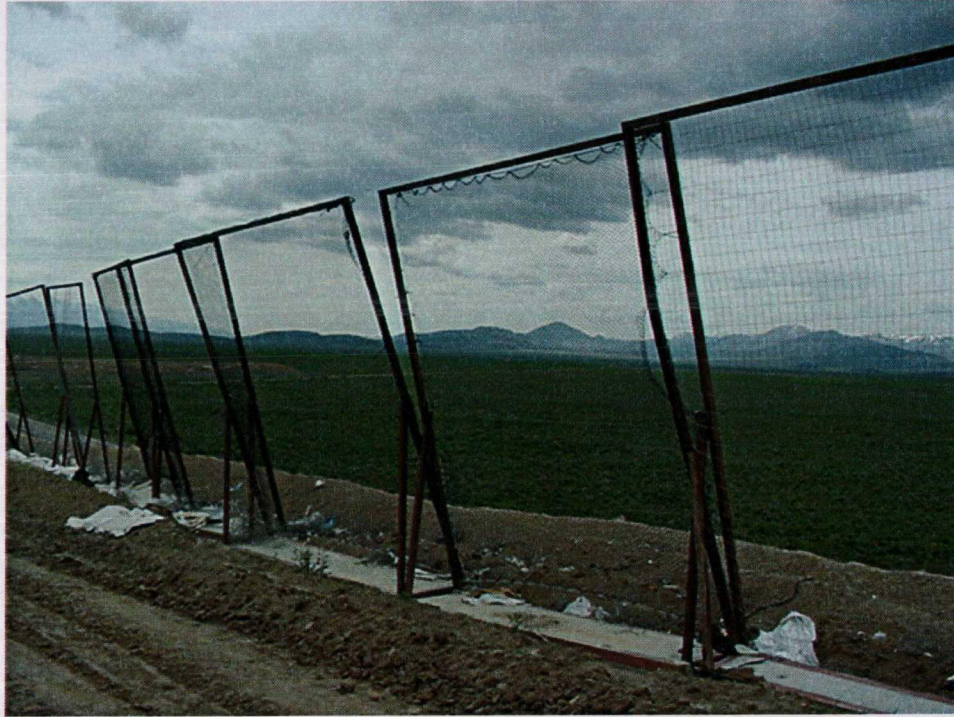
(Portable Wind Screens located on the site)

Blowing litter has been a problem and continues to be a challenge on the site. The active portion of the site is fenced with a six-foot chain link fence to attempt to keep blowing litter from leaving the site. However, the fence alone does not keep litter from blowing. In addition to the fence, portable "wind screens" have been fabricated to collect litter that is blown from the landfill. The "wind screens" are located on top of the berm allowing for maximum efficiency. As the operations continue to be refined, more dirt is mixed with the waste. The additional cover and mixture of dirt also keeps litter from blowing from the site. Occasionally, a wind storm has come across the site that has picked up litter and blown it from the site. When this occurs, the litter is gathered manually and brought back to the site and buried.
