Central Valley Water
Reclamation
Facility

UTAH DIVISION of SOLID and HAZARDOUS WASTE
APPLICATION for a PERMIT to OPERATE a CLASS VIb
LANDFILL

The owner Central Valley Water Reclamation Facility Board (CVWRF) proposes to develop a construction and demolition waste landfill (Class IVb landfill) in accordance with Utah Administrative Code R315 through 320 as revised February 1, 2007. The facility will serve the CVWRF's service area, which consists of population centers along the Wasatch Front from Ogden to Provo and from Park City to Tooele. As a Class IVb landfill the facility will not accept waste from a conditionally exempt small quantity generator of hazardous waste. The facility will accept all types of construction and demolition waste materials that will be placed and compacted in the landfill as it is received. At closure the top surface will have an elevation of about 4,434 feet above Mean Sea Level (msl) or an average of 210 feet above the existing grades.

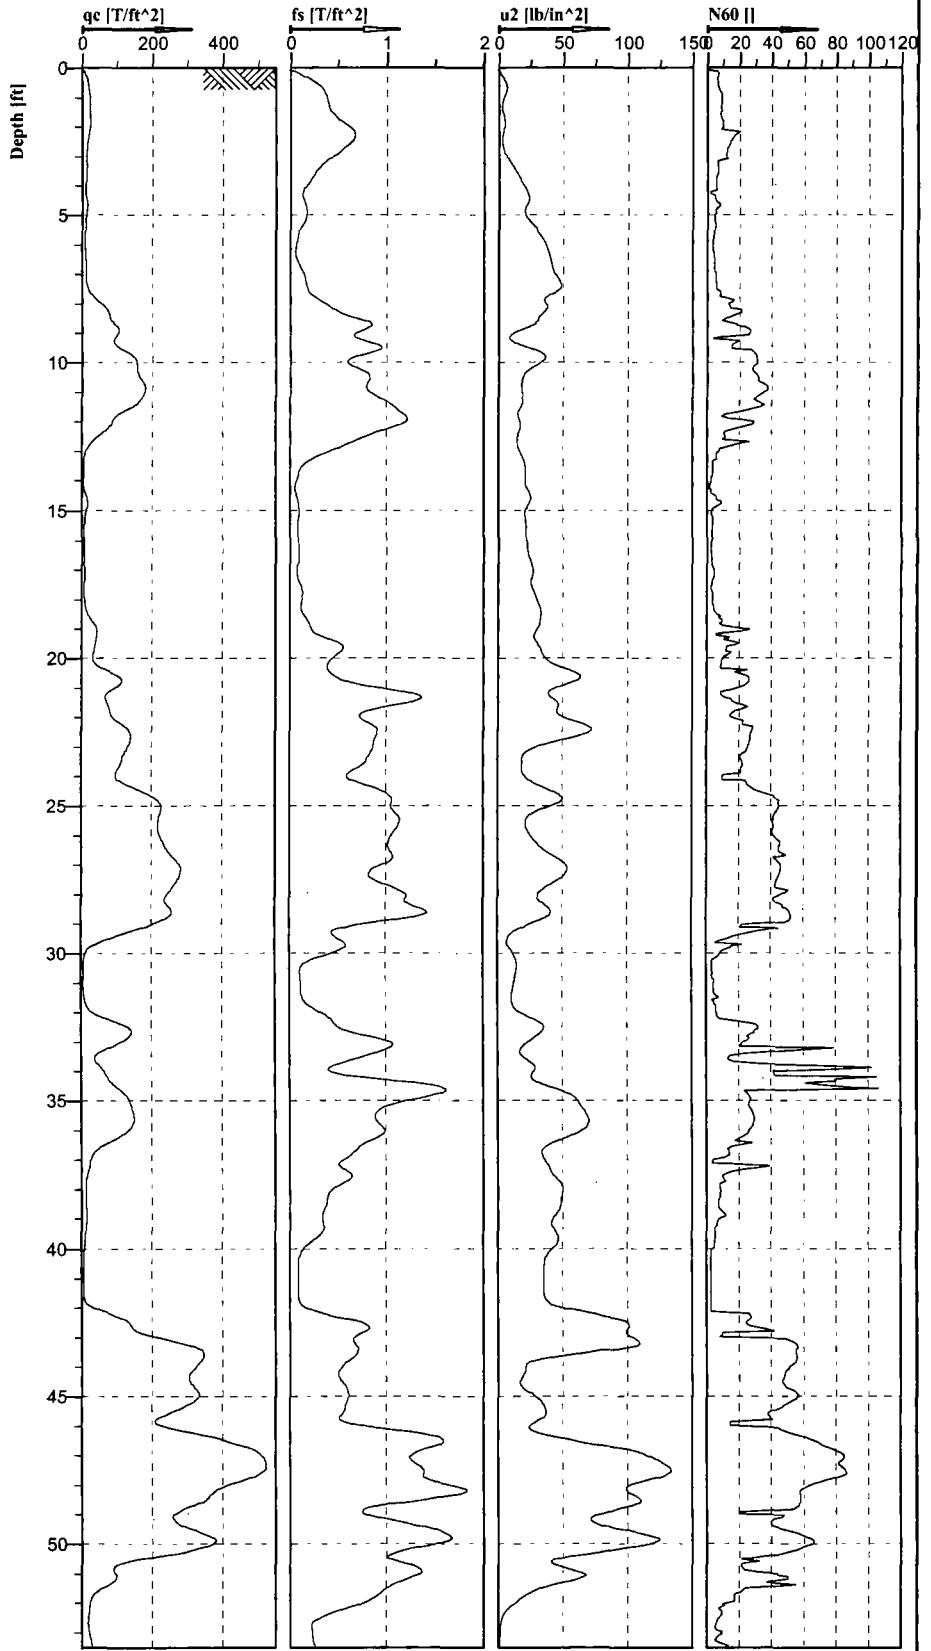
Location: Salt Lake County, UT	Position:	Ground level:	Test no: CPT-1
Project ID: 08G-014	Client: Bay Area Soils Project	Date: 2/7/2008	Scale: 1 : 75
Project: Central Valley Water Reclamation Facility		Page: 1/2	Fig: 9
		File: Land Fill Magna.STD

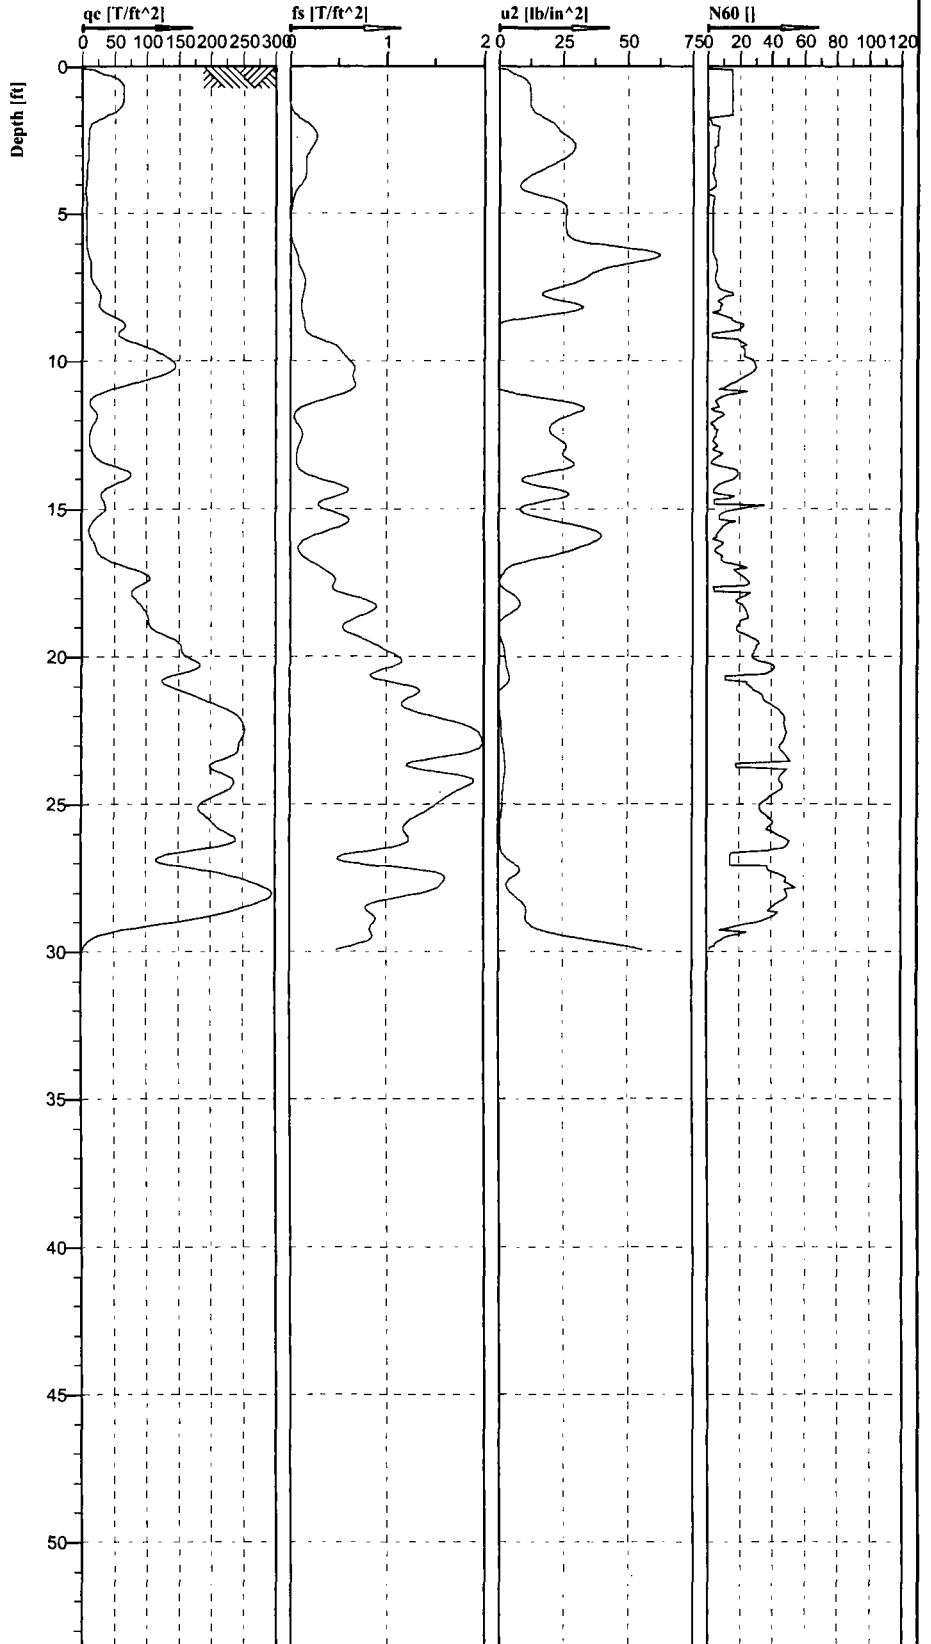
Location: Salt Lake County, UT	Position:	Ground level:	Test no: CPT-2
Project ID: 08G-014	Client: Bay Area Soils Project	Date: 2/7/2008	Scale: 1 : 75
Project: Central Valley Water Reclamation Facility	Page: 1/1	Fig: 10	
File: Land Fill Magna.STD

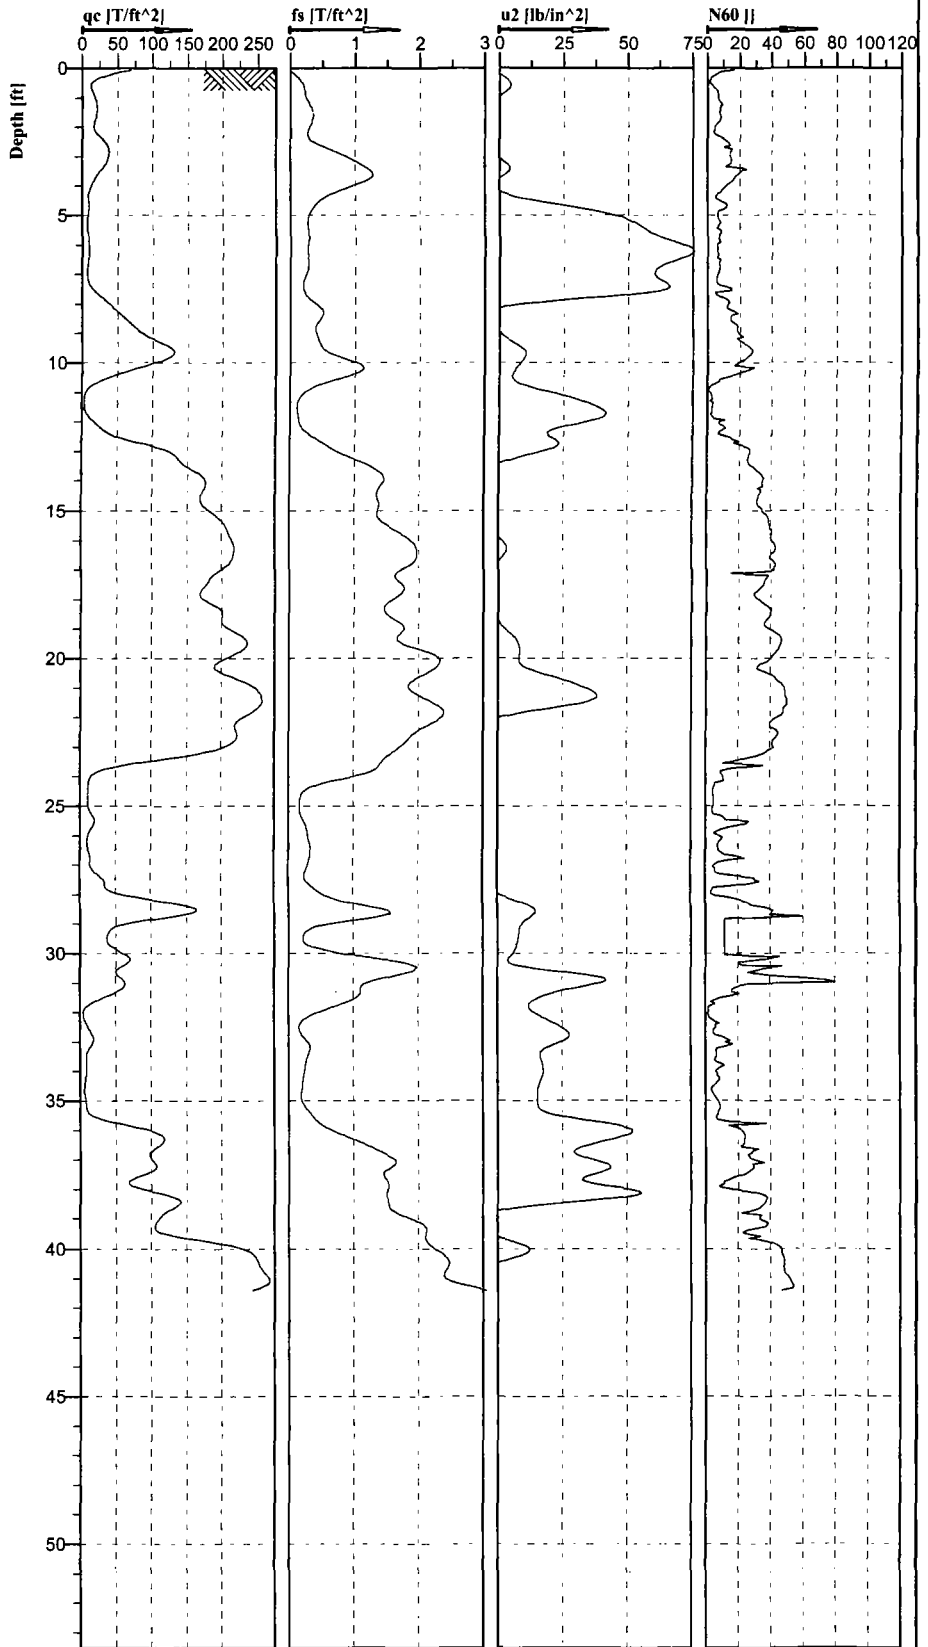
Location: Salt Lake County, UT	Position:	Ground level:	Test no: CPT-6
Project ID: 08G-014	Client: Bay Area Soil Products	Date: 2/8/2008	Scale: 1 : 75
Project: Central Valley Water Reclamation Facility		Page: 1/1	Fig: 14
		File: Land Fill Magna.STD

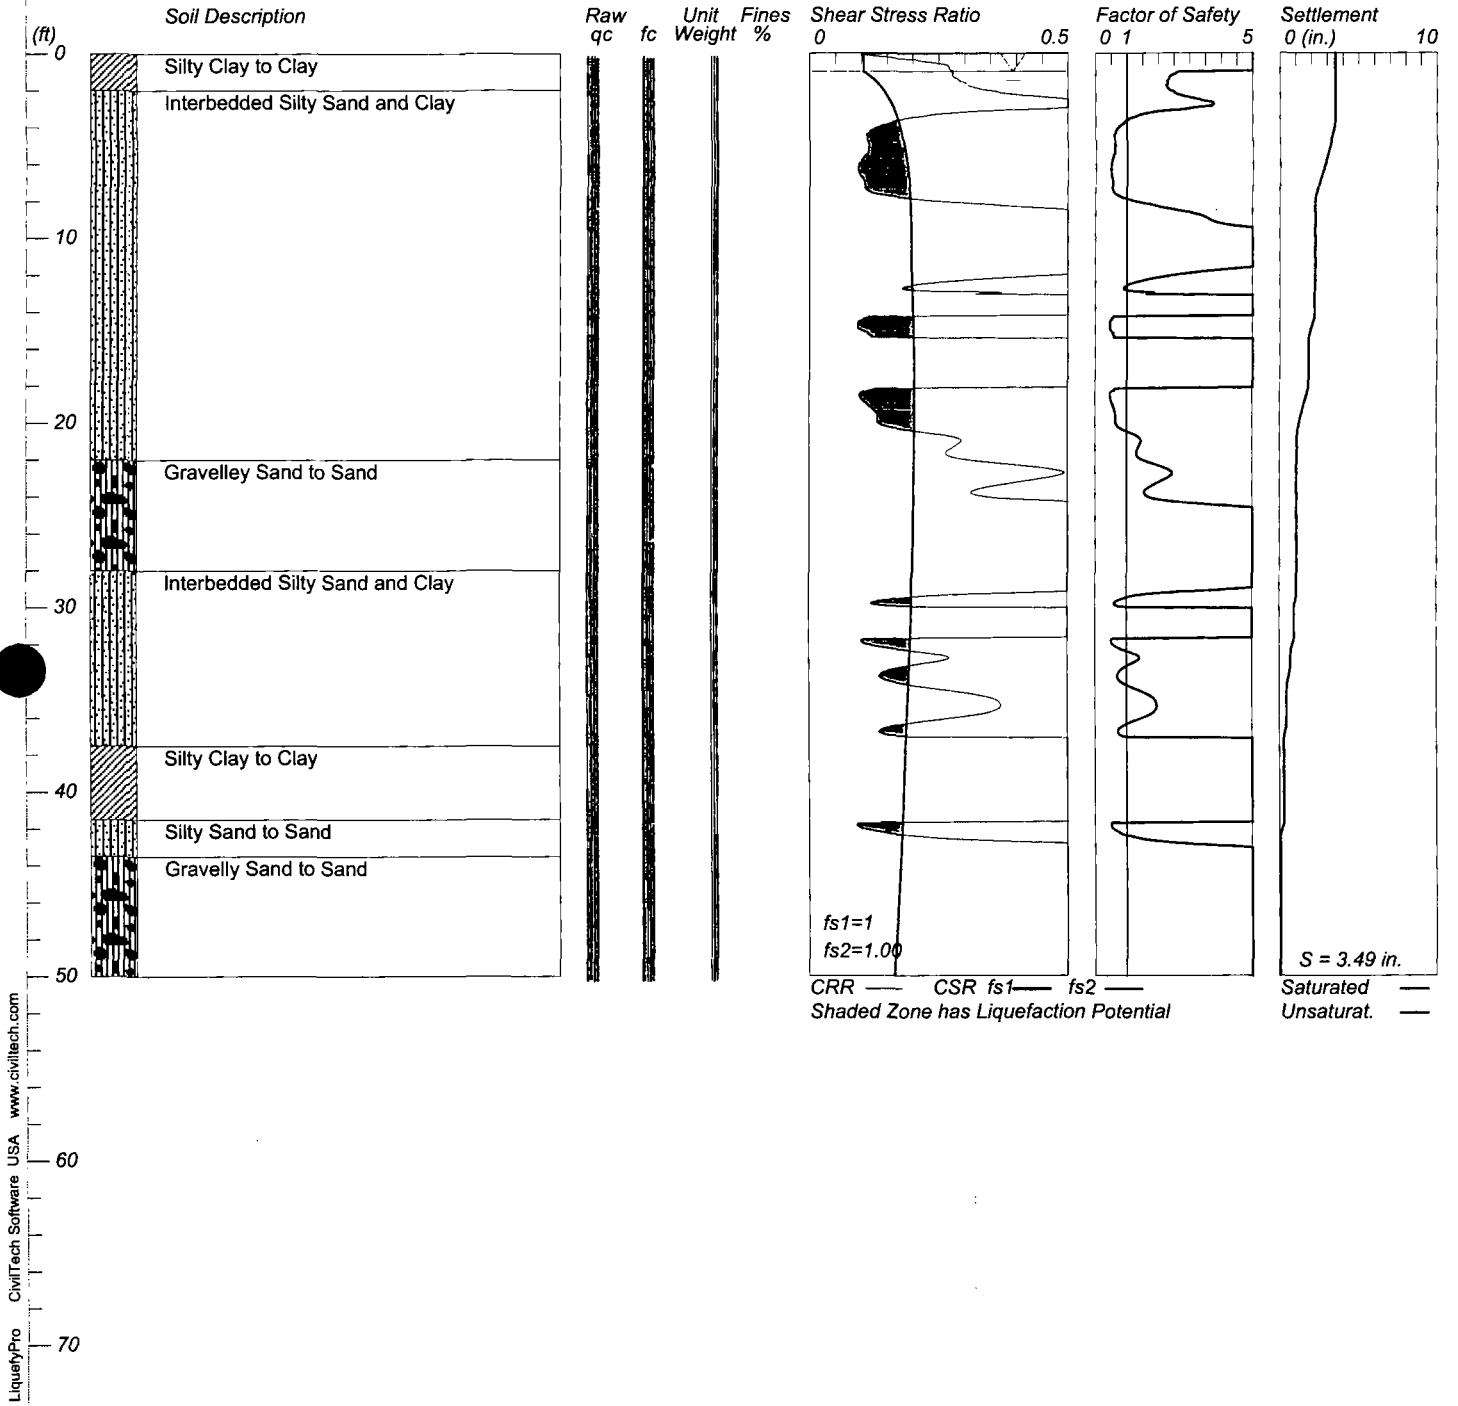
Magnitude=7.5
Acceleration=0.16g

LIQUEFACTION ANALYSIS

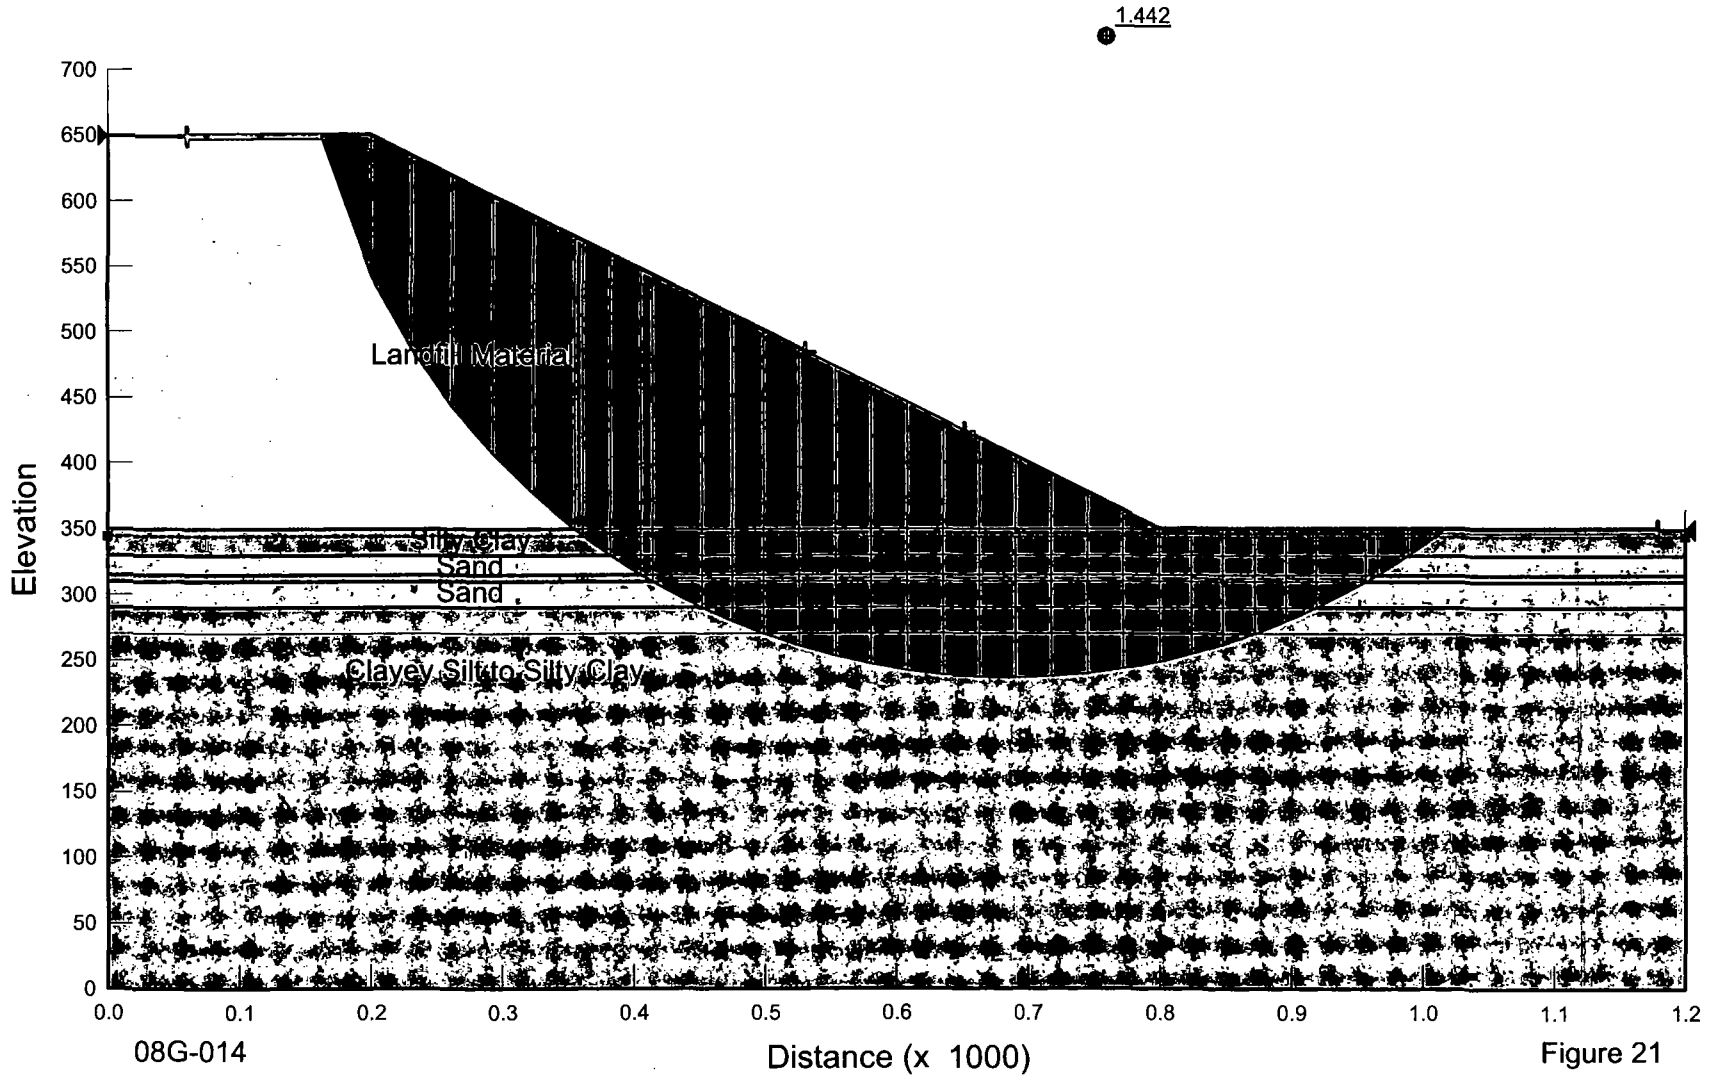
Central Valley Water Reclamation Facility
Static Conditions

Name: Landfill Material Weight: 135 pcf Cohesion: 0 psf Phi: 38 °
Name: Silty Clay 1 Weight: 113 pcf Cohesion: 200 psf Phi: 26 °
Name: Sand Weight: 120 pcf Cohesion: 0 psf Phi: 32 °
Name: Clayey Silt Weight: 114 pcf Cohesion: 200 psf Phi: 24 °

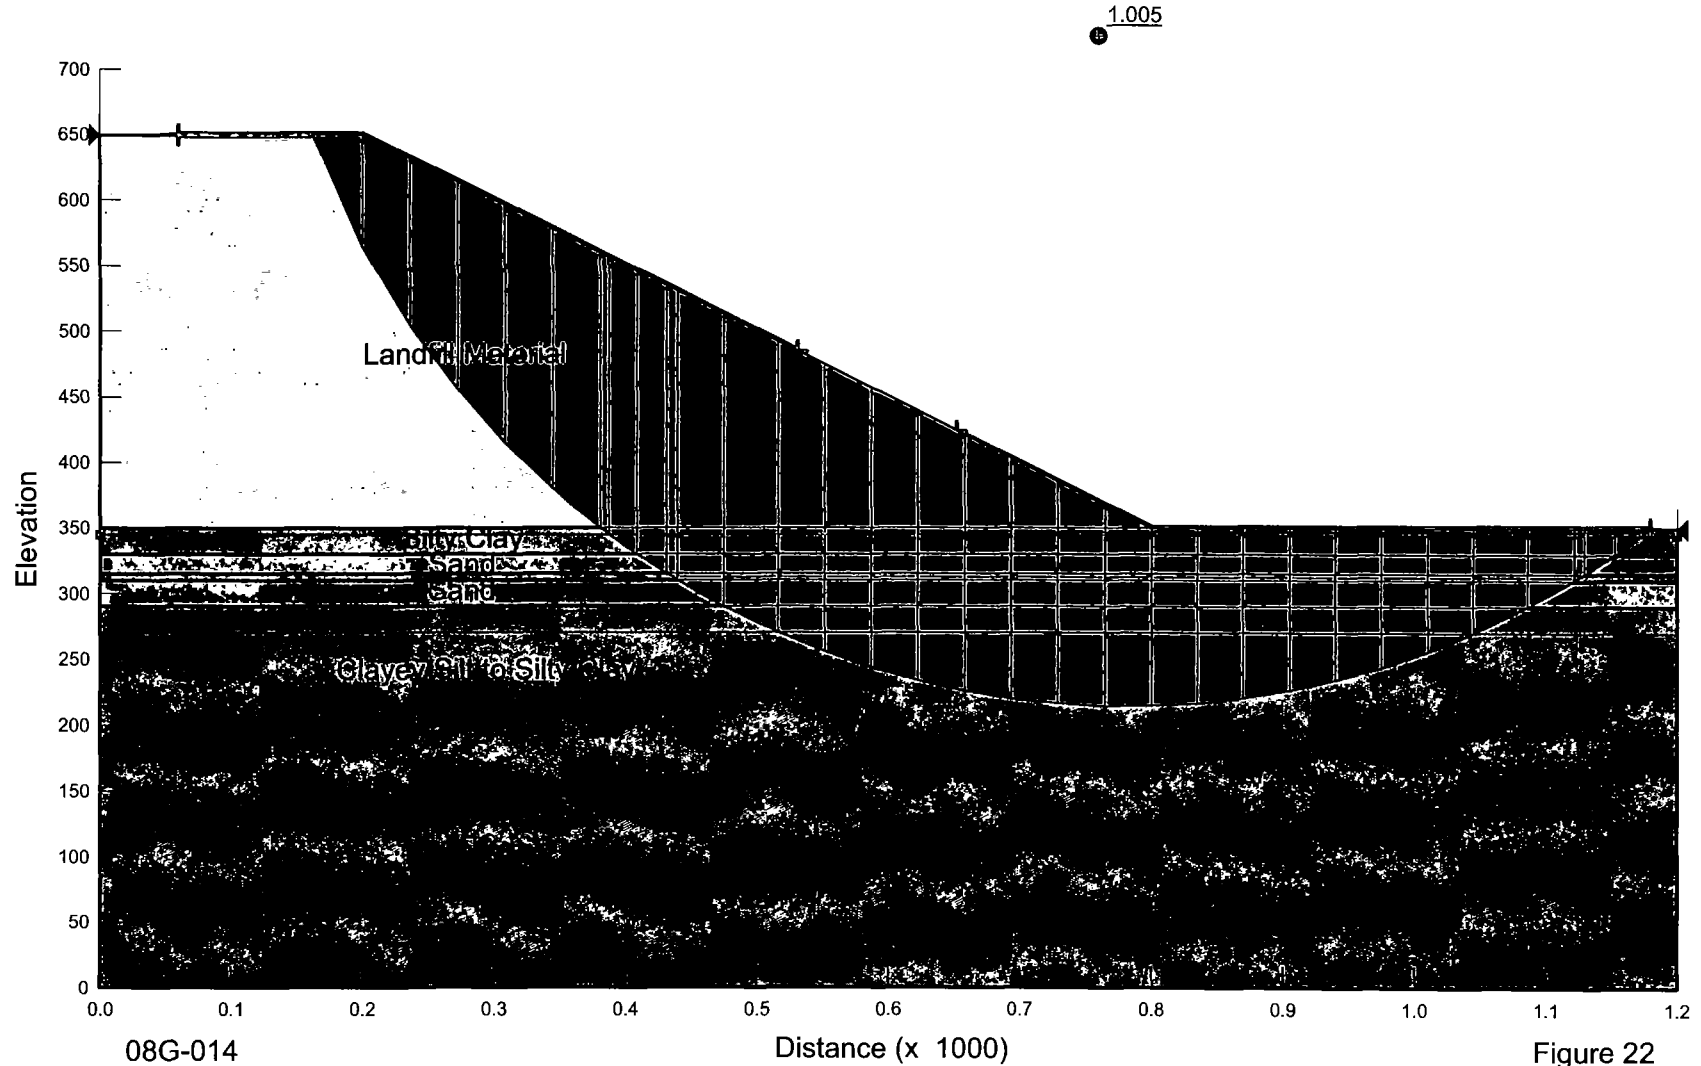
Central Valley Water Reclamation Facility
Pseudo-static Conditions
P.G.A. = 0.15g

Name: landfill material Weight: 135 pcf Cohesion: 0 psf Phi: 38 °
Name: Silty Clay 1 Weight: 113 pcf Cohesion: 200 psf Phi: 26 °
Name: Sand Weight: 120 pcf Cohesion: 0 psf Phi: 32 °
Name: Clayey Silt Weight: 114 pcf Cohesion: 200 psf Phi: 24 °

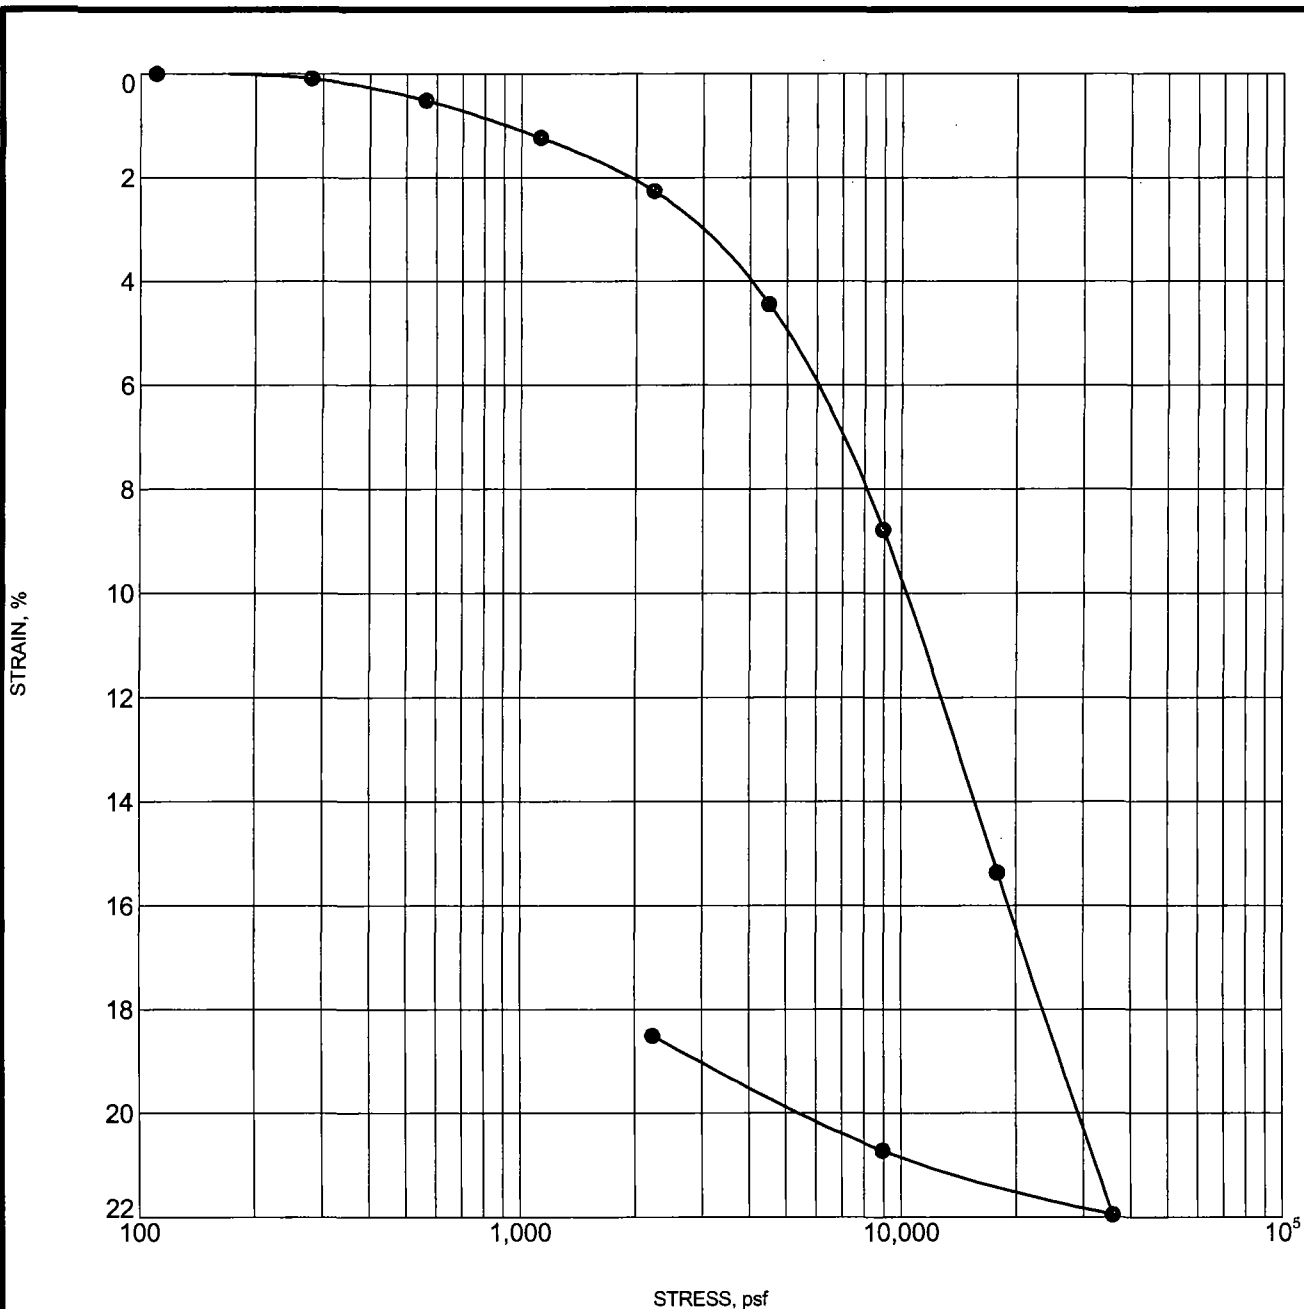
Specimen Identification	Classification	γ_d	MC%
● B-1 11.0	LEAN CLAY(CL)	81	43

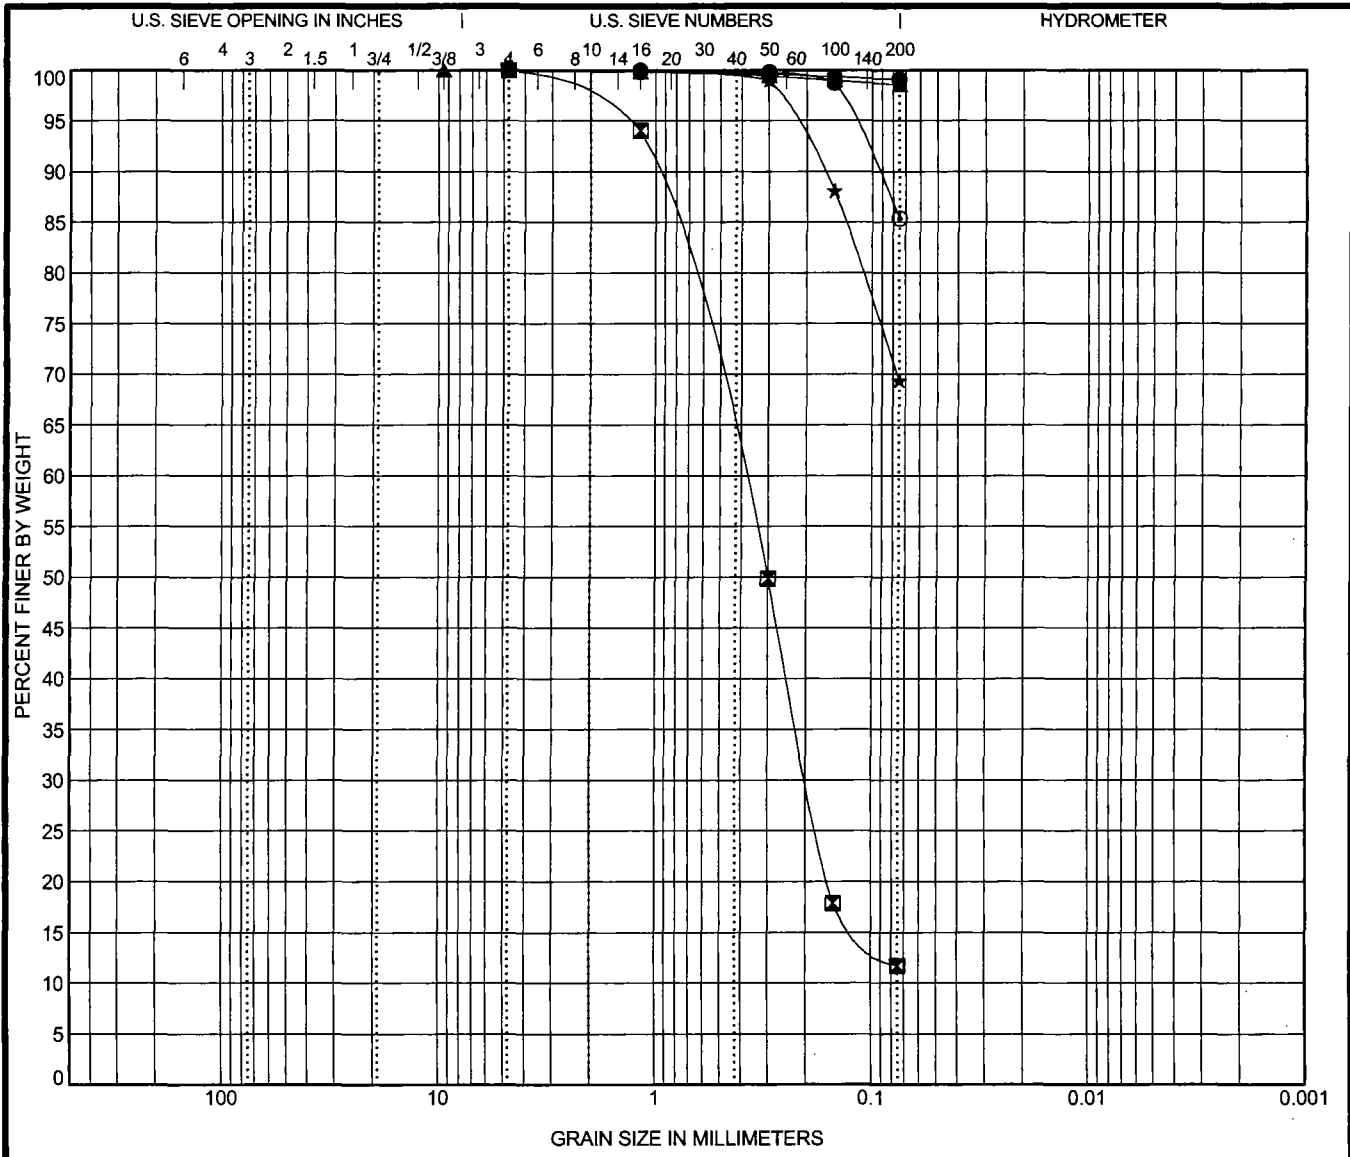
Specimen Identification	Classification	LL	PL	PI	Cc	Cu
● B-1 11.0	LEAN CLAY(CL)	48	24	24		
☒ B-1 27.0	WELL-GRADED SAND with SILT(SW-SM)	NP	NP	NP	1.5	6.6
▲ B-2 3.0	LEAN CLAY(CL)	44	21	23		
★ B-2 17.0	SANDY SILT(ML)	NP	NP	NP		
◎ B-3 7.0	LEAN CLAY(CL)	31	20	11

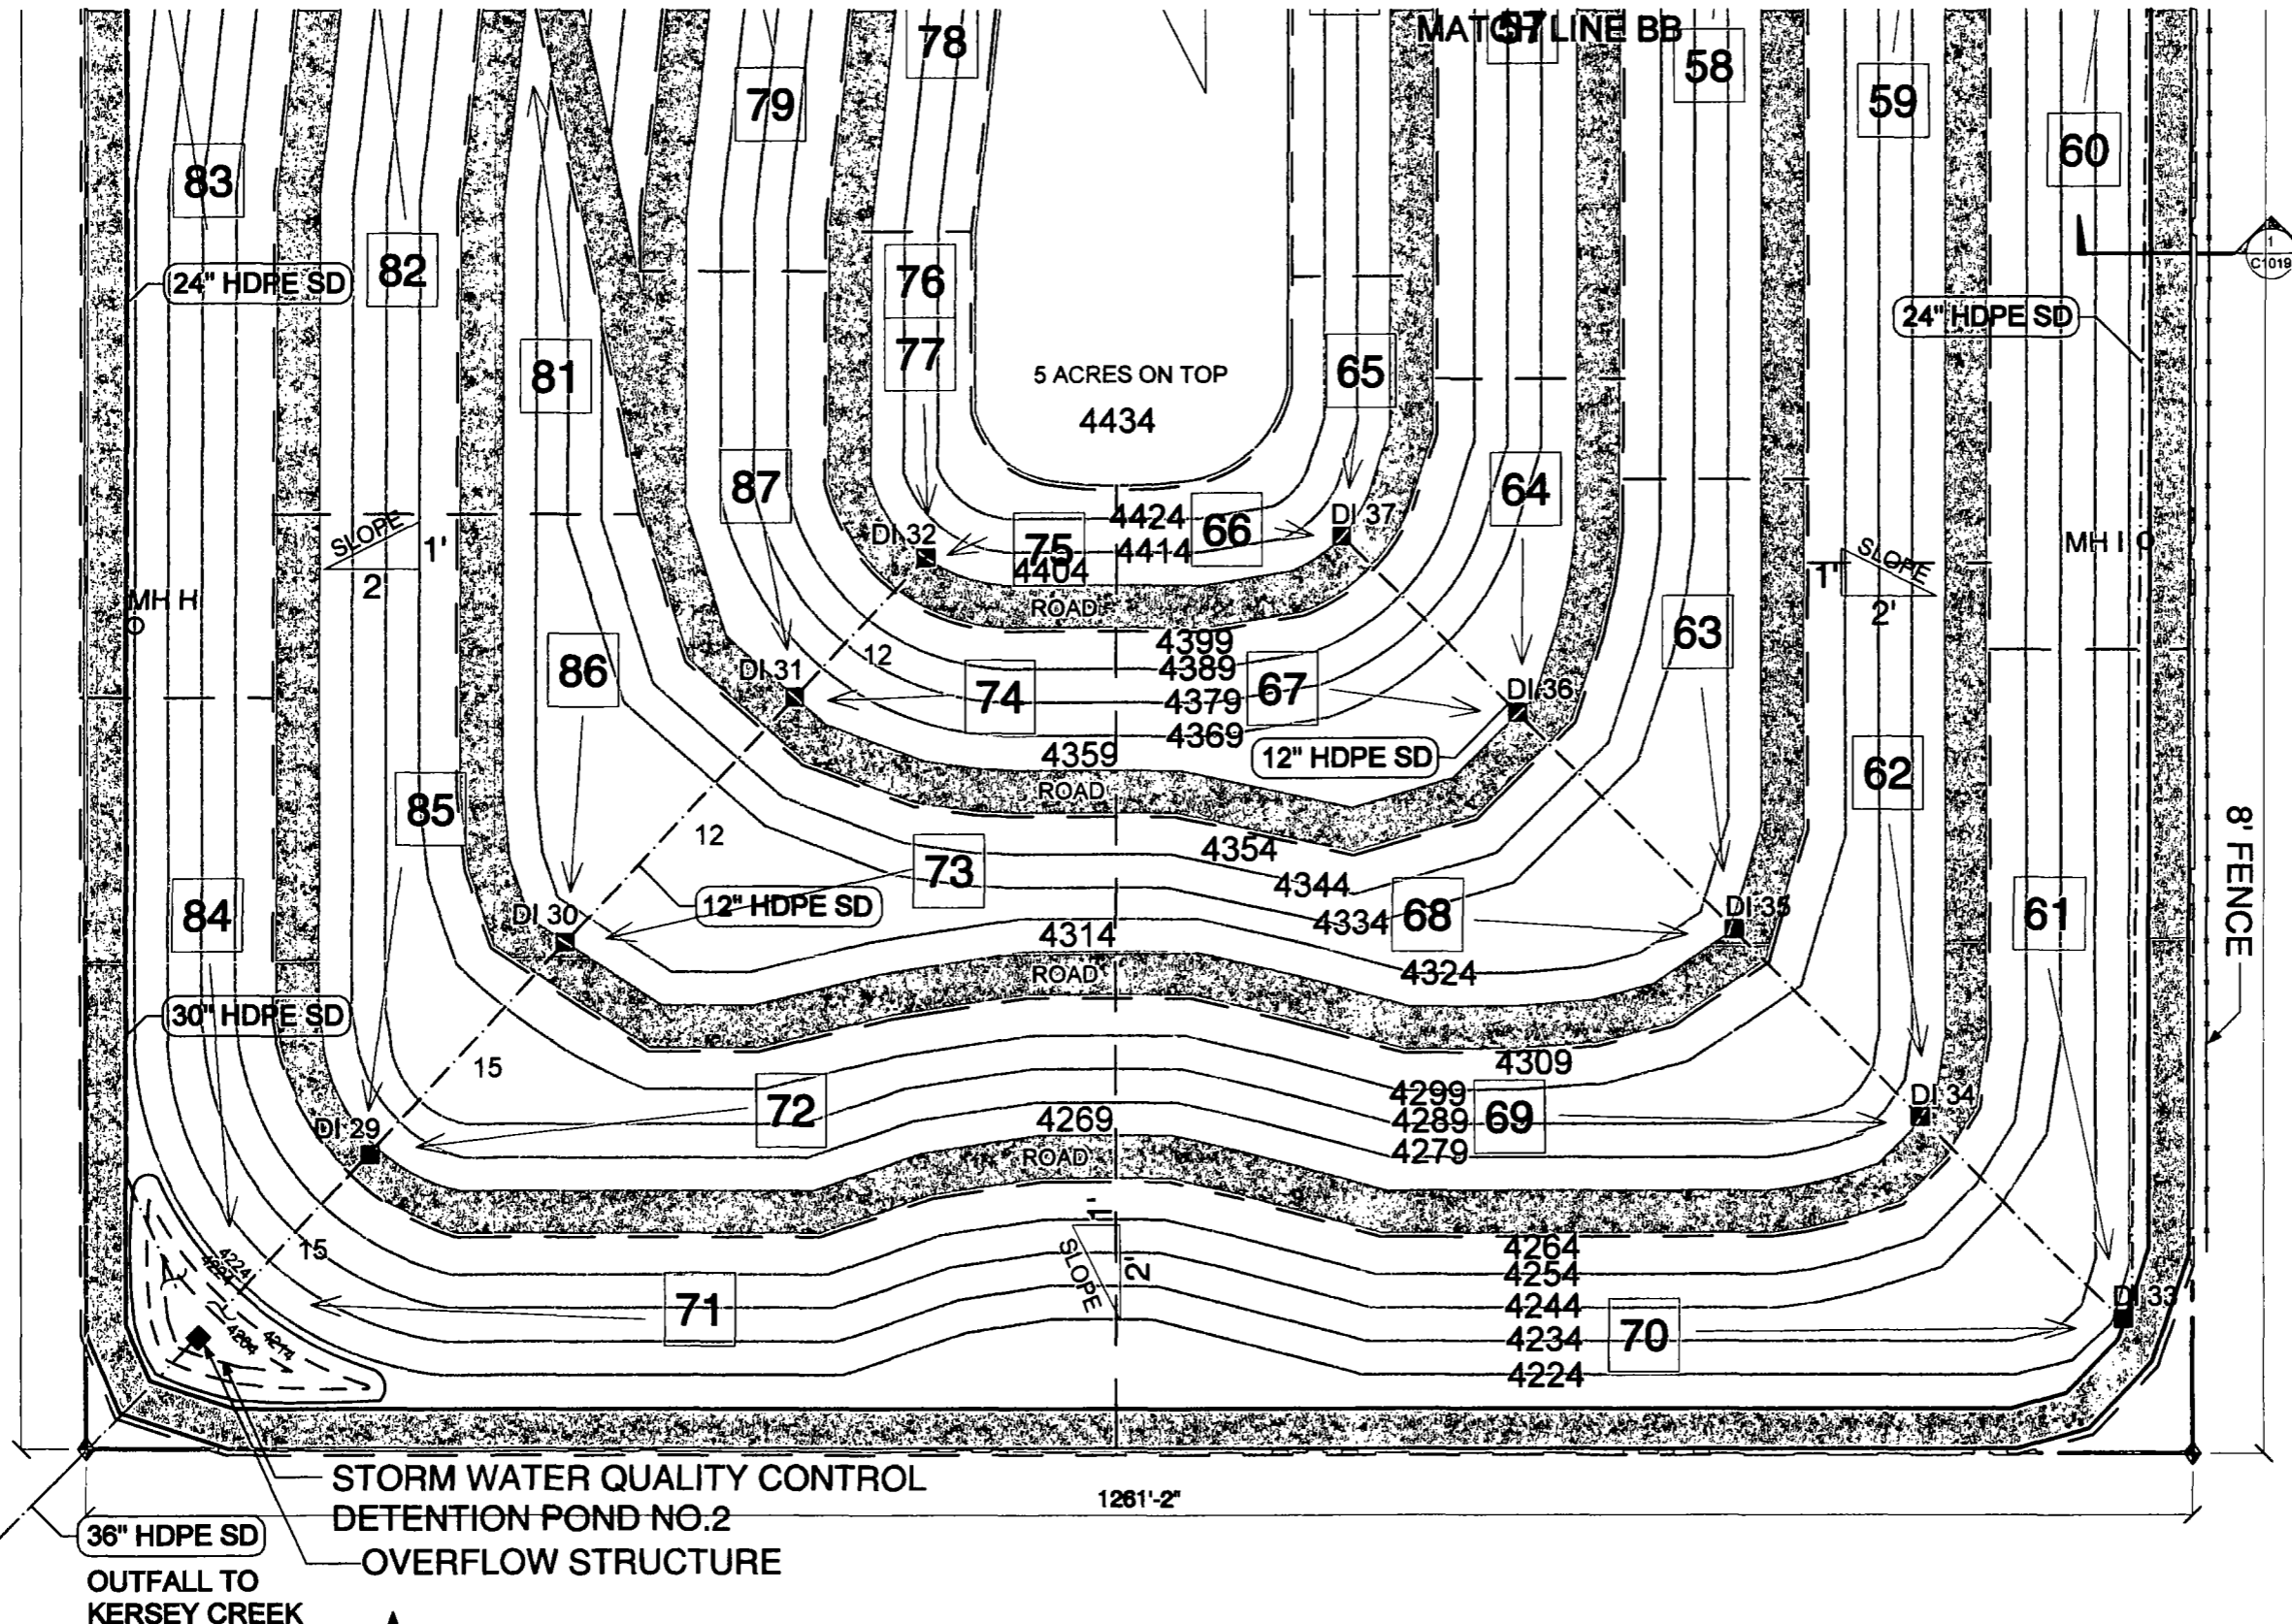
STORM WATER QUALITY CONTROL
DETENTION POND NO.2
OVERFLOW STRUCTURE

36" HDPE SD
OUTFALL TO
KERSEY CREEK

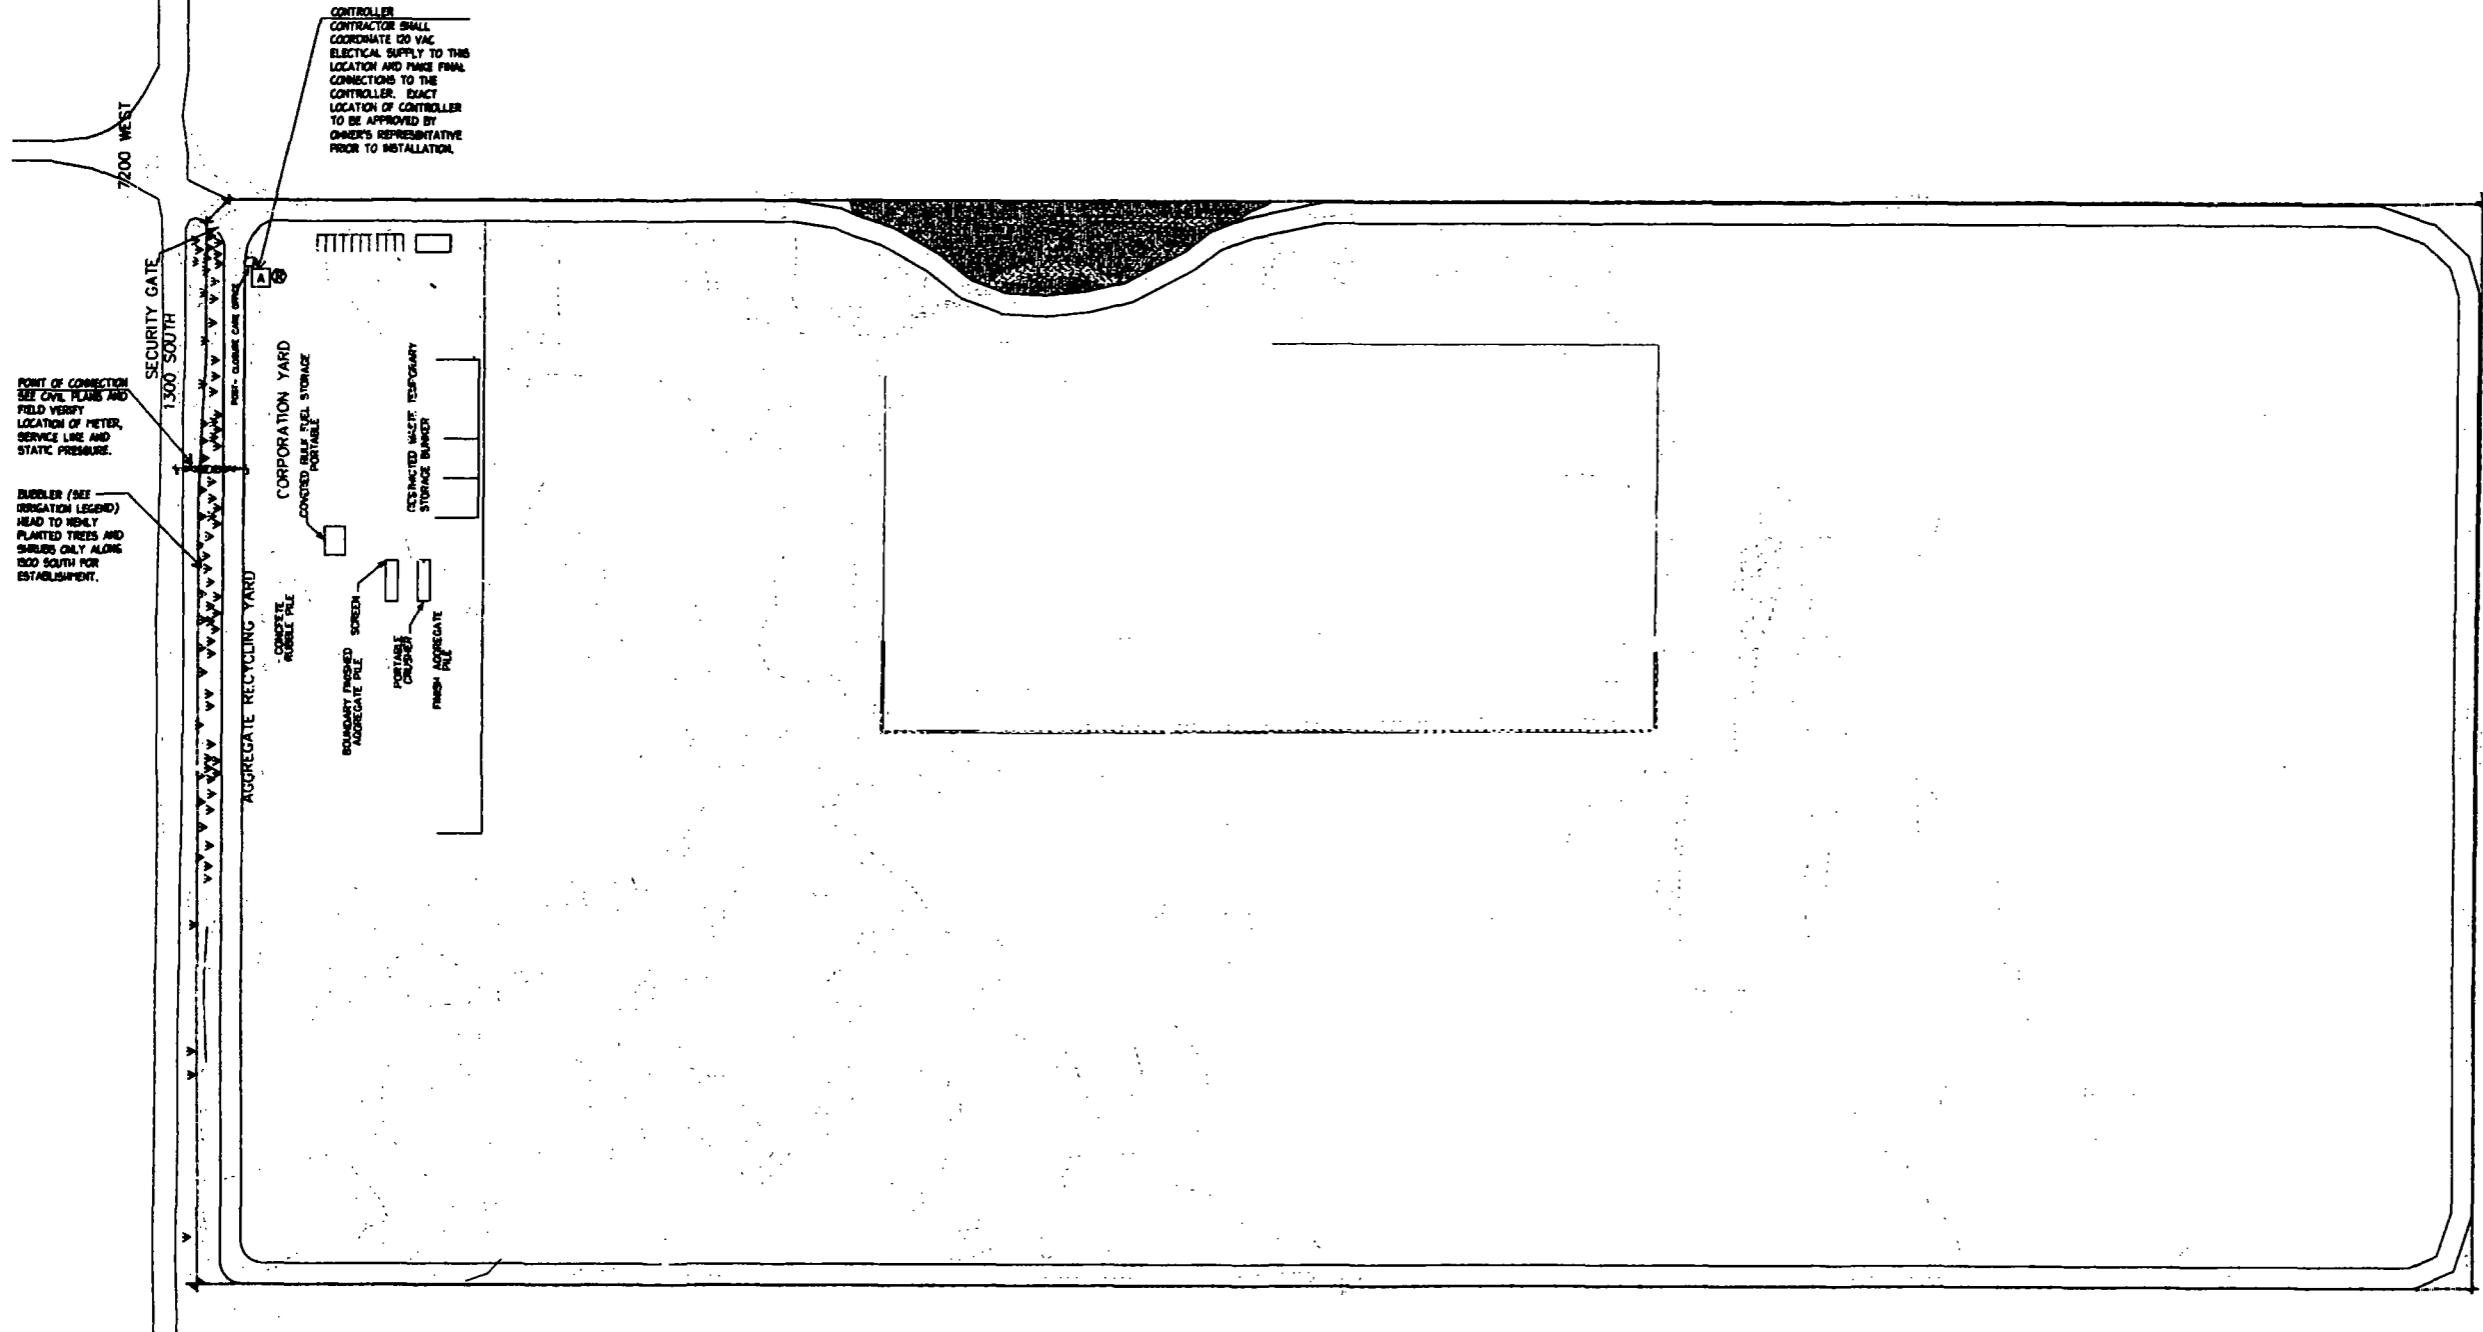
SYMBOL	MANUFACTURER/MODEL/DESCRIPTION	AMC	EM	GPM	RADIUS
V	Hunter SRS-00-PCN Flood Bubblers	360	50	0.5	1'
⊕	Hunter ICV Electric Remote Control Valve, plastic, with 1" globe valve.				
⊖	Hunter HQ-550RC Check Control Valve, yellow rubber cover, red brass and stainless steel, with 3/4" NPT inlet, 2-piece body.				
⊘	HISCO T-FR-600 Isolation Valve. Sized equal to pipe size. Isolation valves shall be used at all valve manifolds and isolation points.				
⊙	1" Hunter 2550 Series Resilient Plug Gate Valve. Use 2" square nut wrench.				
⊙	Hunter HCV Check Valve (Not Shown) Sized equal to pipe size. Use as needed to prevent low head drainage in rubber, spray and drip systems. Install per manufacturer's specifications.				
A	Hunter ICC-1800-M Electronic Mechanical Controller, 16 stations, outdoor model, with metal cabinet.				
⊙	Hunter NRS-250 RAIN-CLIX Rain Sensor. Install within 100 ft of controller, in line of sight. 23-28 VAC, 100 mA power from line transformer. Mount on roof.

⊙	Relco 827VA 2" Reduced Friction Ball Valve. Provide Strong Box Model 558C-300R, Cold Rolled Steel (green) enclosure.				
—	Irrigation Lateral Line, PVC Schedule 40				
—	Irrigation Mainline, PVC Schedule 40				
—	Pipe Sleeves, PVC Class 200
