Central Valley Water
Reclamation
Facility

UTAH DIVISION of SOLID and HAZARDOUS WASTE
APPLICATION for a PERMIT to OPERATE a CLASS VIb
LANDFILL

The owner Central Valley Water Reclamation Facility Board (CVWRF) proposes to develop a construction and demolition waste landfill (Class IVb landfill) in accordance with Utah Administrative Code R315 through 320 as revised February 1, 2007. The facility will serve the CVWRF's service area, which consists of population centers along the Wasatch Front from Ogden to Provo and from Park City to Tooele. As a Class IVb landfill the facility will not accept waste from a conditionally exempt small quantity generator of hazardous waste. The facility will accept all types of construction and demolition waste materials that will be placed and compacted in the landfill as it is received. At closure the top surface will have an elevation of about 4,434 feet above Mean Sea Level (msl) or an average of 210 feet above the existing grades.

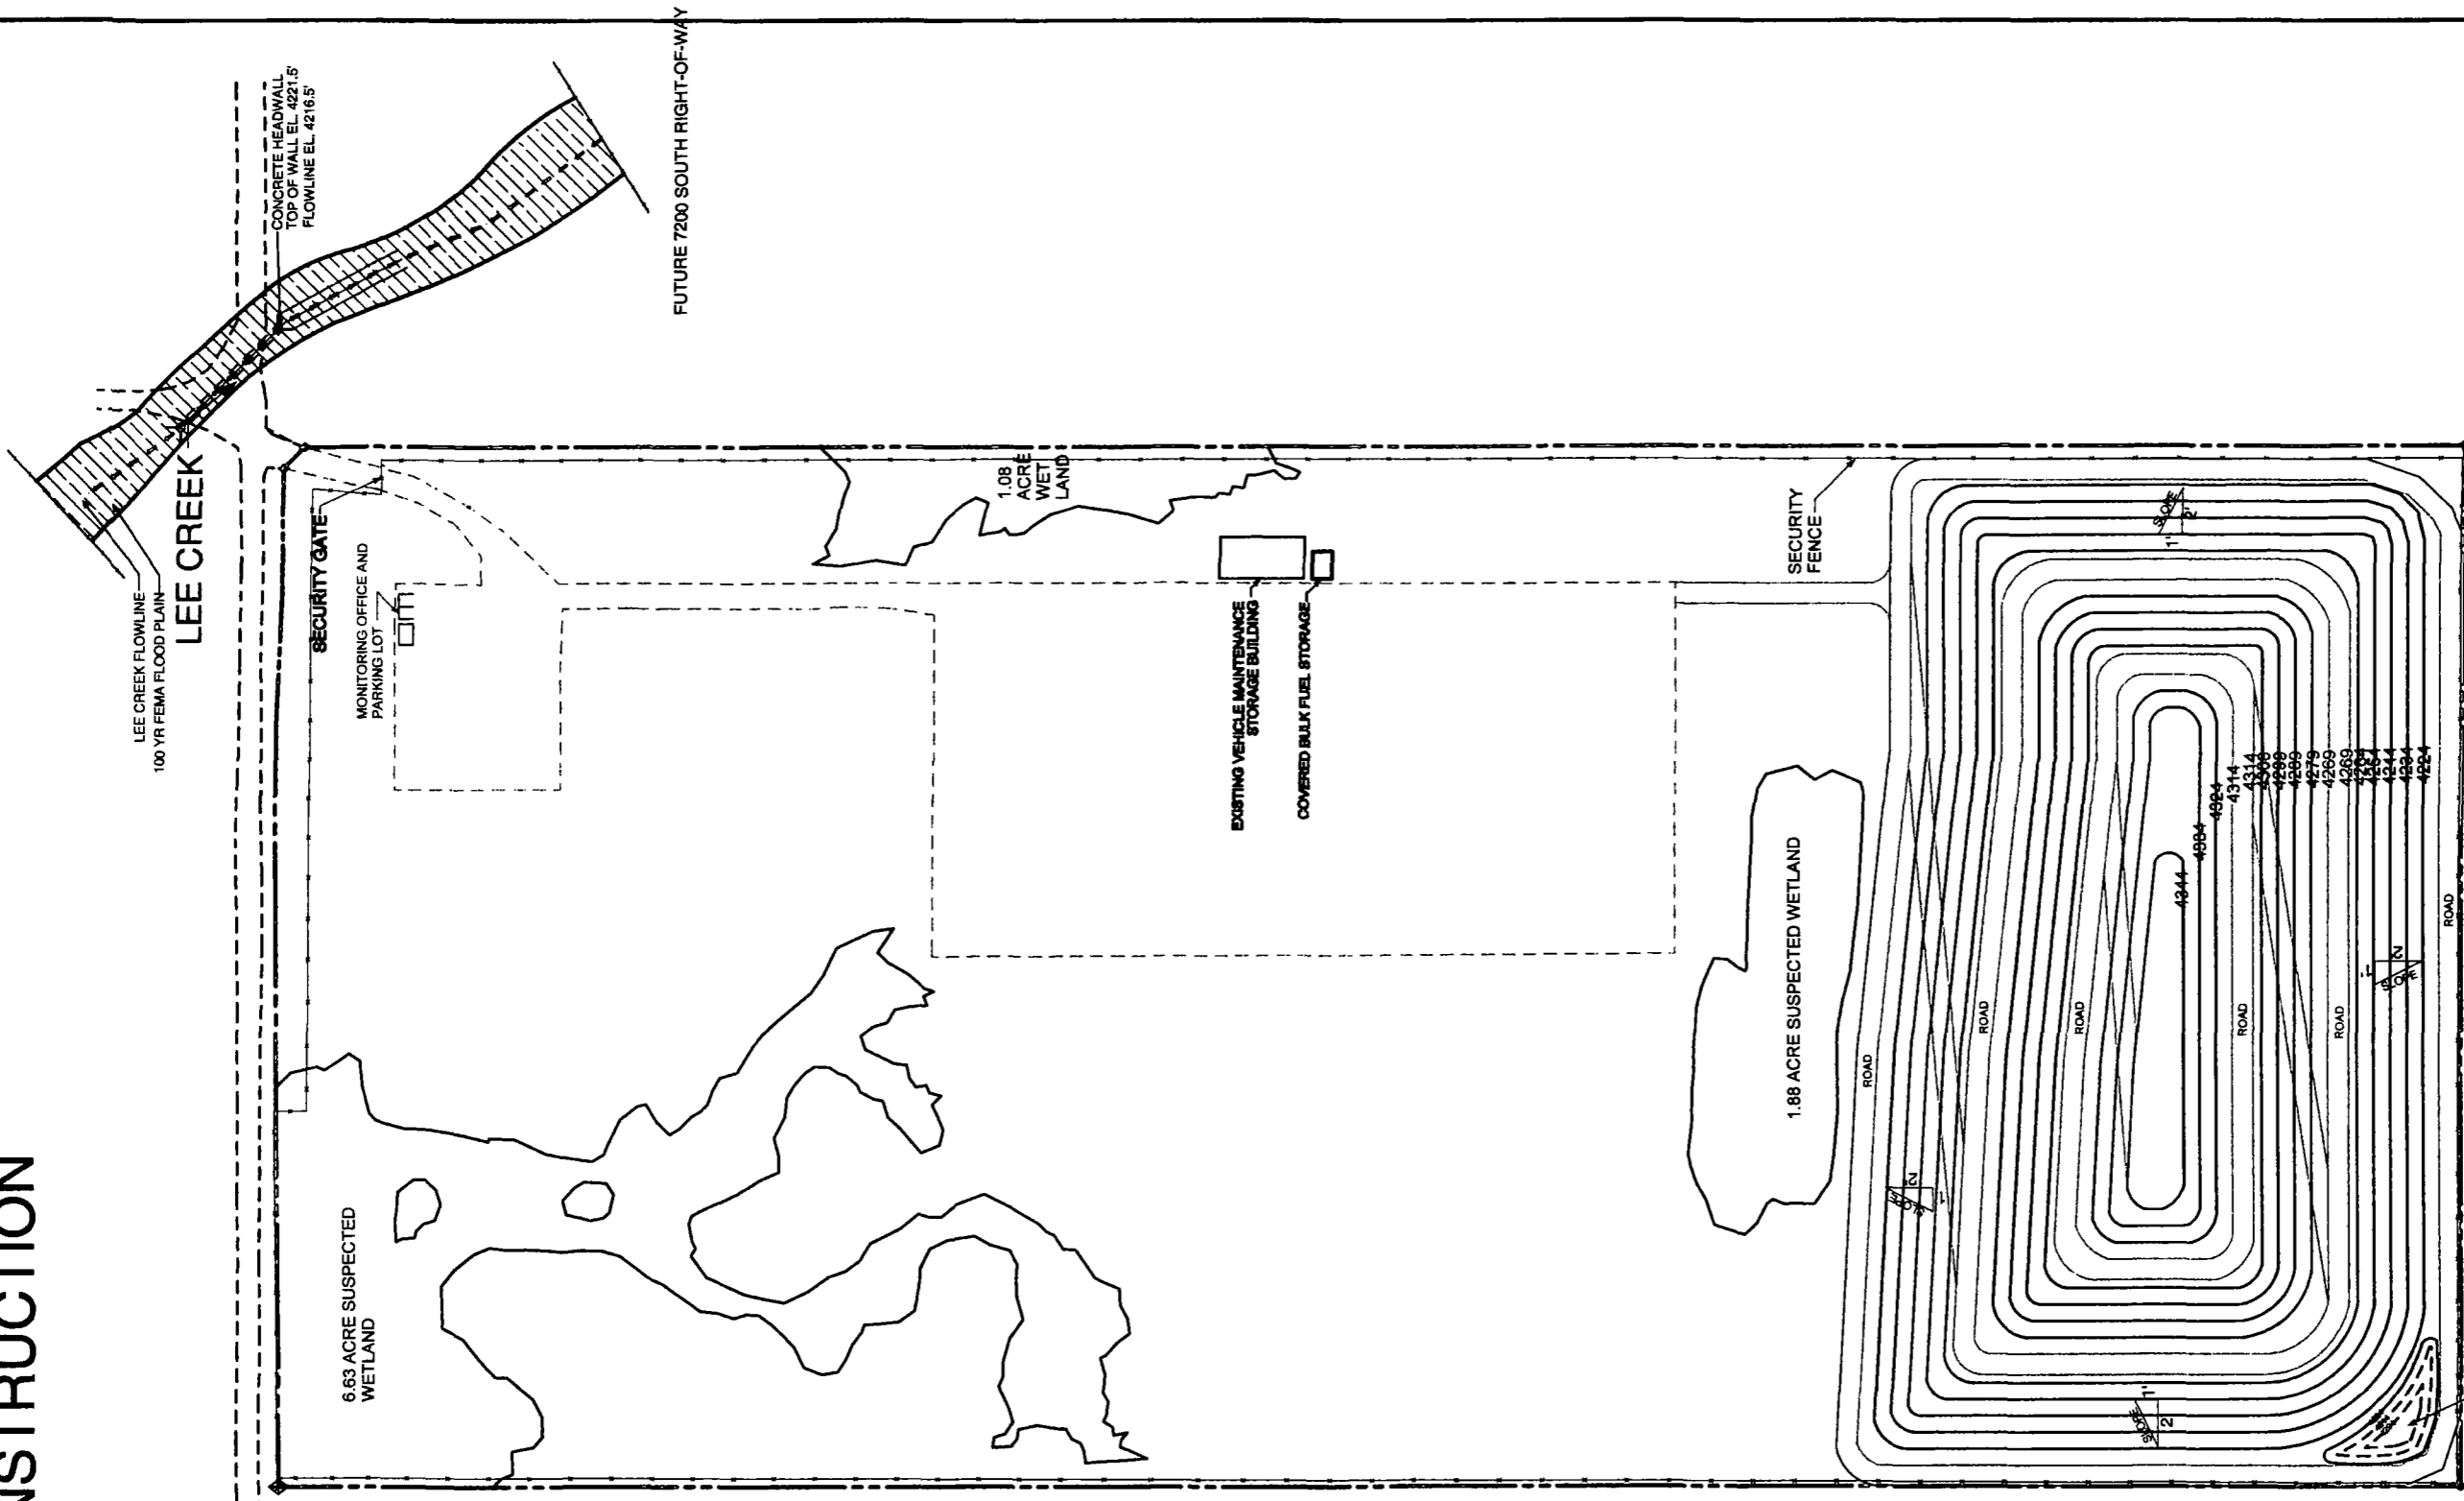
FINAL CLOSURE PLAN
 SCALE: 1" = 100' VOLUME 1.532 M YD³
 SLOPE 2 TO 1, ROADS @ 45'
