**GROUND-WATER QUALITY CLASSIFICATION FOR THE PRINCIPAL BASIN-FILL
AQUIFER, EAST SHORE AREA, DAVIS COUNTY, UTAH**

Prepared for the Davis County Health Department

Janae Wallace, Paul Inkenbrandt, and Mike Lowe

Utah Geological Survey

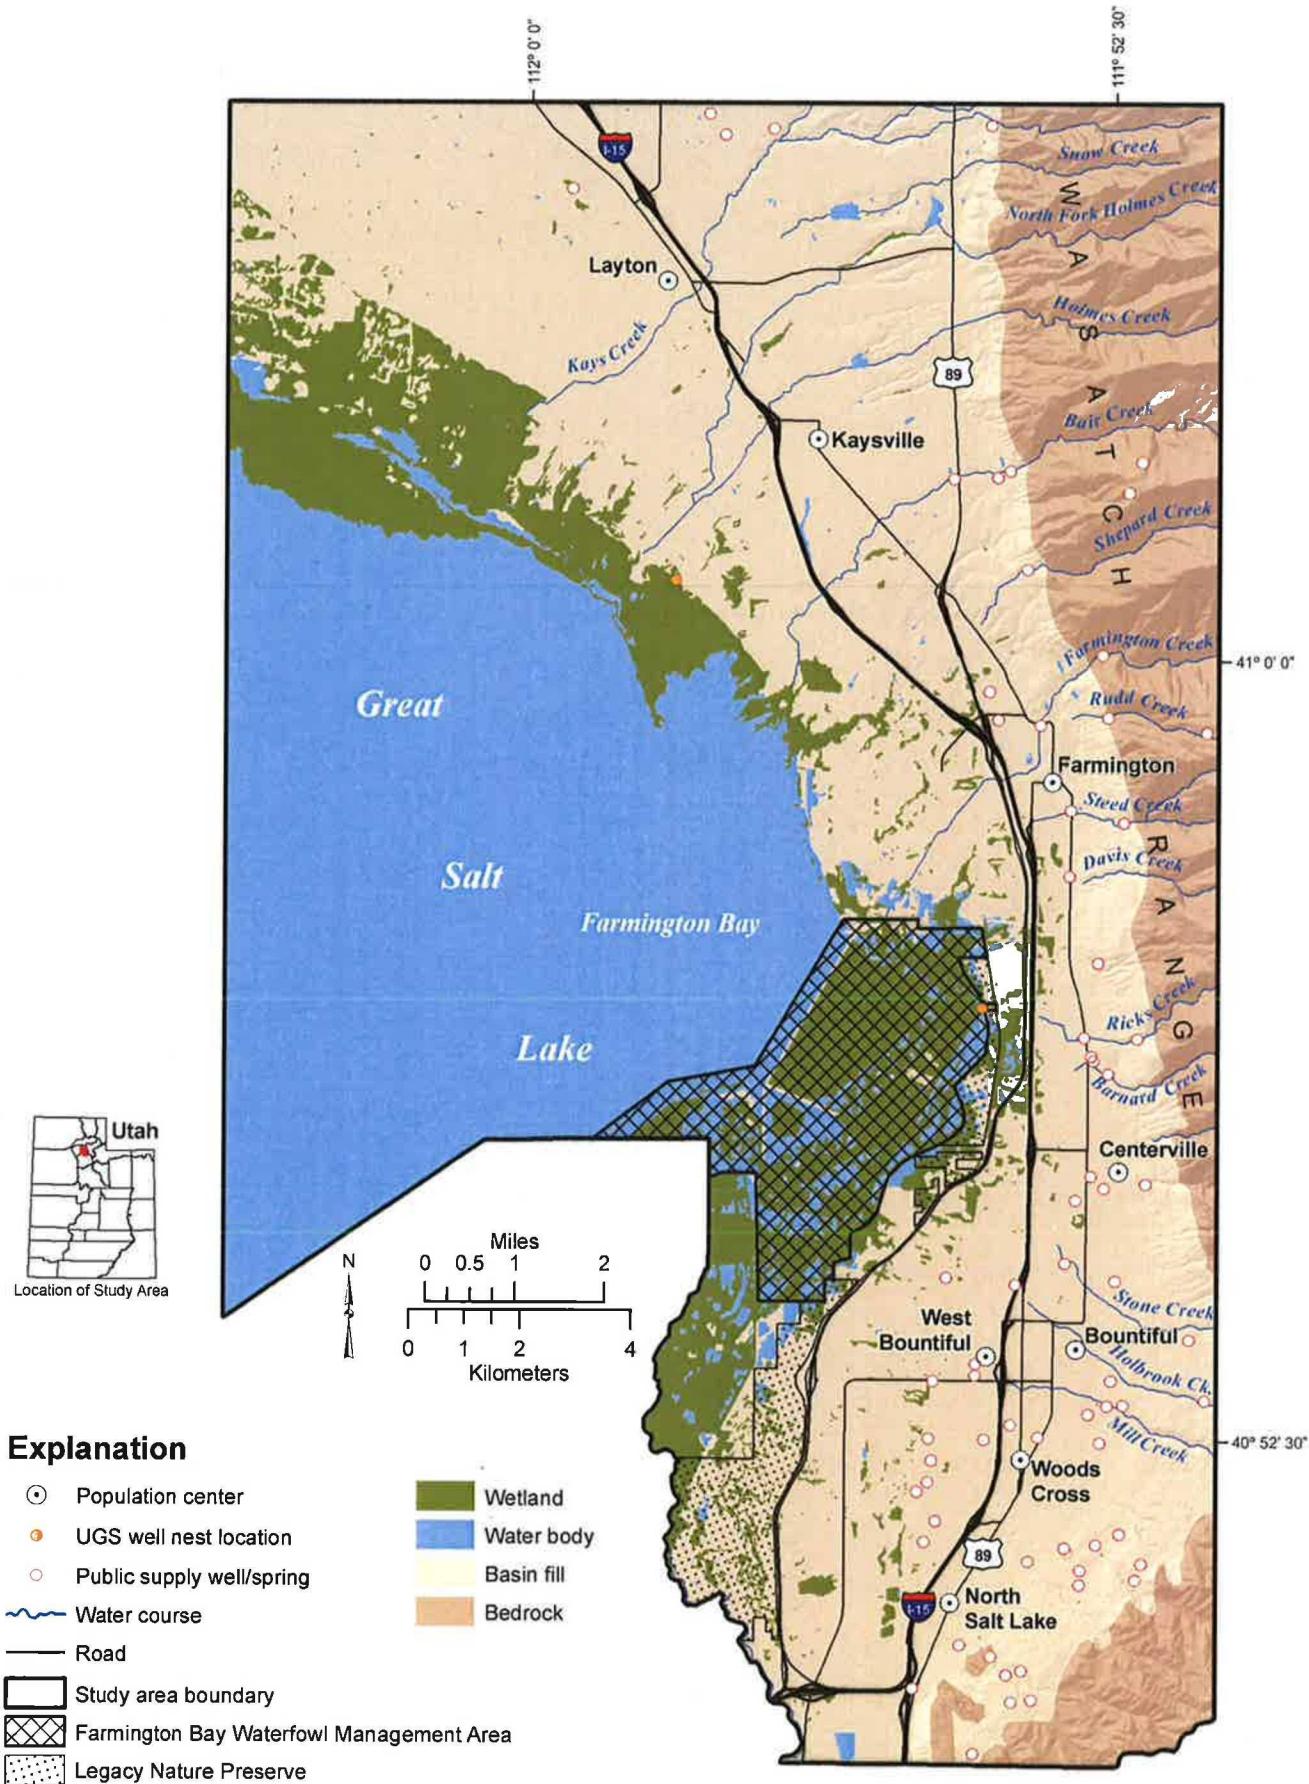
Figure 1. Farmington Bay area, Davis County, Utah.

The study area (figure 1) is in the southern part of the east shore area of Great Salt Lake in the Ogden Valley segment of the Wasatch Front Valleys section of the Great Basin physiographic province (Stokes, 1977). The east shore area is a basin lowland extending northward from the Salt Lake salient to the town of Willard, Box Elder County, and from the western margin of the Wasatch Range to the eastern shore of Great Salt Lake (Clark and others,

1990); this report covers the Davis County portion of the east shore area (figure 1). Because the area considered for this ground-water quality classification is part of the larger east shore area hydrologic system, we describe the geologic setting for the entire aquifer system. Elevation ranges from over 9000 feet (2700 m) for some peaks in the Wasatch Range to about 4200 feet (1280 m) at the shore of Great Salt Lake. The Weber and Ogden Rivers are the first and second largest streams in the east shore area, respectively, contributing 90% of the surface-water inflow (Clark and others, 1990, tables 3 and 4). The major Davis County streams include Holmes, Farmington, Ricks, Parrish, Centerville, Stone, and Mill Creeks (Clark and others, 1990, table 3). Dozens of other perennial, intermittent, and ephemeral streams flow westward from the Wasatch Range into the east shore area (Clark and others, 1990, table 4).

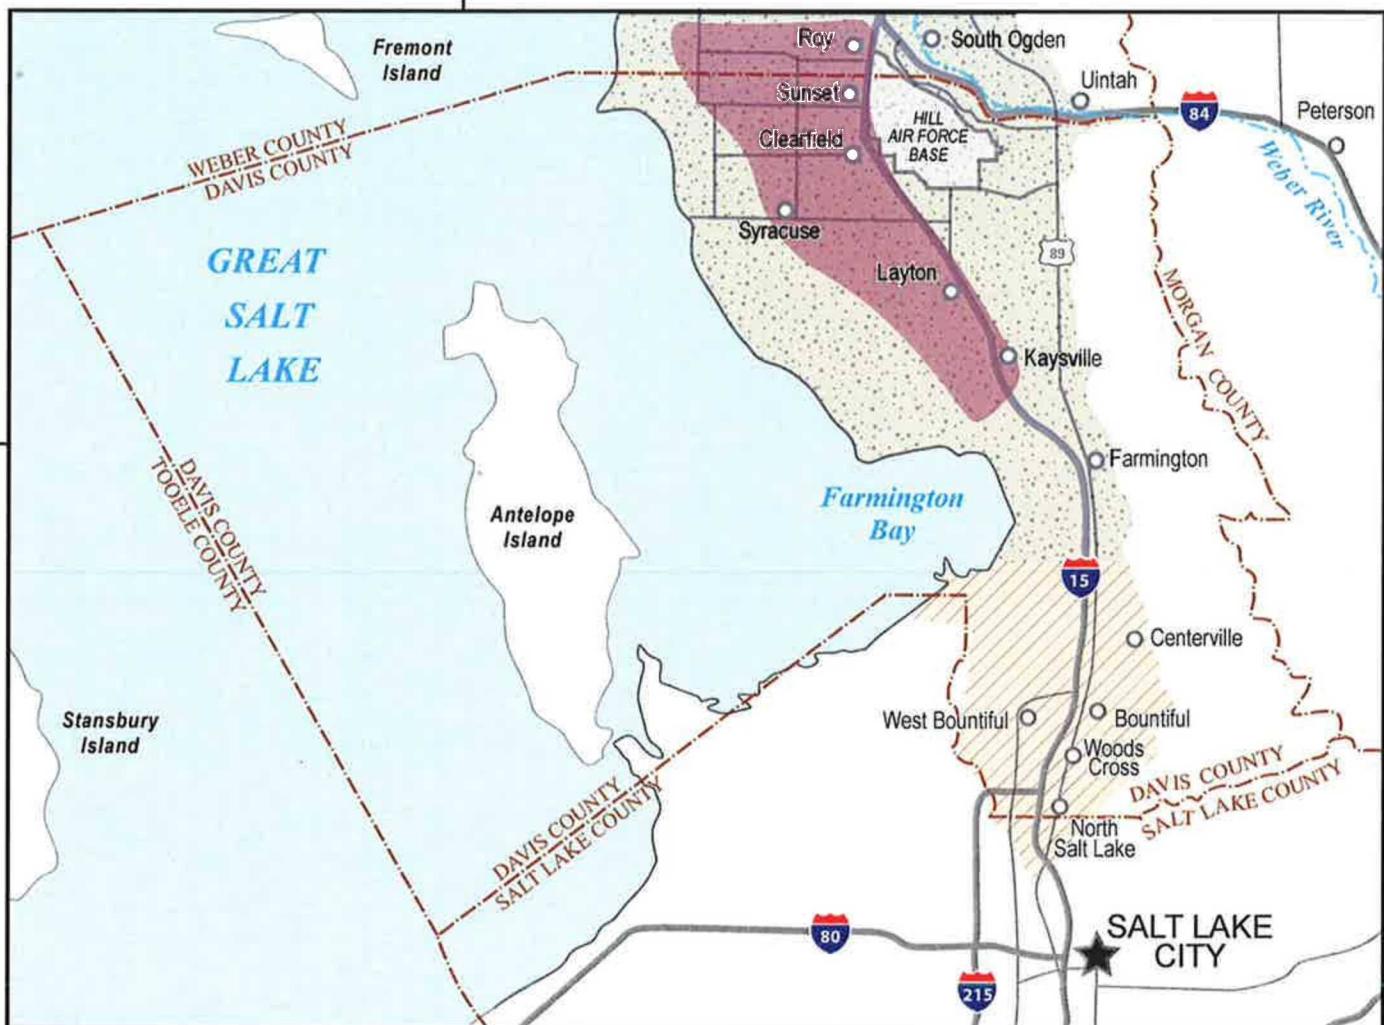
- [Diagonal hatching] Bountiful area
- [Stippled shading] Weber Delta area
- [Solid maroon] Area where the Sunset and Delta Aquifers can be differentiated

Figure 2. The Weber Delta and Bountiful sub-areas of the east shore aquifer system, and extent of area where Delta and Sunset aquifers are distinguishable in Davis County, Utah (modified from Clark and others, 1990).

Because the basin-fill aquifer within the study area is part of the larger east shore hydrologic area, we include a description of the east shore aquifer system that includes areas outside Davis County. The east shore aquifer system can be divided into two somewhat separate hydrologic sub-areas, the Weber Delta sub-area and the Bountiful sub-area, both of which are in Davis County (figure 2). The Weber Delta sub-area is about 40 miles long (60 km) and 3 to 20 miles (5-30 km) wide, and extends from the Wasatch Range westward to the Great Salt Lake, and from Willard, in Box Elder County southward to Centerville (Feth and others, 1966; Clark and others, 1990; Gates, 1995). The Bountiful sub-area covers about 40 square miles (100 km²) extending from northern Centerville to the Salt Lake County line (figure 2) (Thomas and Nelson, 1948; Clark, 1991).

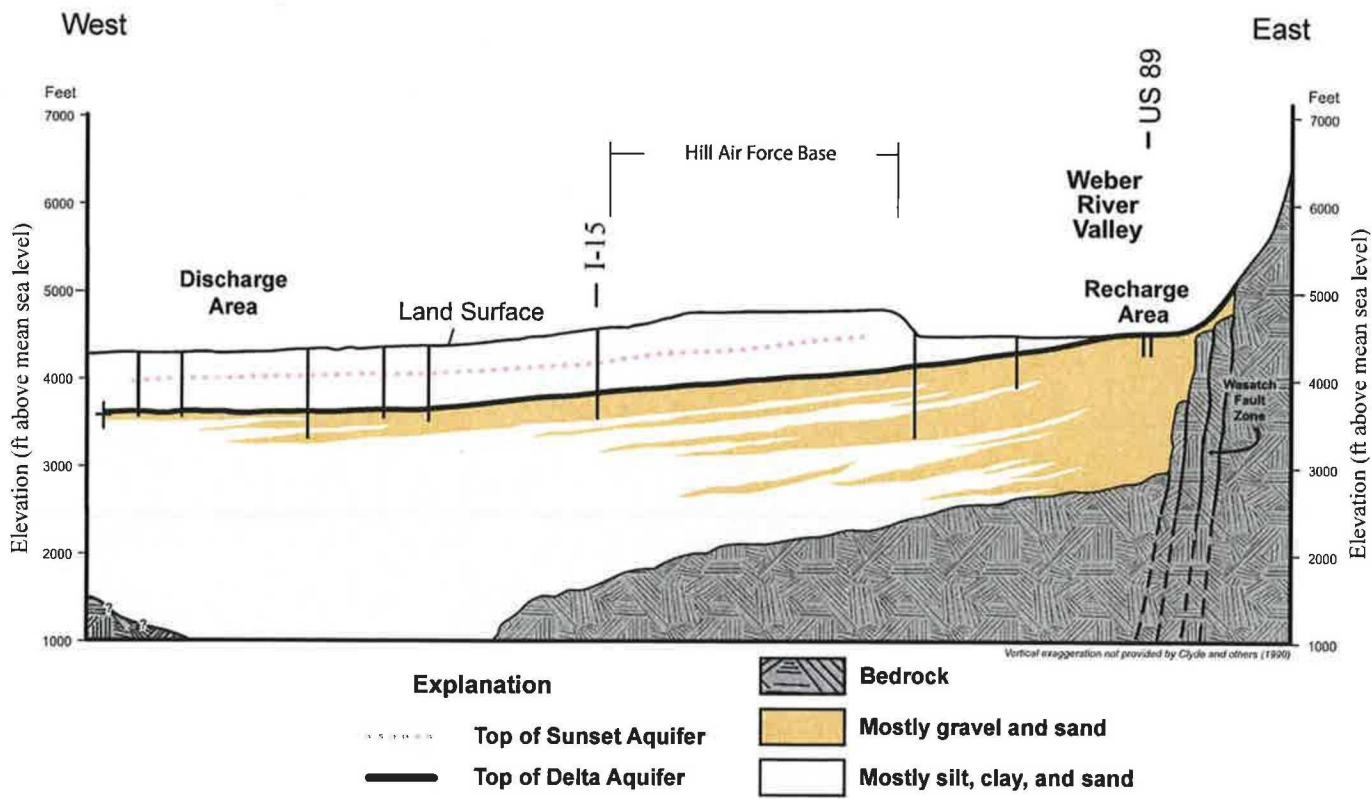
Figure 3. Geologic profile through the central Weber Delta subdistrict, east shore area of Great Salt Lake, Utah (modified from Hurlow and others, 2011).

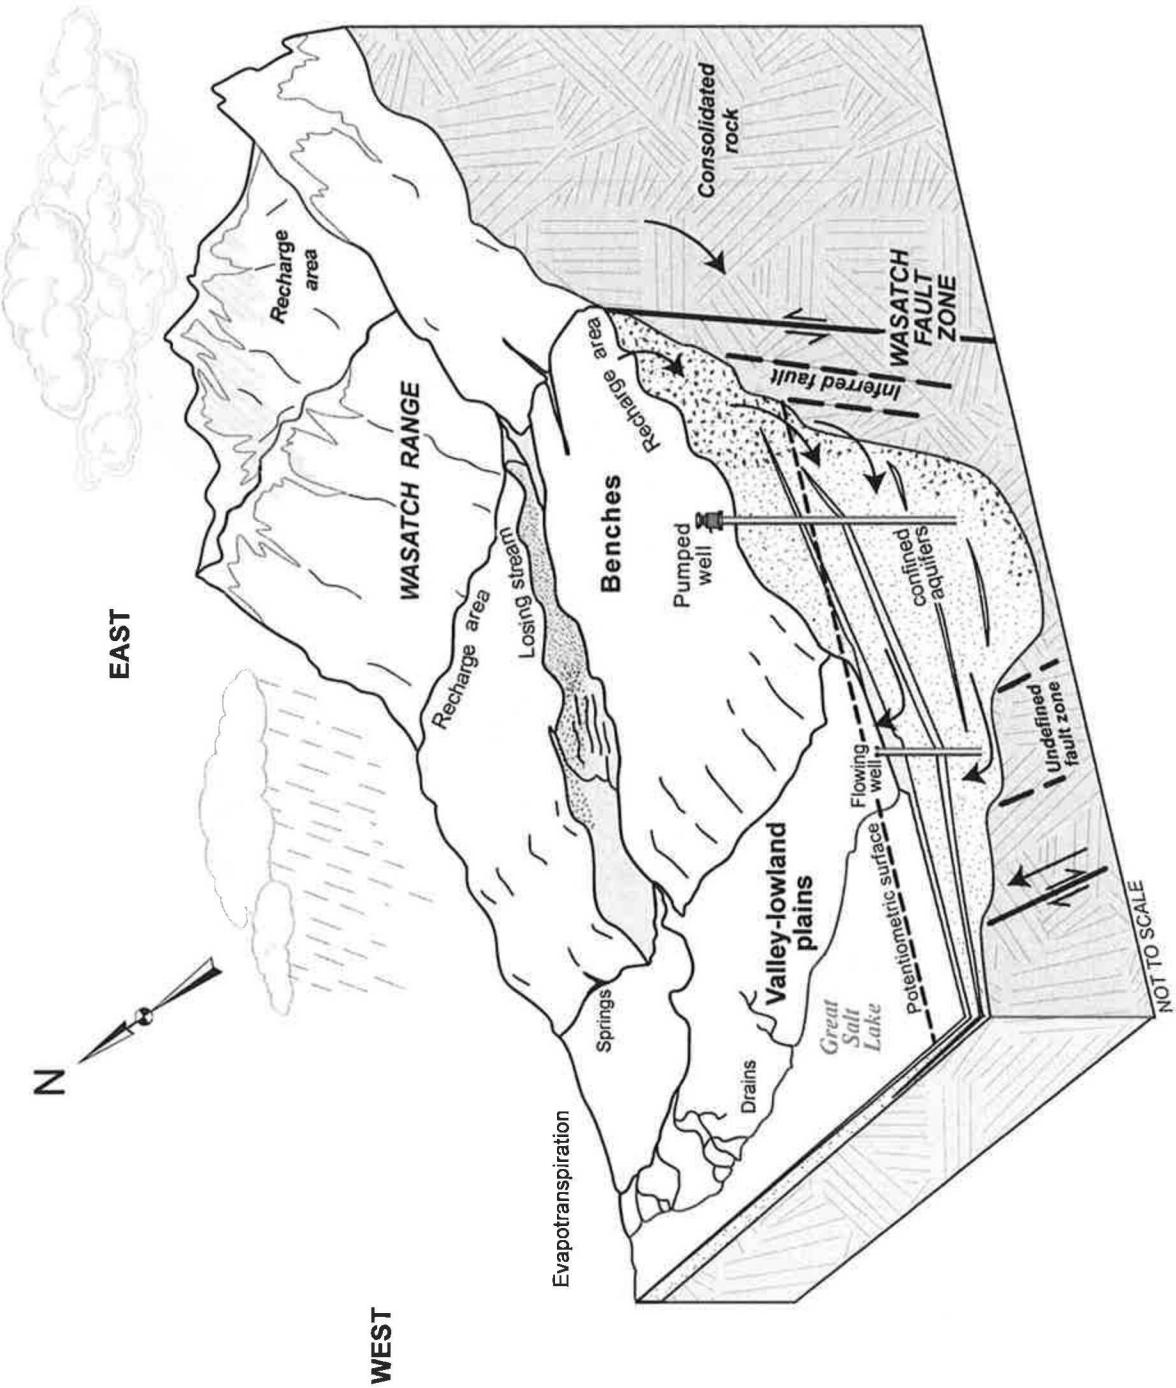
Figure 4. Generalized block diagram showing water-bearing formations, probable direction of ground-water movement (arrows), and areas of recharge and discharge, east shore area of Great Salt Lake, Davis County, Utah (after Clark and others, 1990).

Important ground-water resources in the east shore area exist in unconsolidated to semiconsolidated Quaternary basin-fill deposits (Feth and others, 1966; Clark and others, 1990). These deposits include relatively coarse-grained alluvial sediments near the mountain front, and finer grained lacustrine and alluvial sediments westward away from the mountains (Feth and others, 1966; Bolke and Waddell, 1972; Clark and others, 1990) (figure 4).

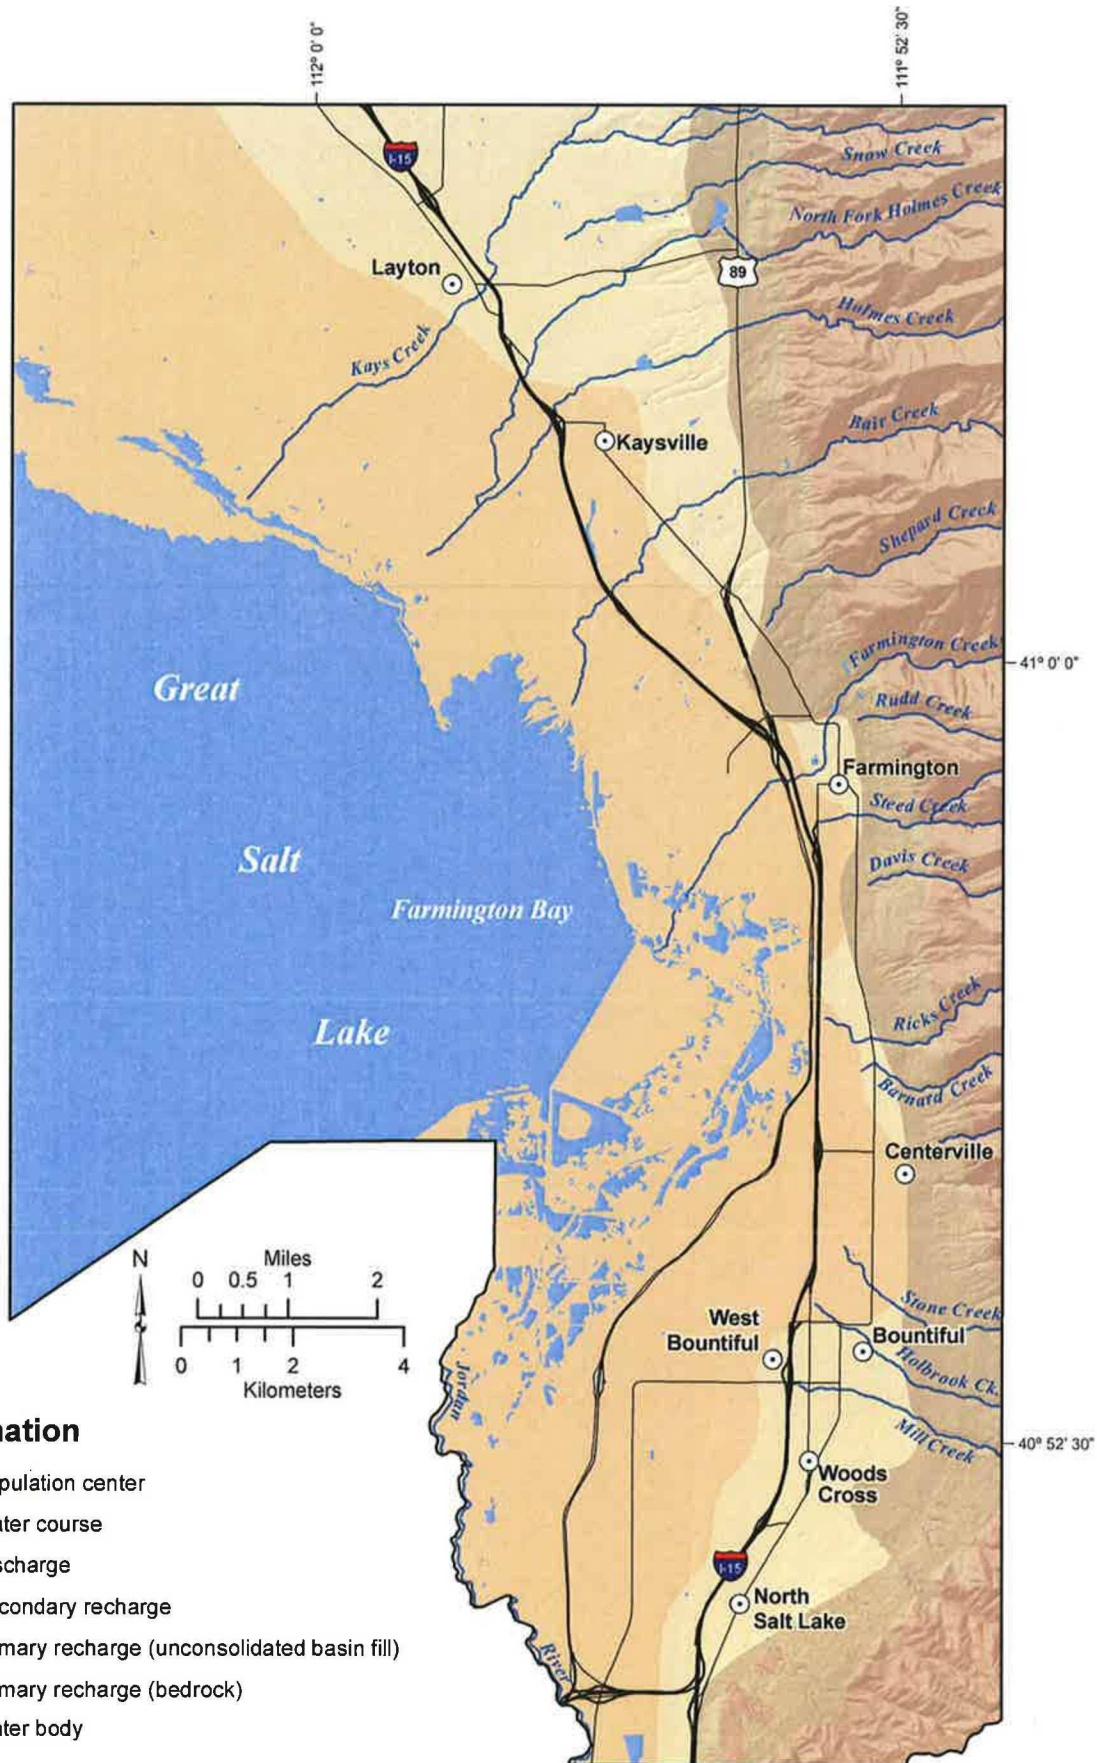
Figure 5. Recharge and discharge areas for the east shore area, Davis County, Utah (from Anderson and others, 1994).

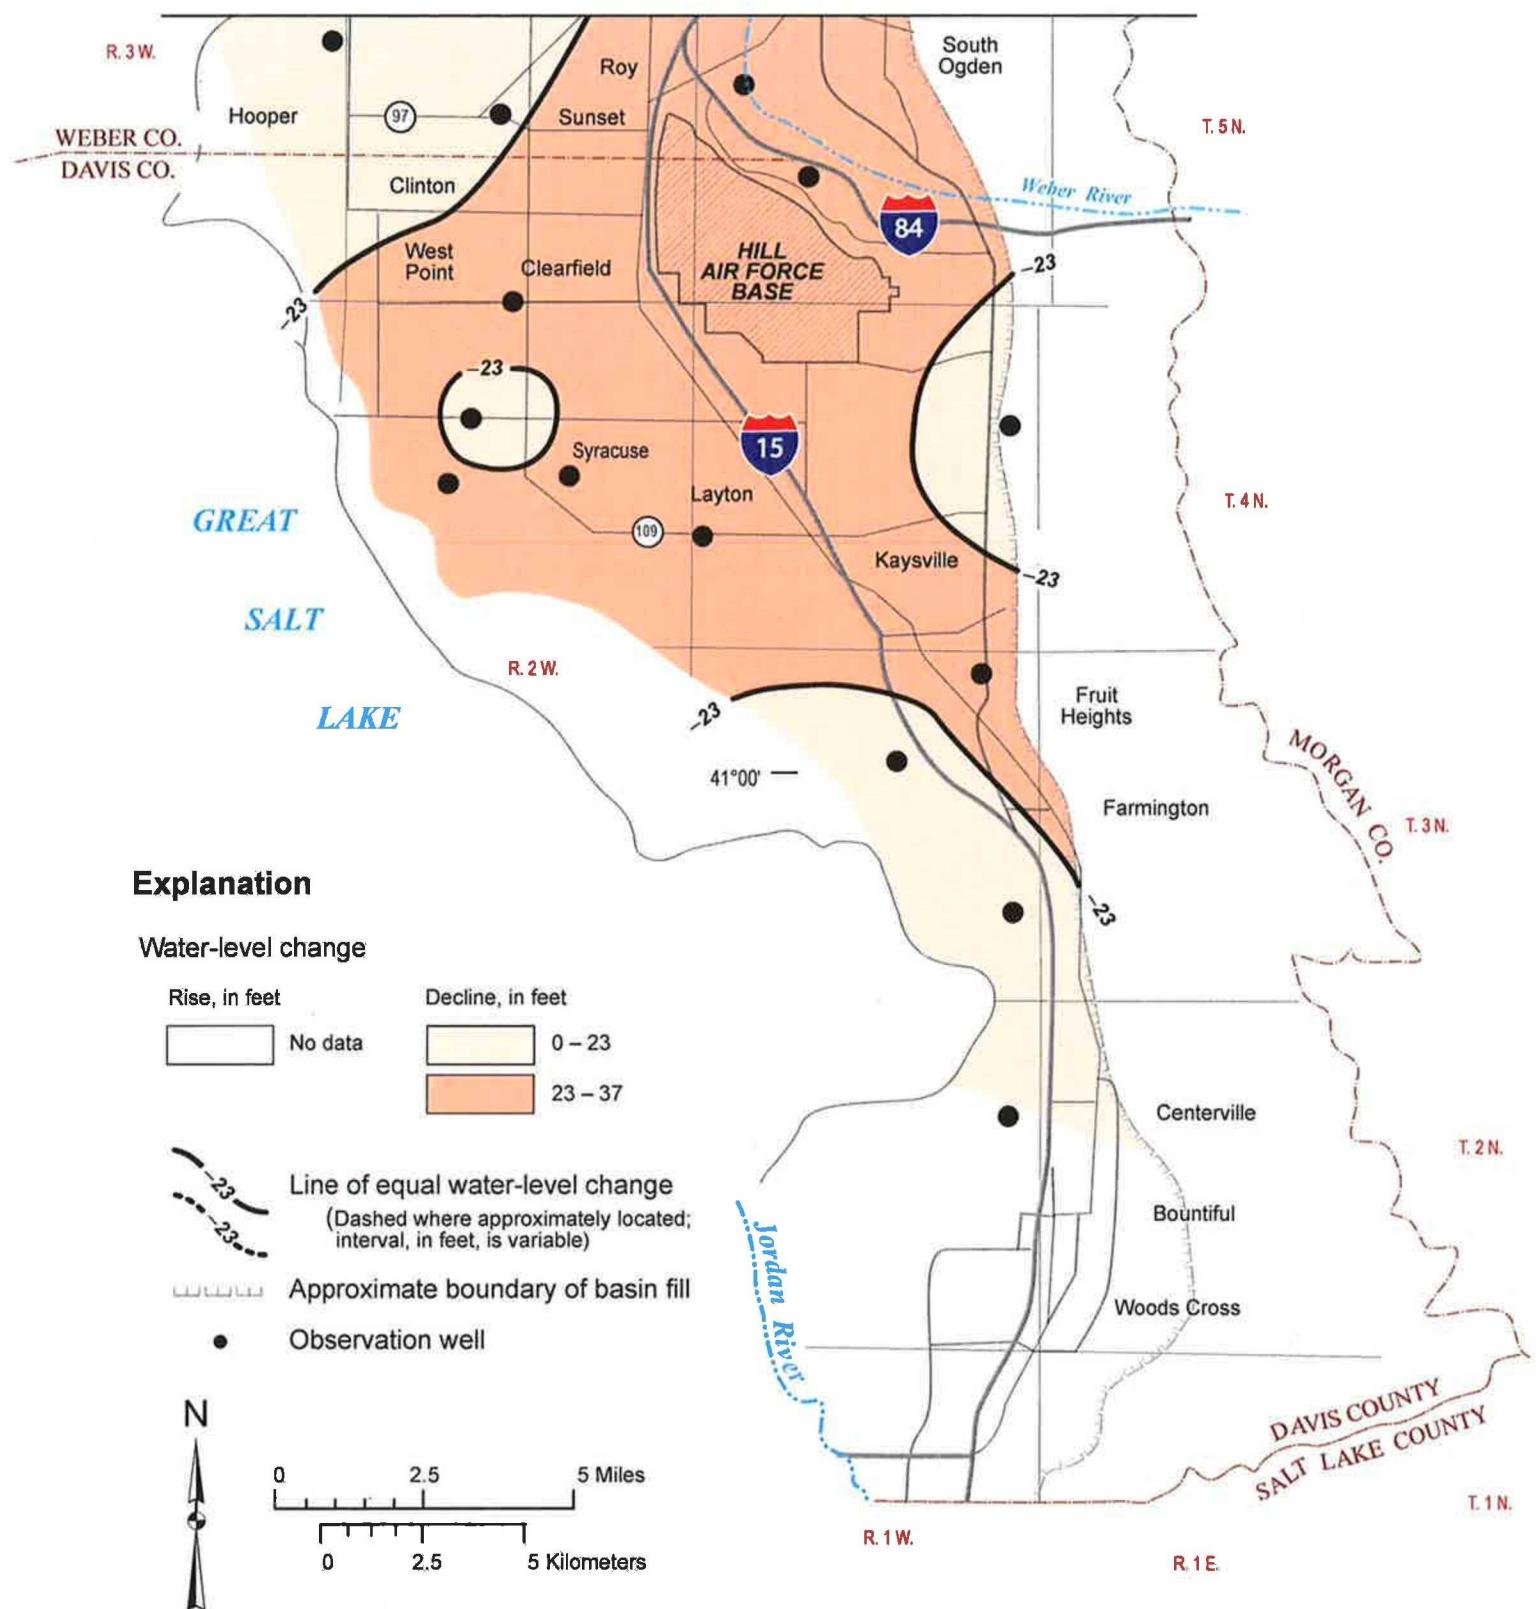
Figure 6. Change of water level from March 1975 to March 2005, east shore area, Weber and Davis Counties, Utah (modified from Burden and others, 2005).

indicating that ground-water mining is a concern. The trend in declining water levels in the east shore aquifer system does not appear to have slowed; Burden and others (2005) documented water-level declines of as much as 36.7 feet (11.2 m) from 1975 to 2005 (figure 6).

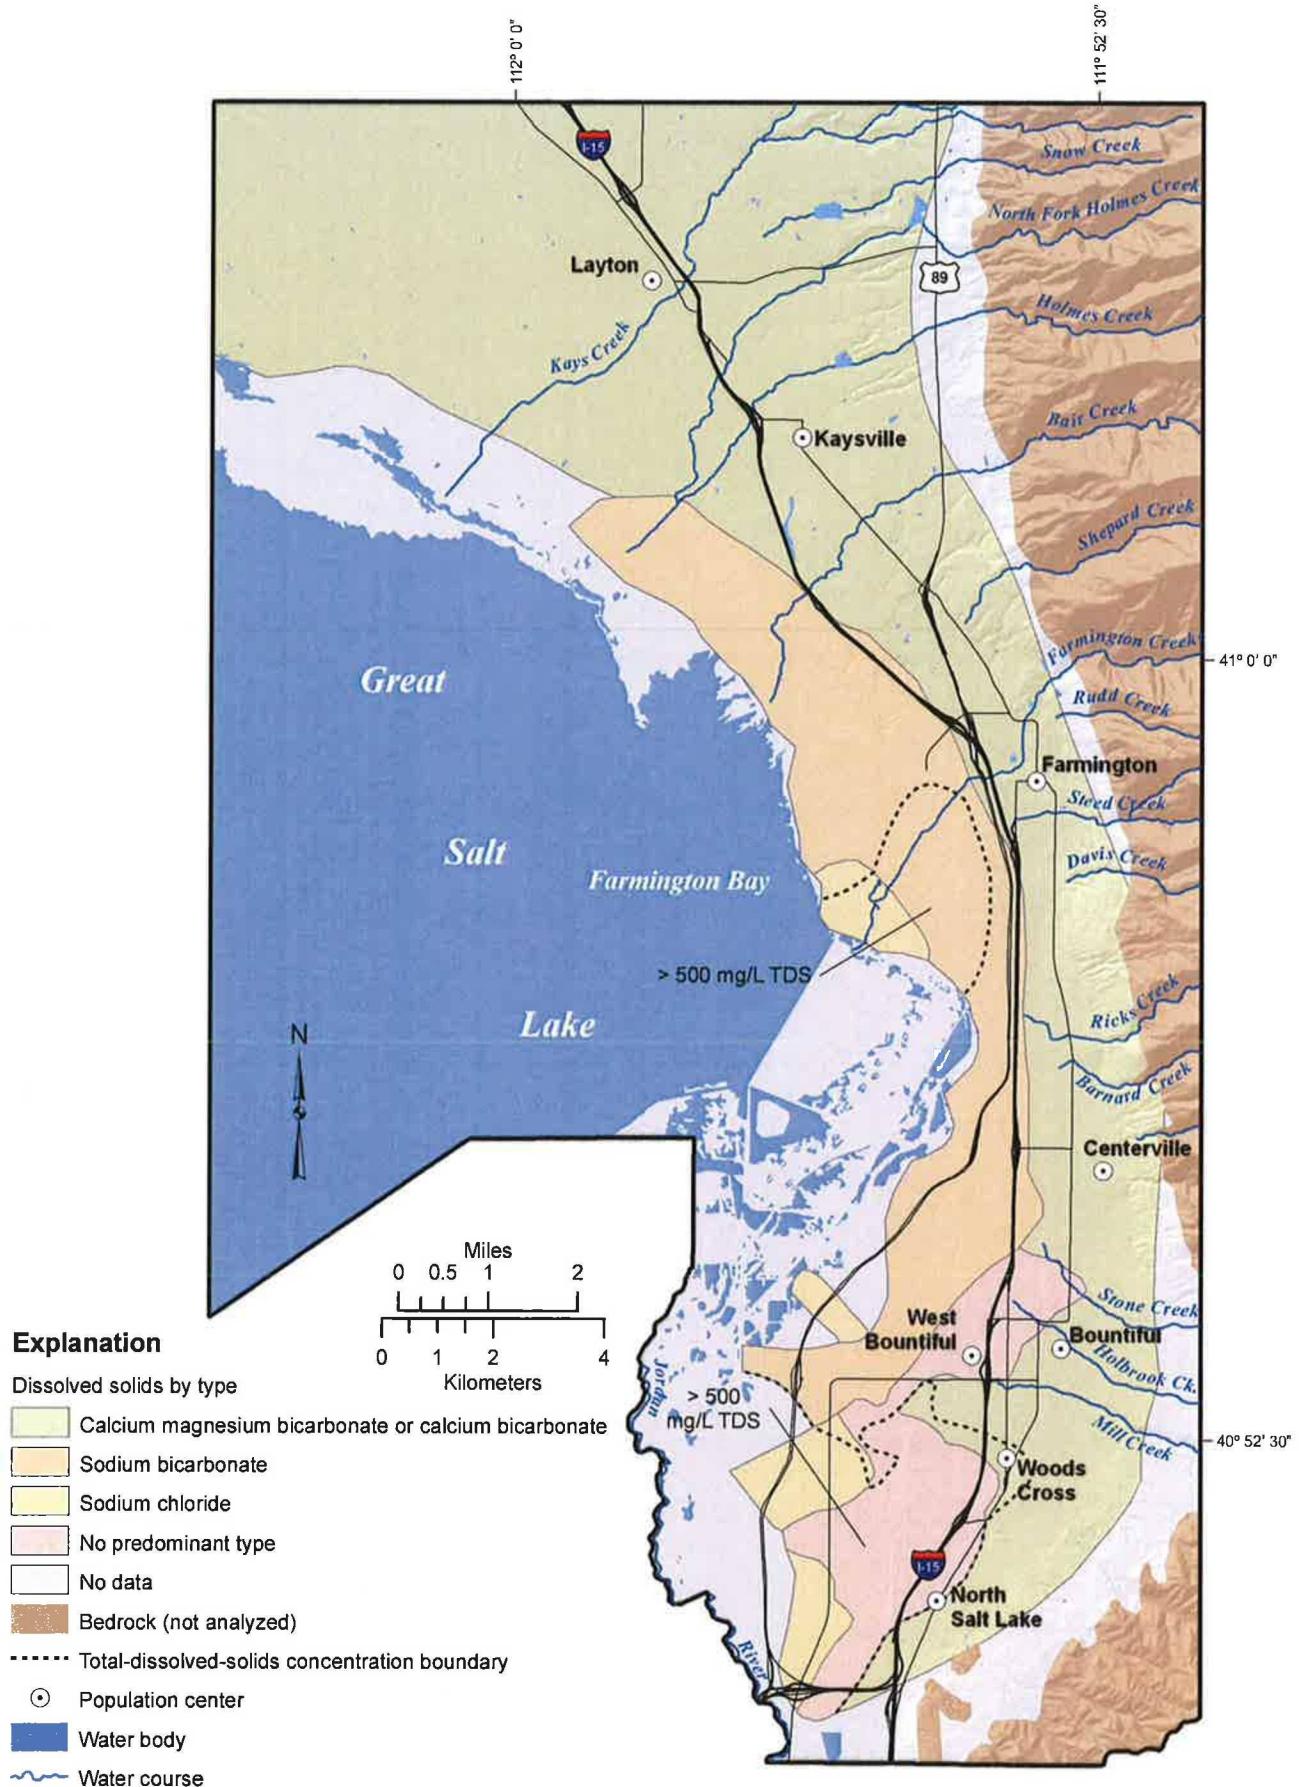
Figure 7. Ground-water quality types and areas with greater than or less than 500 mg/L total-dissolved-solids (TDS) concentrations, east shore area, Davis County, Utah (modified from Clark and others, 1990).

Ground-water quality in the east shore area aquifer system is generally good, with total-dissolved-solids (TDS) concentrations ranging from 92 mg/L to 9800 mg/L, based on ground-water quality data from Smith (1961, table 3), Smith and Gates (1963, table 4), Feth and others (1966, table 9), Bolke and Waddell (1972, table 2), Plantz and others (1986, table 5), Clark and others (1990, table 13), and Anderson and others (1994, table 2). Geochemically, ground-water types in the east shore aquifer system are calcium-magnesium-bicarbonate, sodium-bicarbonate, sodium-chloride, and no predominant type (Smith and Gates, 1963; Feth and others, 1966; Bolke and Waddell, 1972; Clark and others, 1990) (figure 7). The calcium-magnesium-bicarbonate type is the predominant ground-water type in the east shore area of Great Salt Lake, and generally contains less than 300 mg/L TDS (Feth and others, 1966, figure 14). The sodium-bicarbonate type ground water is along the eastern margin of Great Salt Lake in the southern part of the study area, and generally contains less than 400 mg/L TDS (Smith and Gates, 1963). The sodium-chloride type occurs mostly in a few areas along the shore of Great Salt Lake, and contains from 500 mg/L TDS to more than 9000 mg/L TDS (Smith and Gates, 1963, figure 8; Feth and others, 1966, figure 14). Mixed-type water exists in the Bountiful/North Salt Lake area, and contains from 500 to 1000 mg/L TDS (Smith and Gates, 1963, figure 8; Feth and others, 1966, figure 14).

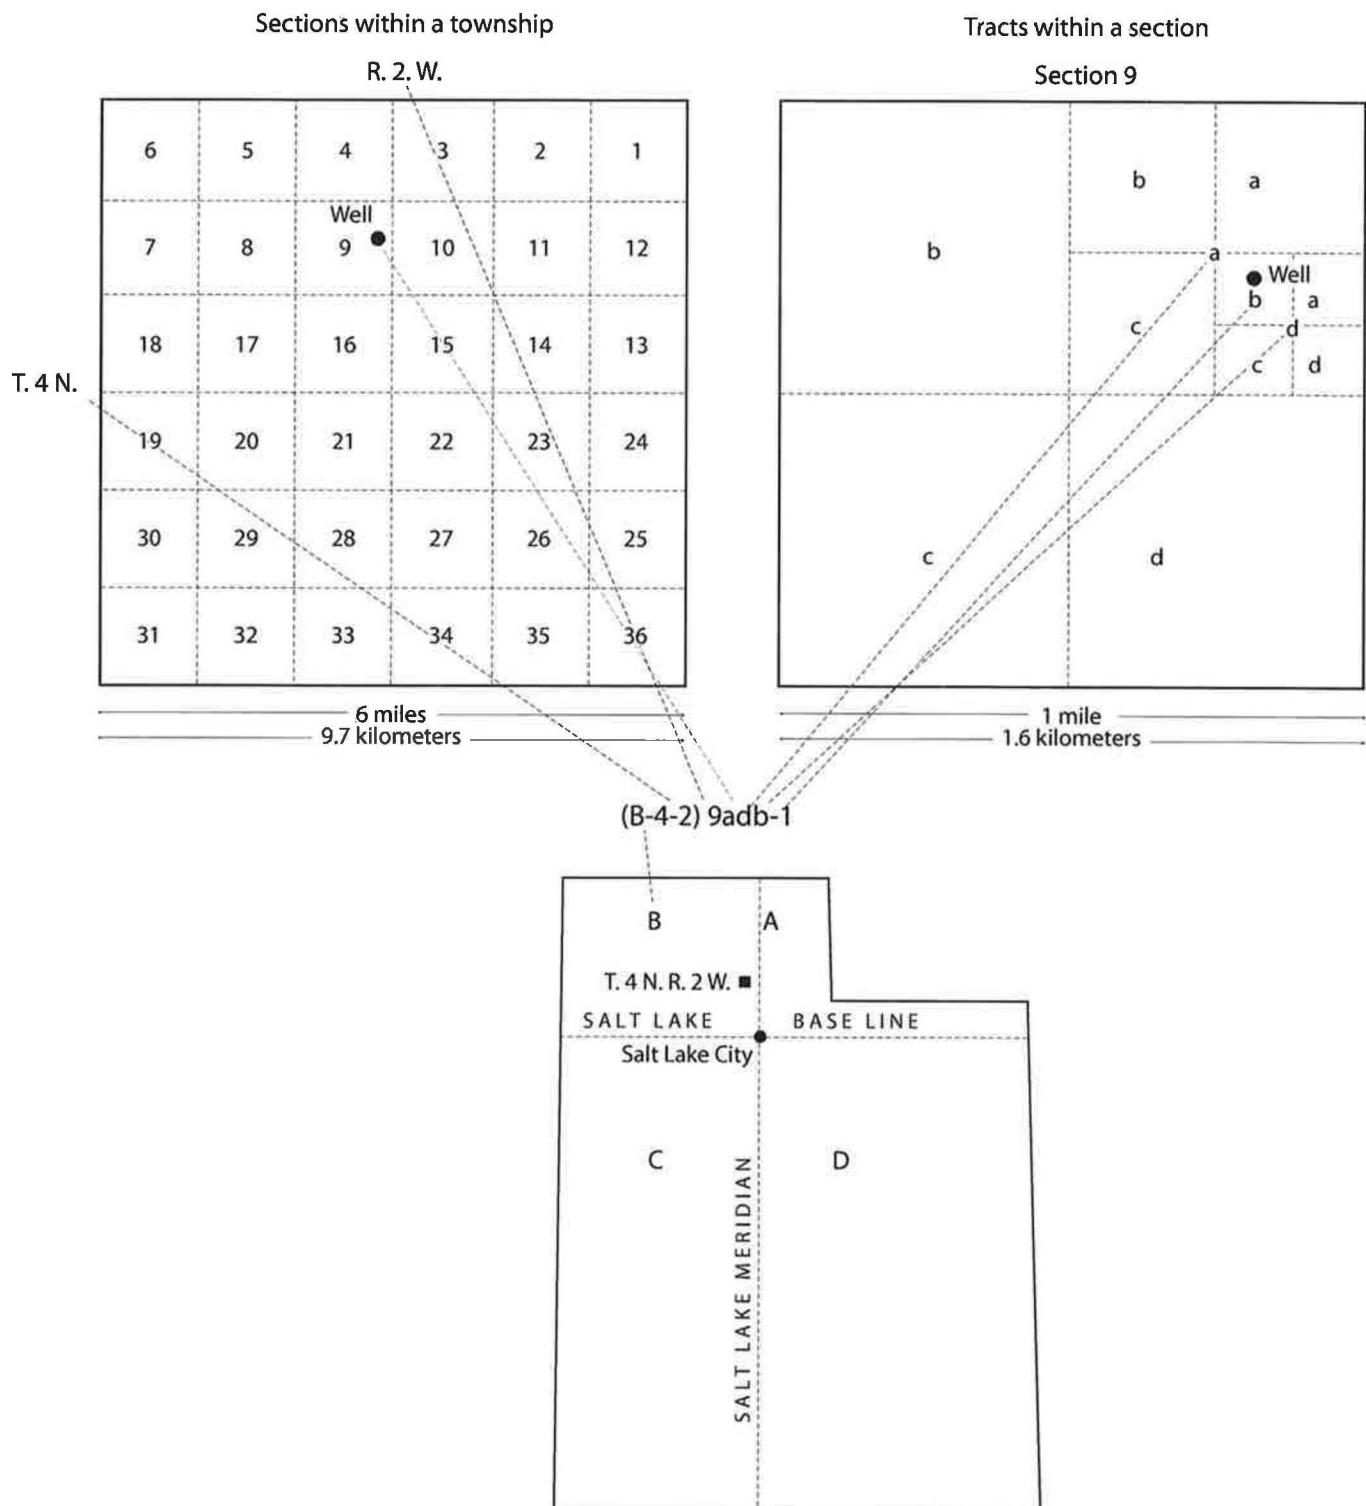
Figure A.1. Numbering system for wells in Utah using USGS cadastral location.

The numbering system for wells in this study is based on the Federal Government cadastral land-survey system that divides Utah into four quadrants (A-D) separated by the Salt Lake Base Line and Meridian (figure A.1.). The study area includes the northwestern quadrant (D). The wells are numbered with this quadrant letter (B), followed by township and range, all enclosed in parentheses. The next set of characters indicates the section, quarter section, quarter-quarter section, and quarter-quarter-quarter section designated by letters a through d, indicating the northeastern, northwestern, southwestern, and southeastern quadrants, respectively. A number after the hyphen corresponds to an individual well within a quarter-quarter-quarter section. For example, the well (B-4-2)9adb-1 would be the first well in the northwestern quarter of the southeastern quarter of the northeastern quarter of section 9, Township 4 North, Range 2 West (NW $\frac{1}{4}$ SE $\frac{1}{4}$ NE $\frac{1}{4}$ section 9, T. 4 N., R. 2 W.).
