Temperature Total Maximum Daily Load (TMDL) for Upper Nine Mile Creek Watershed

EPA Approval Date: March 2, 2017

Prepared for:
US Environmental Protection Agency, Region 8

Prepared by:
Utah Department of Environmental Quality
Division of Water Quality
Sandy Wingert, Project Manager
Ben Holcomb, Technical Support
Jim Bowcutt, Implementation
Carl Adams, Project Supervisor

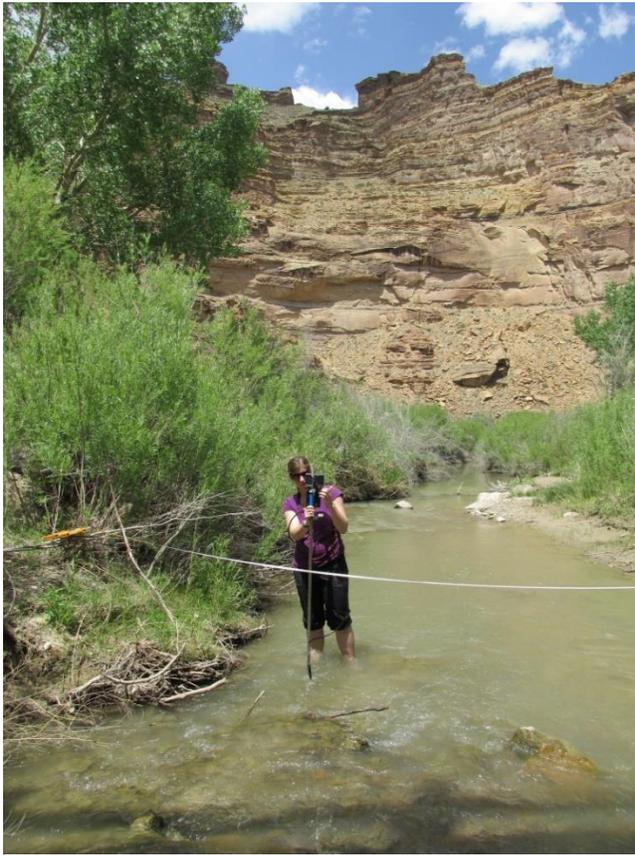
Figure 33. Measuring Instantaneous Stream Flow in Nine Mile Creek.

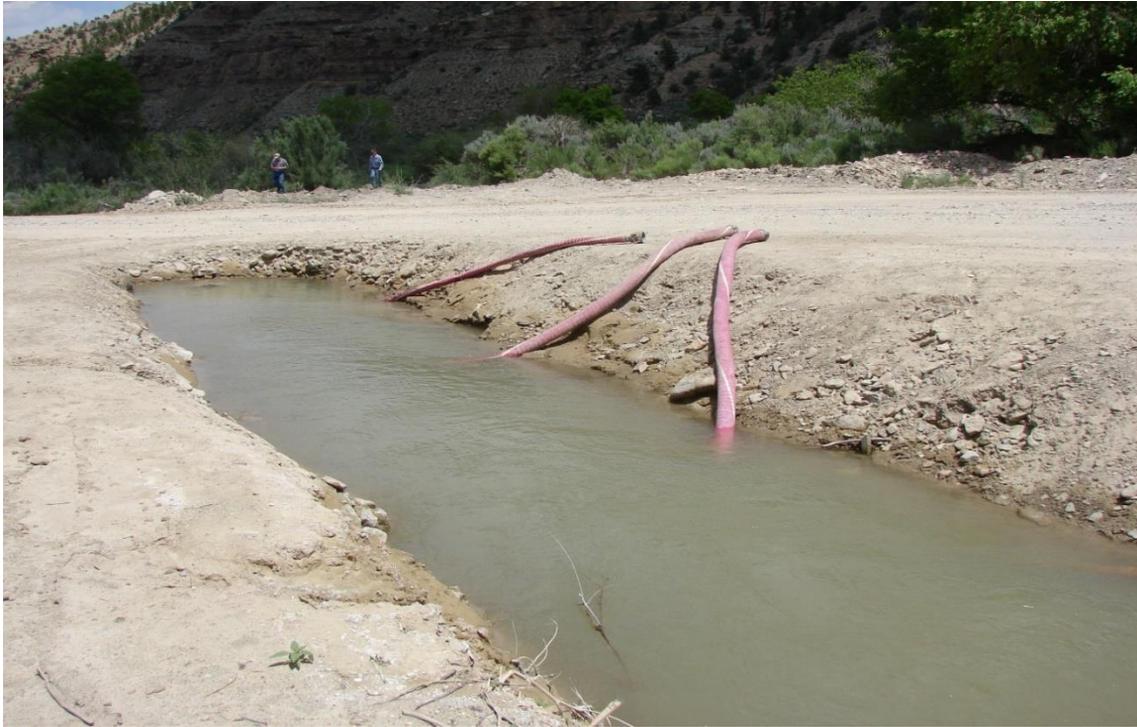
Figure 34. Water Withdrawal Staging Area for Energy Development Along Banks of Nine Mile Creek.

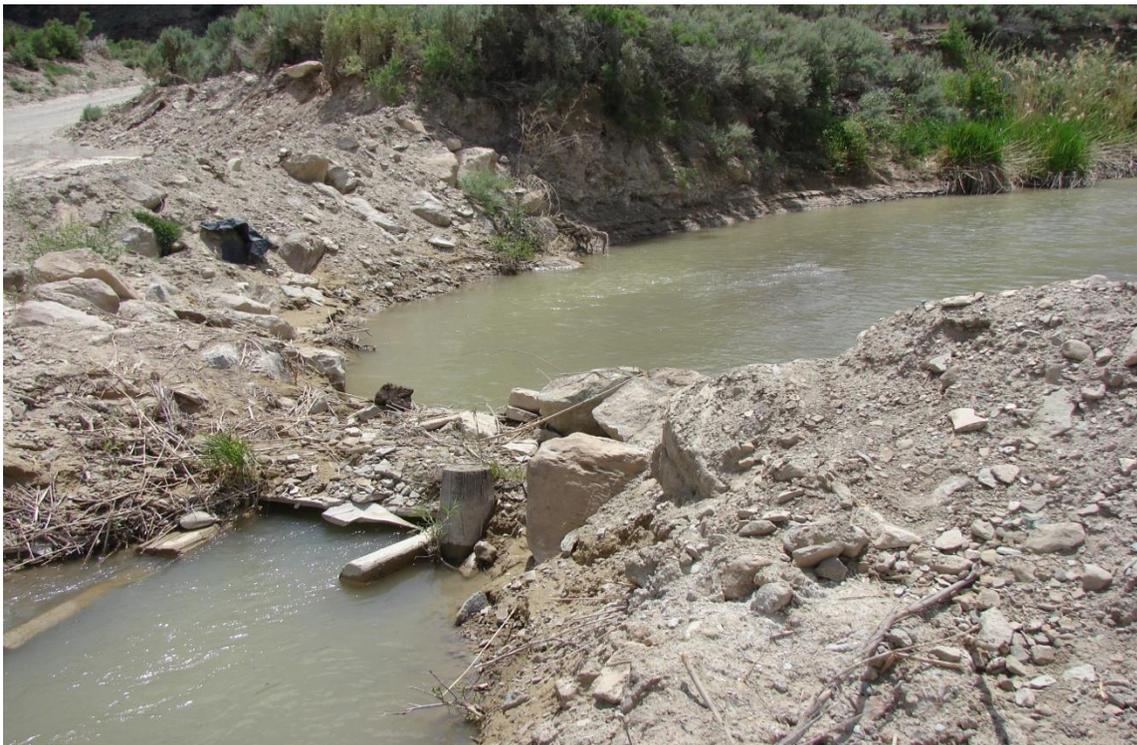
Figure 35. Nine Mile Creek Dammed for Water Withdrawal for Energy Development.

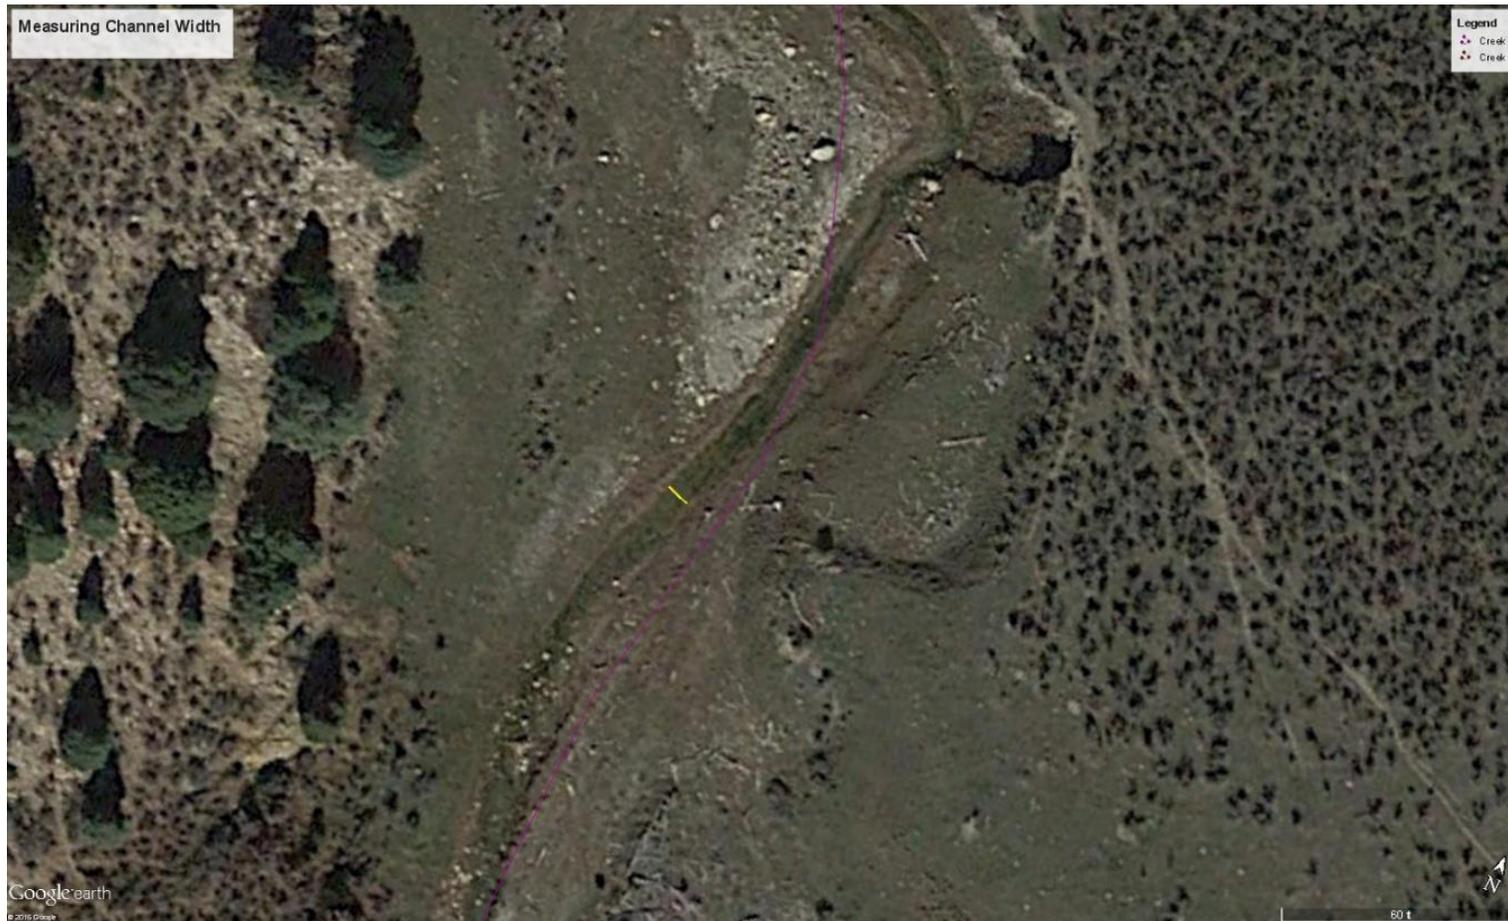
Figure 40. Example of Collecting Stream Widths (yellow hash mark) in Google Earth Pro. This example has an estimated 2.05m width.
