# East Bench – Sevier River NWQI/MRBI Watershed Assessment

Figure 1.1.a East Bench-Sevier River Watershed

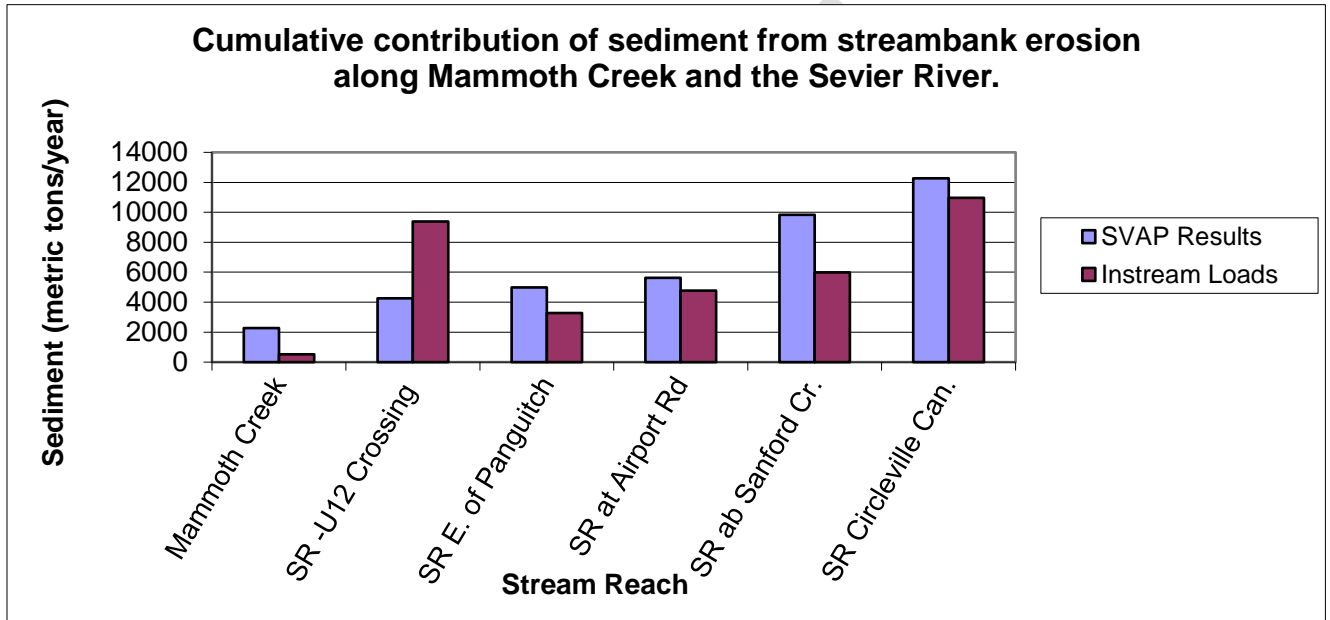
Figure 3.3.g Estimated sediment loads from streambank erosion.

Relative increases in sediment as TSS as measured in in-stream loads from water quality data mirror the increases predicted during the survey using SECI protocol. While the SECI estimates the total amount of sediment delivered to the stream from the volume of material being lost each year, TSS only measures the suspended fraction of sediment transported in the stream. The estimates of streambank erosion would be expected to be higher since not all of the material entering a stream would be suspended in the water column but comprise bed load as well. Since the SECI survey was incomplete and did not include other tributaries we would expect the sediment contribution to be much greater. The site at SR at U12 crossing exhibited extremely high TSS values in the 2001-02 intensive sampling season which is responsible for the spike in TSS load at this site. In addition, numerous irrigation withdrawals in the area upstream of Panguitch may regulate the amount of TSS in the river since in some cases the withdrawals are complete dry dams and the water is flooded onto fields to the east of the Valley. The monitoring station 4949660 (Sevier River East of Panguitch) is one such site, located below a complete diversion which had resulted in lower observed stream flow and loads for both TSS and phosphorus.

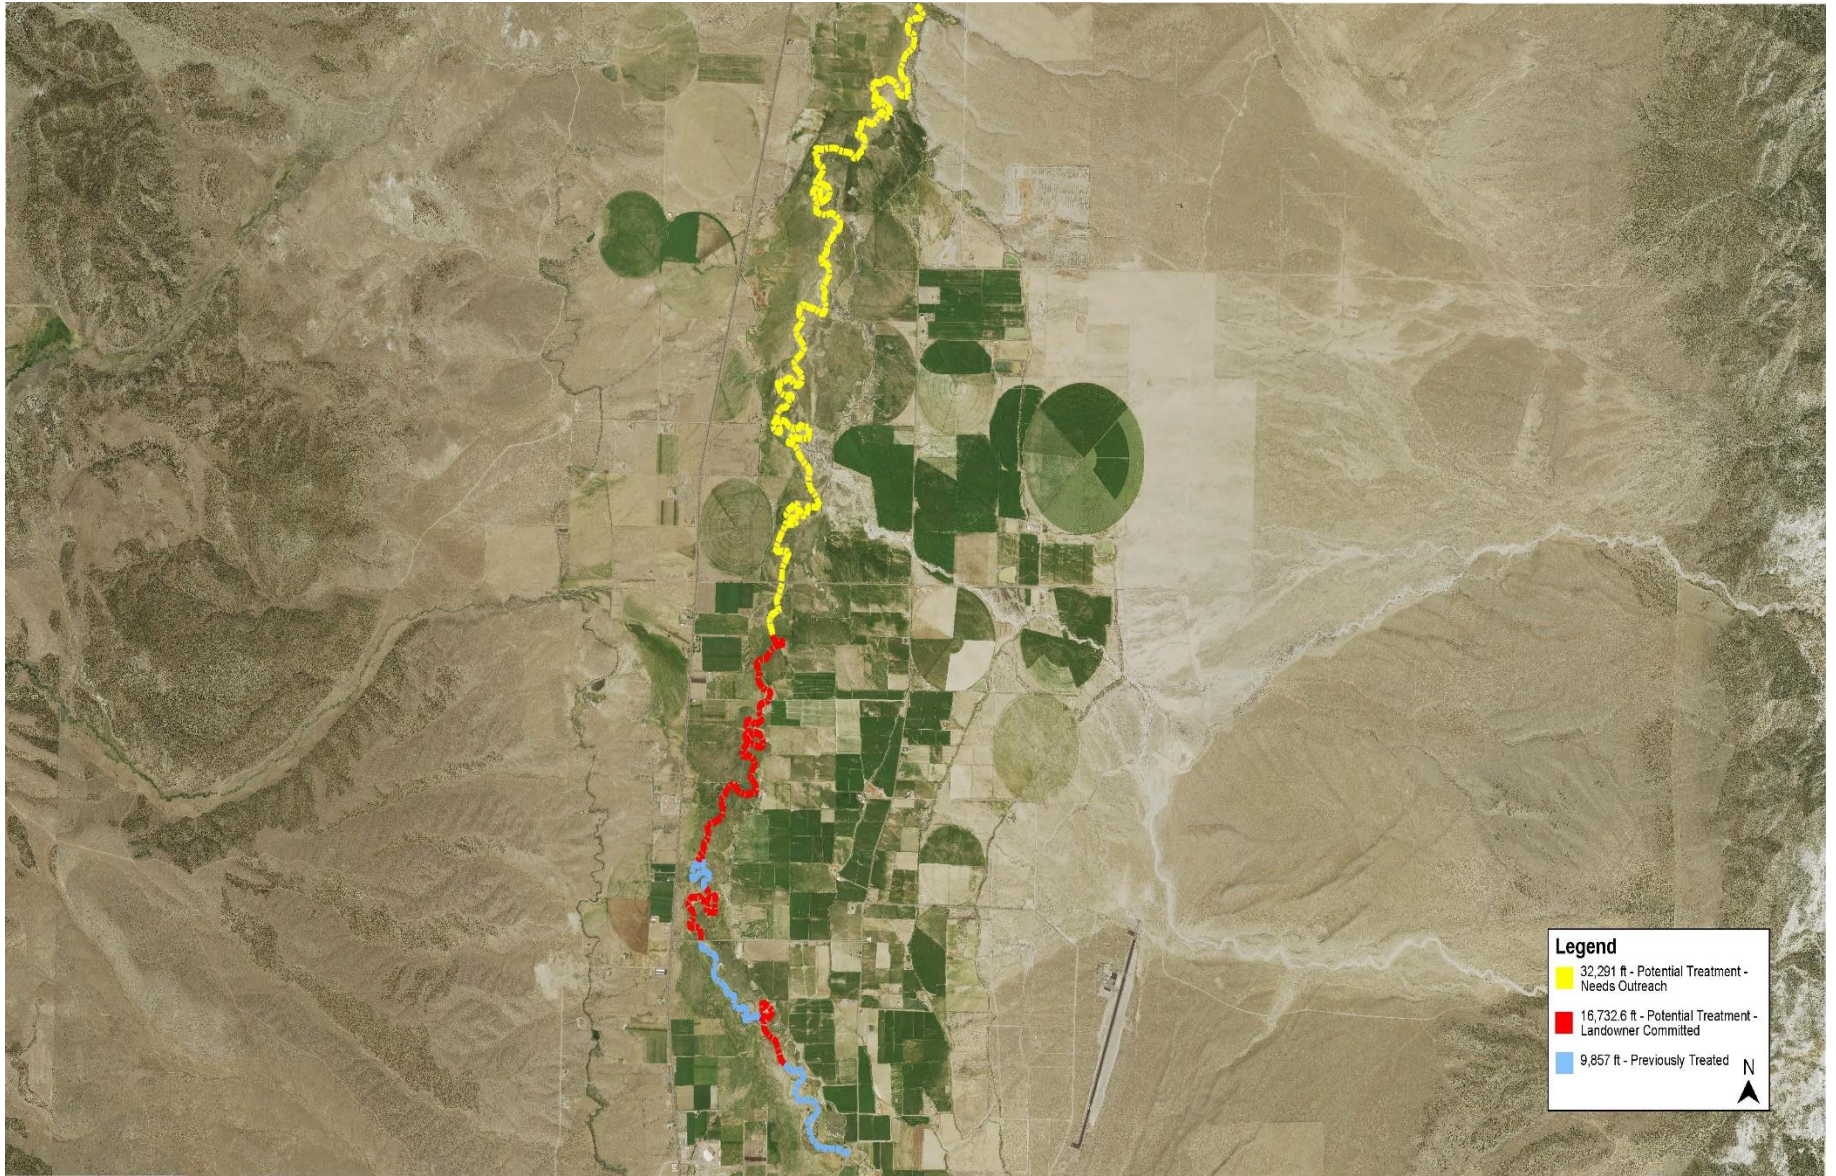
Figure 4.4.a Treatment Areas

The following maps show the irrigated acres along the stream, the potential treatment areas, those that have been restored along the stream, and those that are planned to be restored.
